## EVALUATION AND ASSESSMENT

LITCHFIELD SCHOOL DISTRICT

LITCHFIELD, NEW HAMPSHIRE

SEPTEMBER 27, 2017

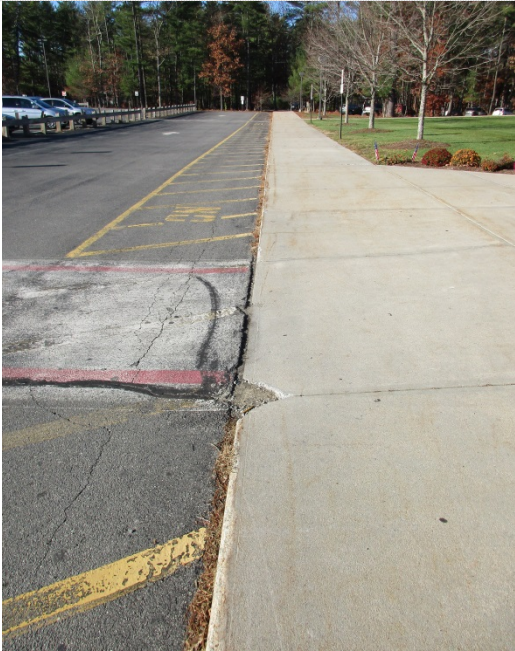
Concrete deterioration at main entrance; no detectable plate. Note faded striping.

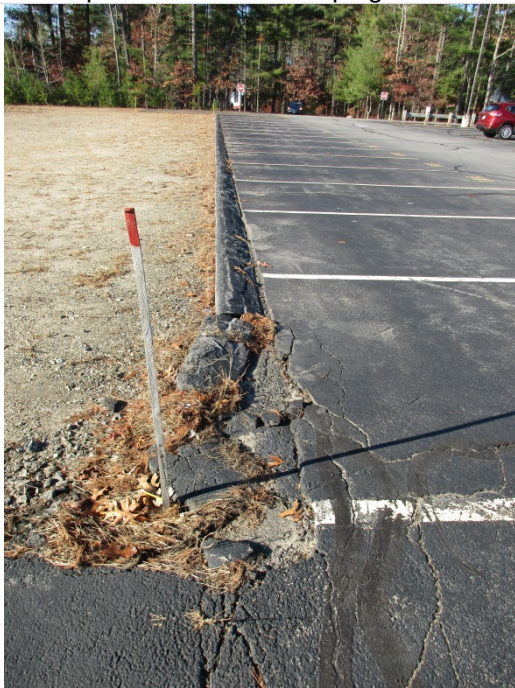
Cracked, broken asphalt & curbing

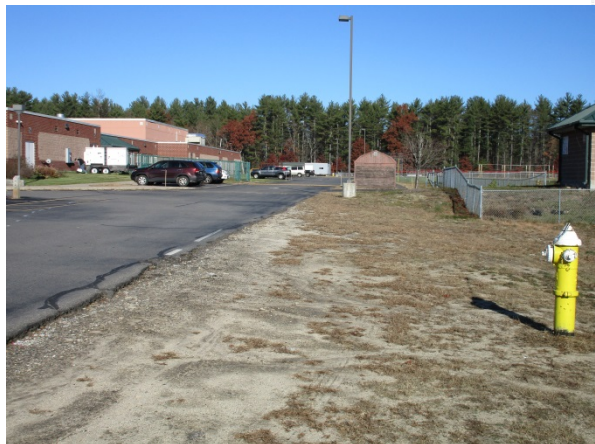
Erosion & sparse vegetation at edge of pavement

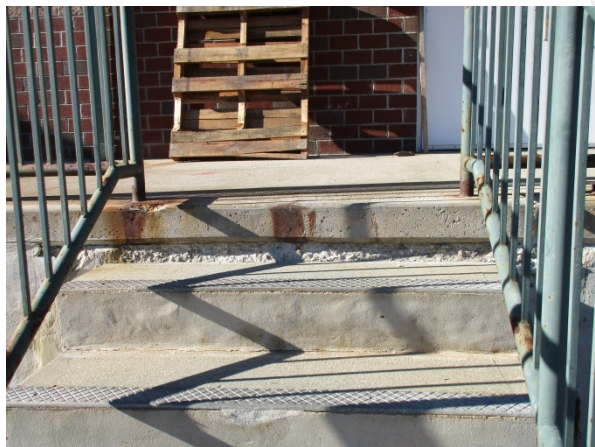
Concrete corrosion at loading dock stairs.

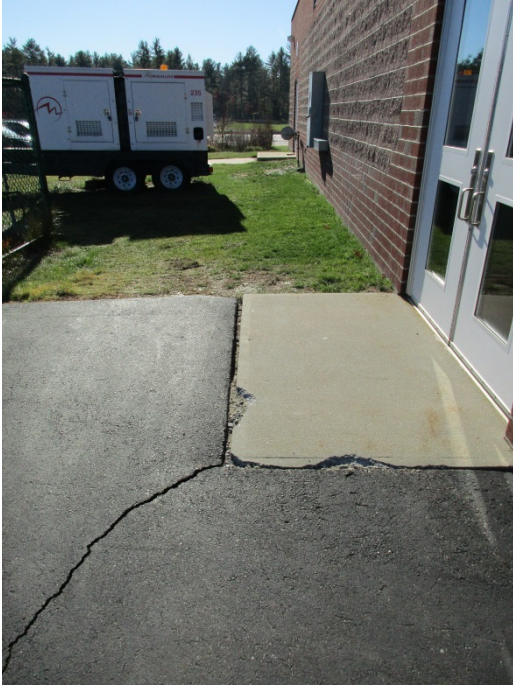
At door 25D there is a gap between the door pad and the asphalt sidewalk of 1-2 inches in width. This door pad has two significant patches of spalling and there is a large crack in the paved sidewalk angling away from the door pad.

Concrete spalling & asphalt cracking, door 25D

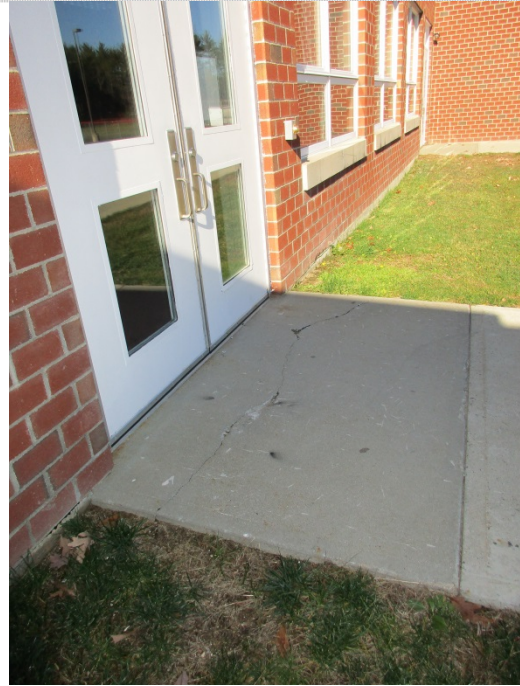
Concrete cracking

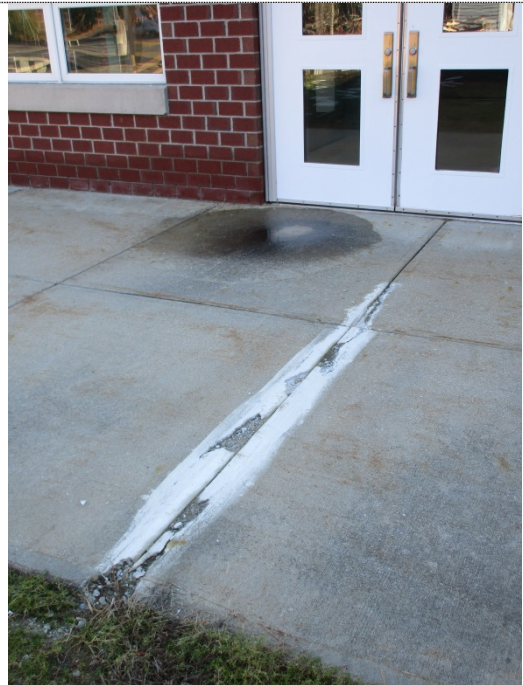
The rain gutter above door 10C leaks and drips water onto the pavement in front of these doors, creating a slip and fall risk during cold weather.

Gutter leak (one of two) & concrete deterioration at door 10C.

- Repair leaks in the roof gutters to eliminate drips onto sidewalk in front of the doors and entrance 10C.
- Develop a Stormwater Inspection and Maintenance Plan, if one doesn't already exist, identifying the components of the stormwater management system that require regular

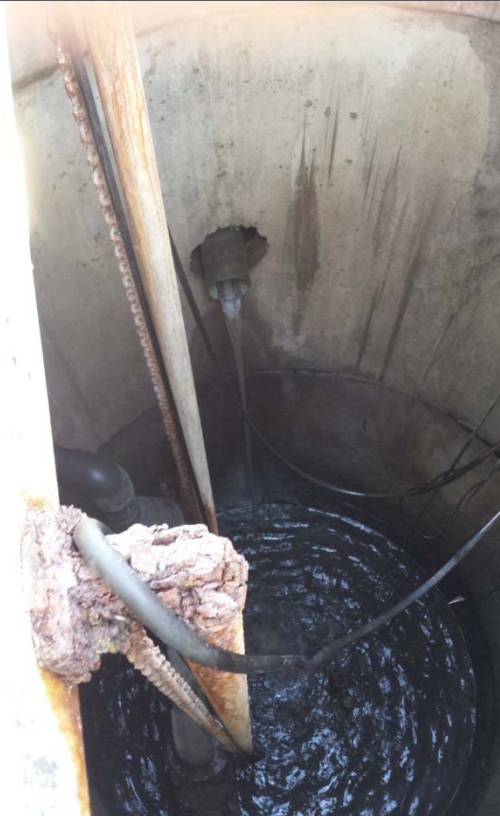
The inside of the pump station is in good condition, with the exception of the brackets securing the pump guide brackets to the sidewall. They are corroded and require replacement. The lifting chains and guide rails are galvanized (as per the design drawings) but the school should consider replacing them with stainless steel because it has greater longevity in the corrosive environment of a sewer pump station.

Corroded pump station components.

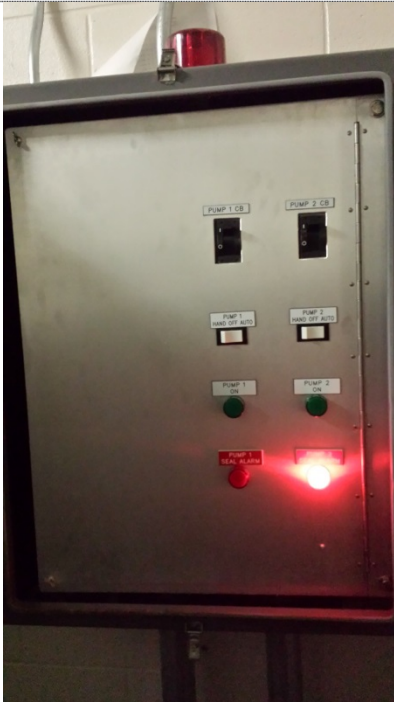
Pump seal failure indicator

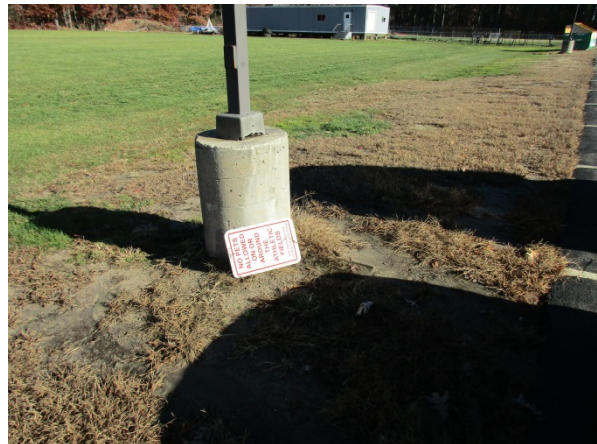
Remount sign.

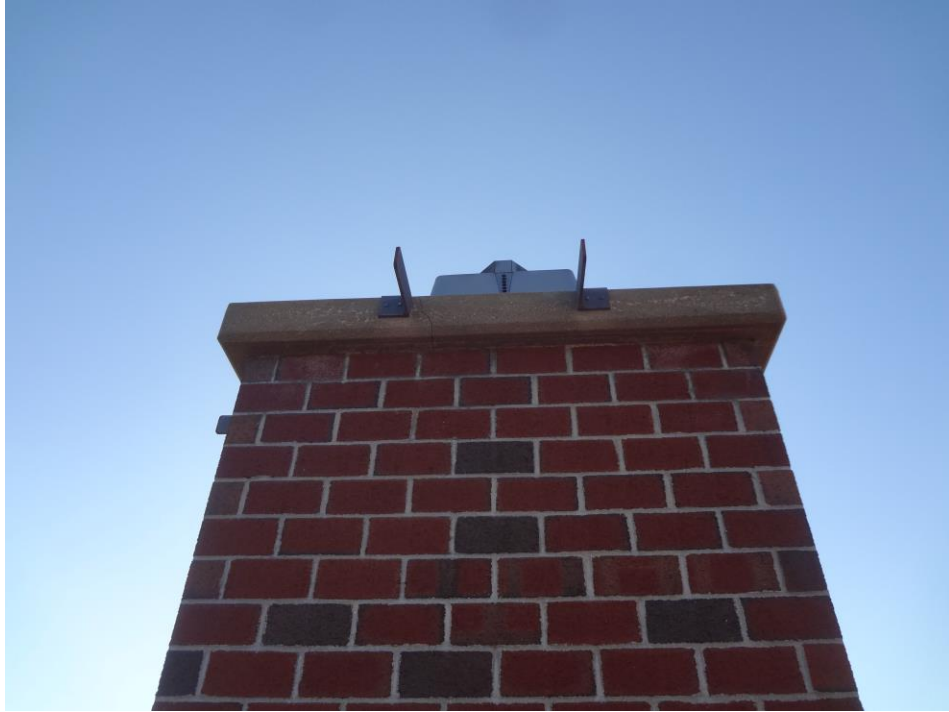
Crack in Concrete Chimney Cap

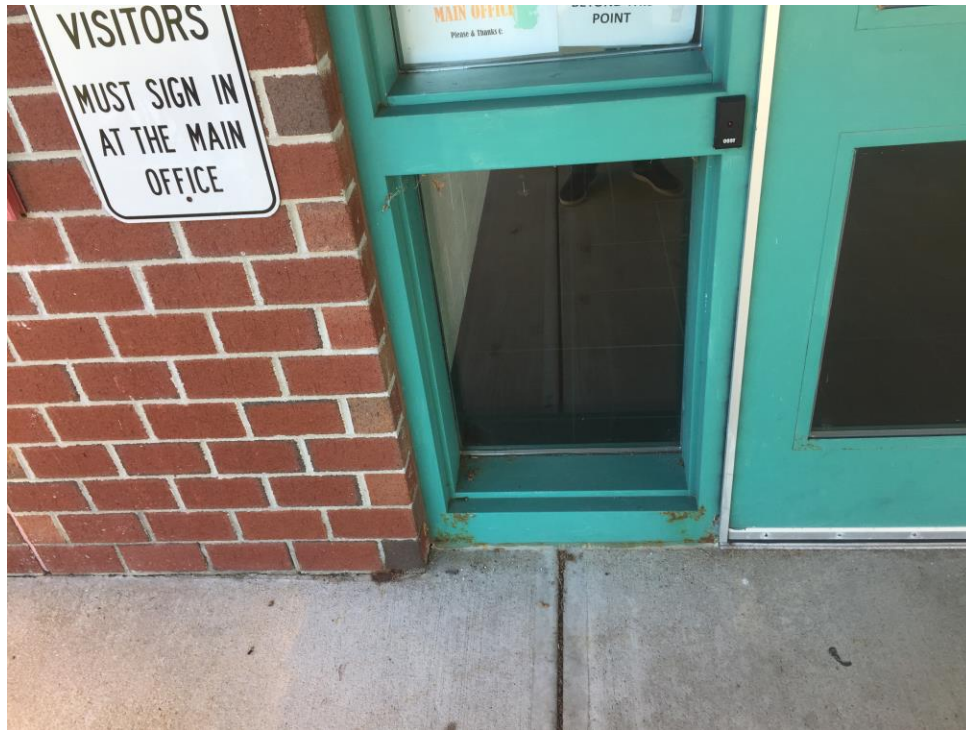
Rusted Door Frame at Main Entry

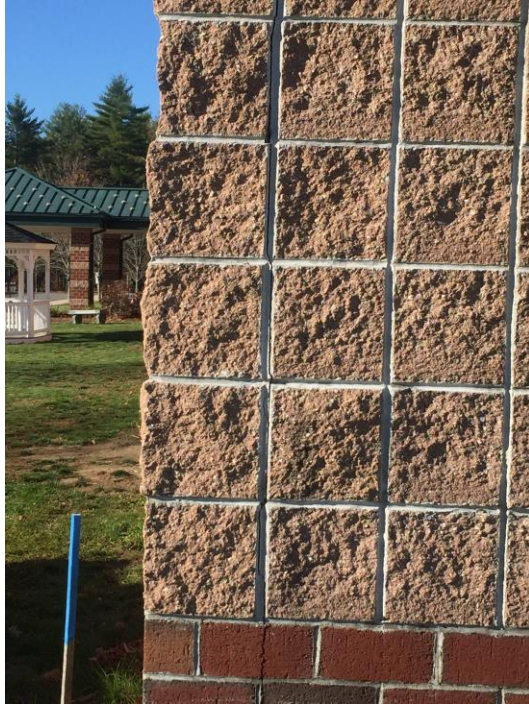
Crack in Mortar Joint

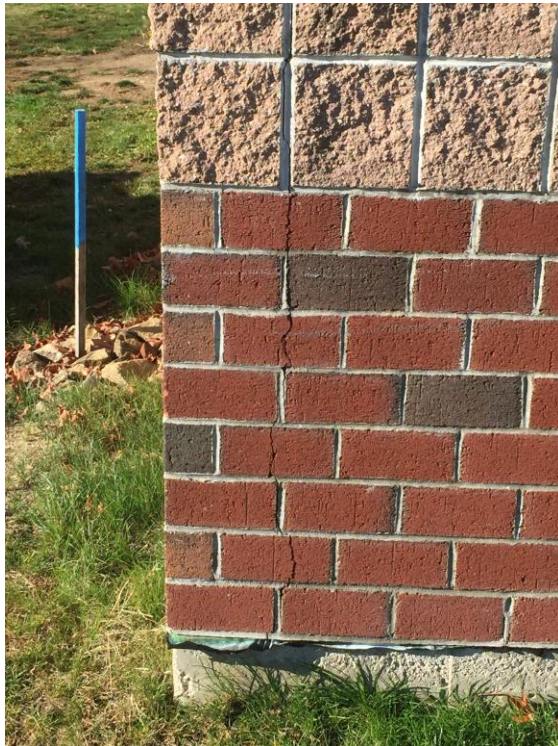
Crack in Brick

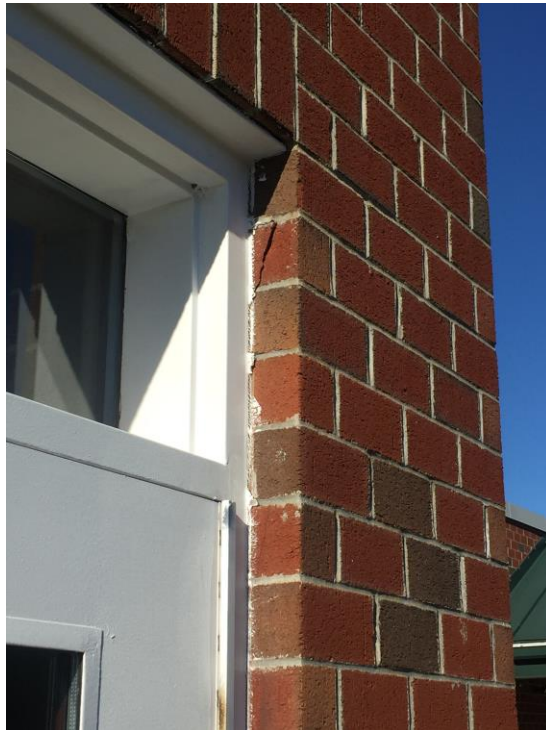
Crack in Brick at Door Head

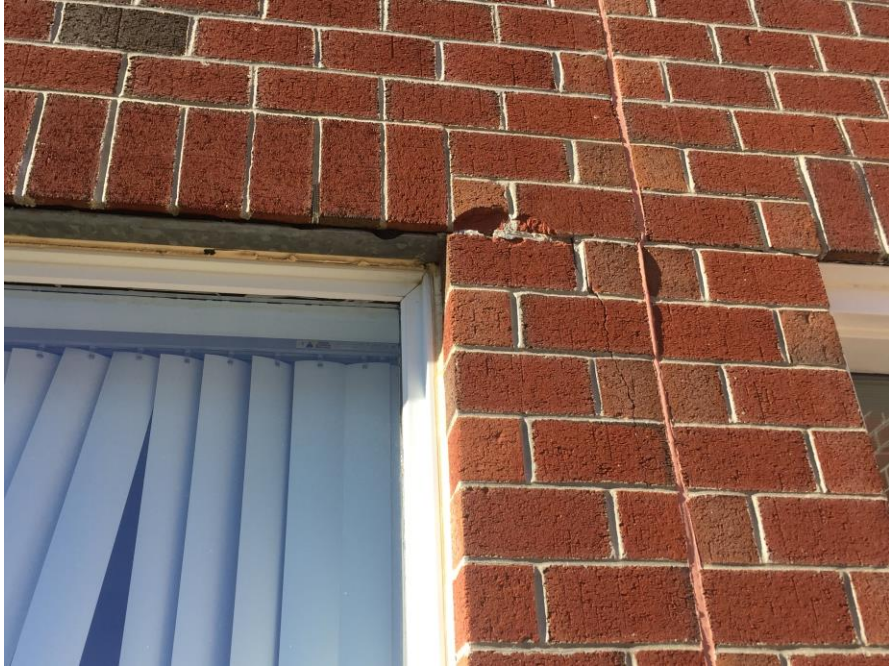
Crack in Brick at Window Head

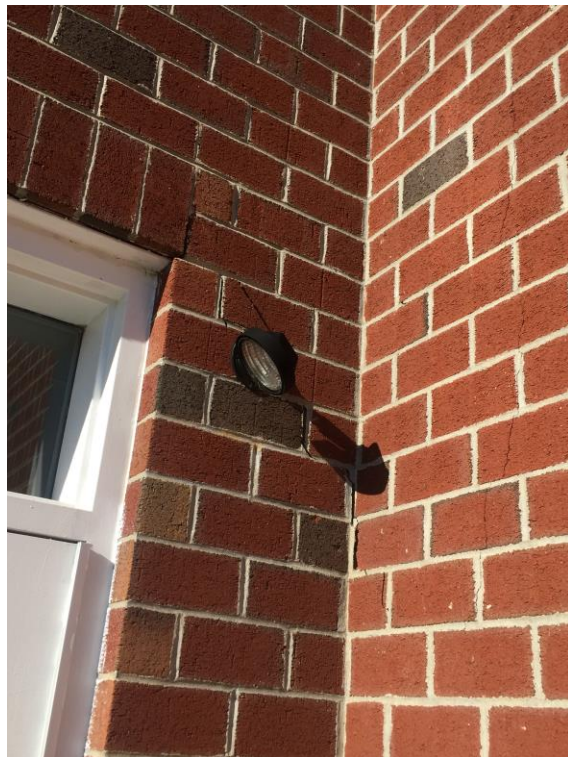
Crack in Brick at Door Head

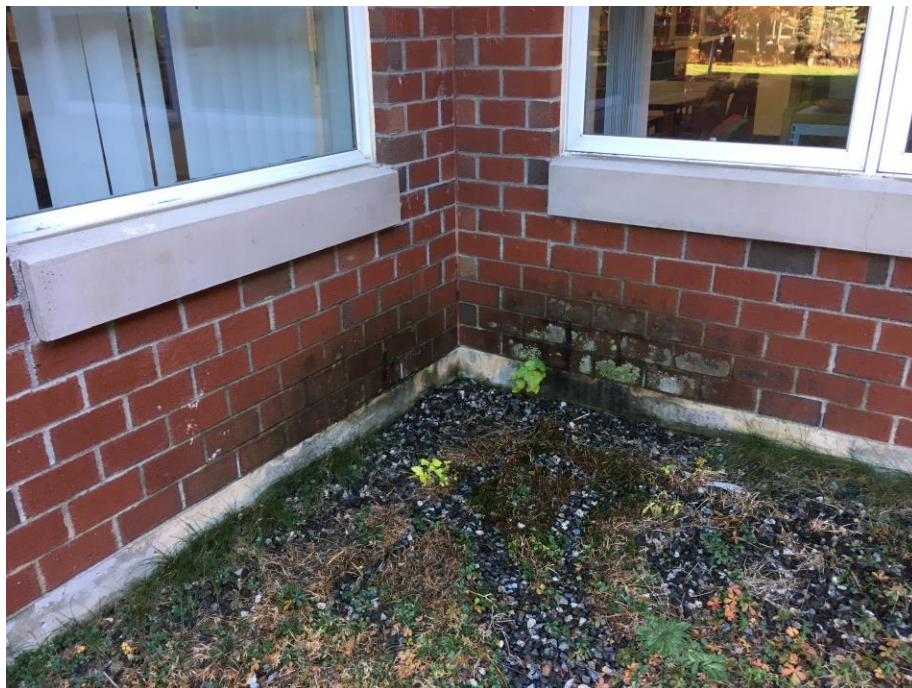
Deteriorated Mortar at Roof Drip Zone

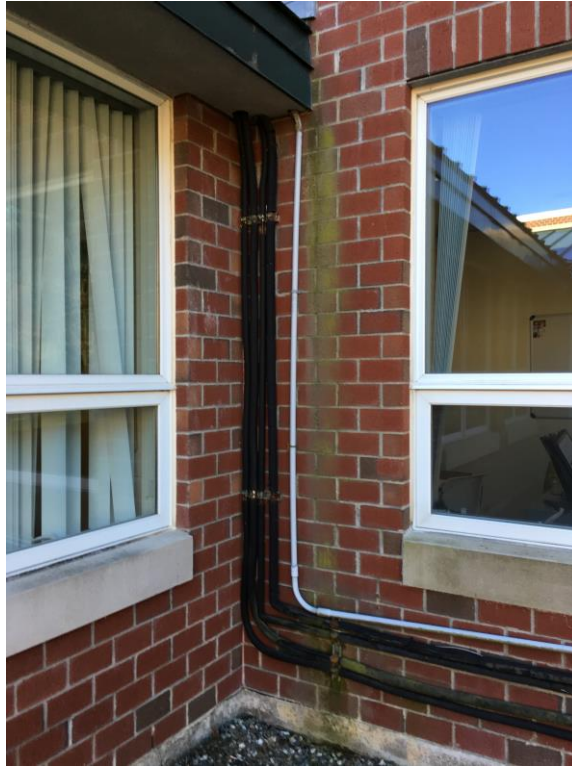
Roof Runoff on the Brick

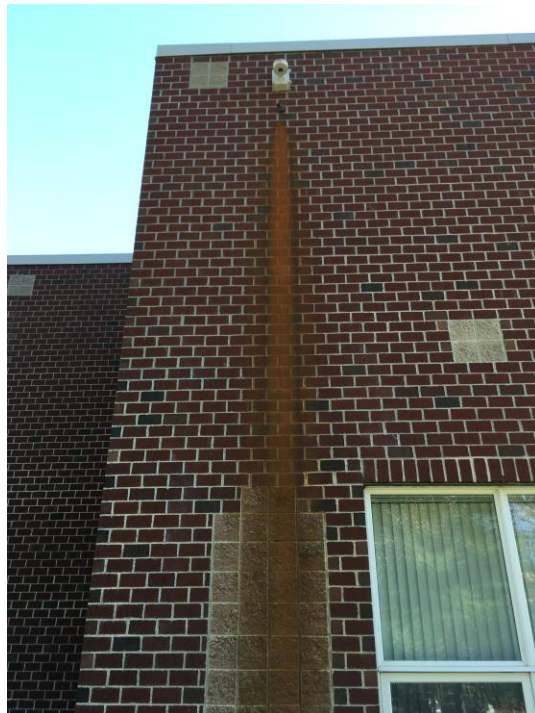
Sprinkler Stain

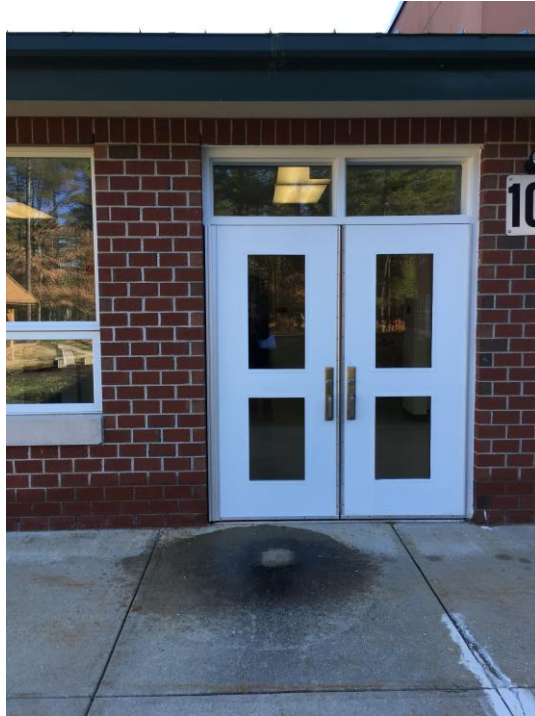
The gymnasium exterior entrance gutter has two major leaks and is in need of immediate repair. There are also soffit lights that need to be reset. There is also a gutter at the loading dock that needs to be sealed.

Leaking Gutter

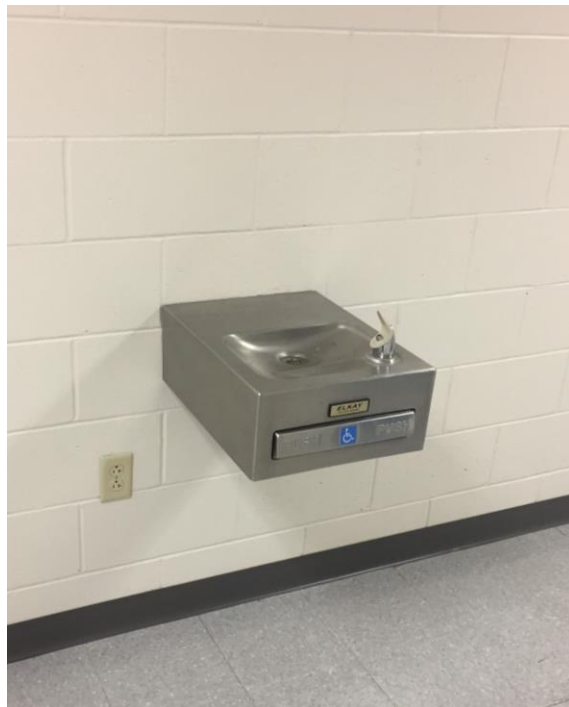
Drinking fountain without guard

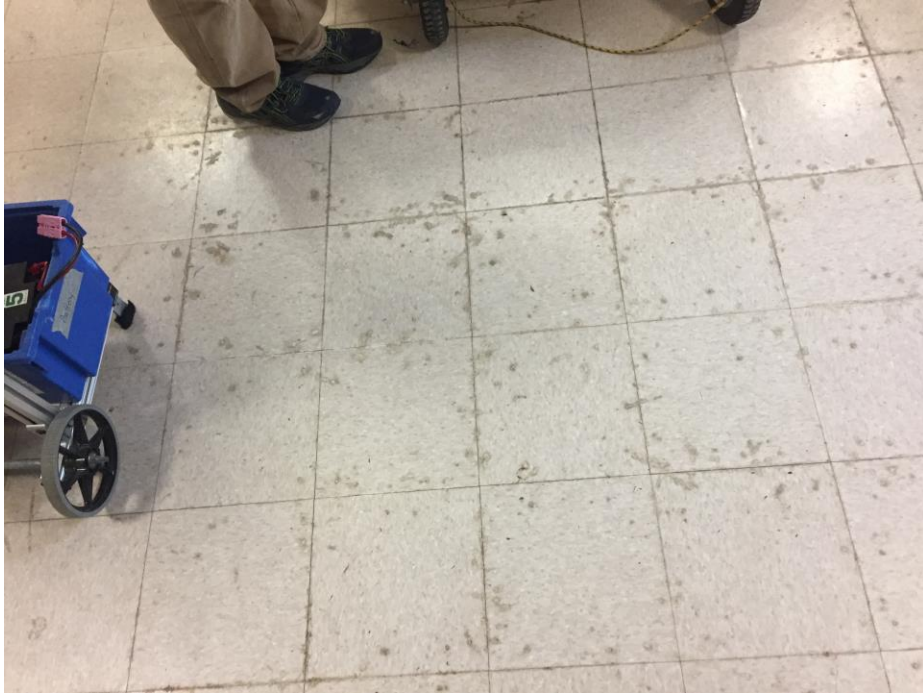
There are other areas in the music areas and adjacent corridors where the tile is damaged due to the underlying concrete being uneven, spalling or cracking. The tech lab floor tile is suffering from moisture under the tile.

Damaged Floor tile

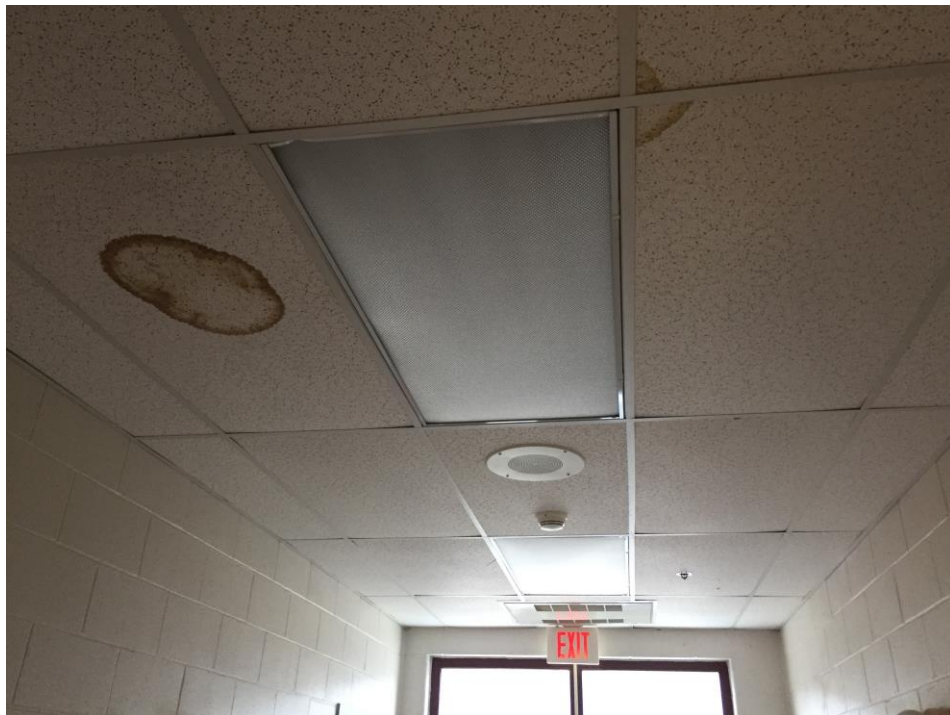
Stained ceiling tiles

Ceiling tiles that are water stained, dirty, or damaged should be replaced at the end of each school year. Since appearance is purely aesthetic, replacement is not mandatory.

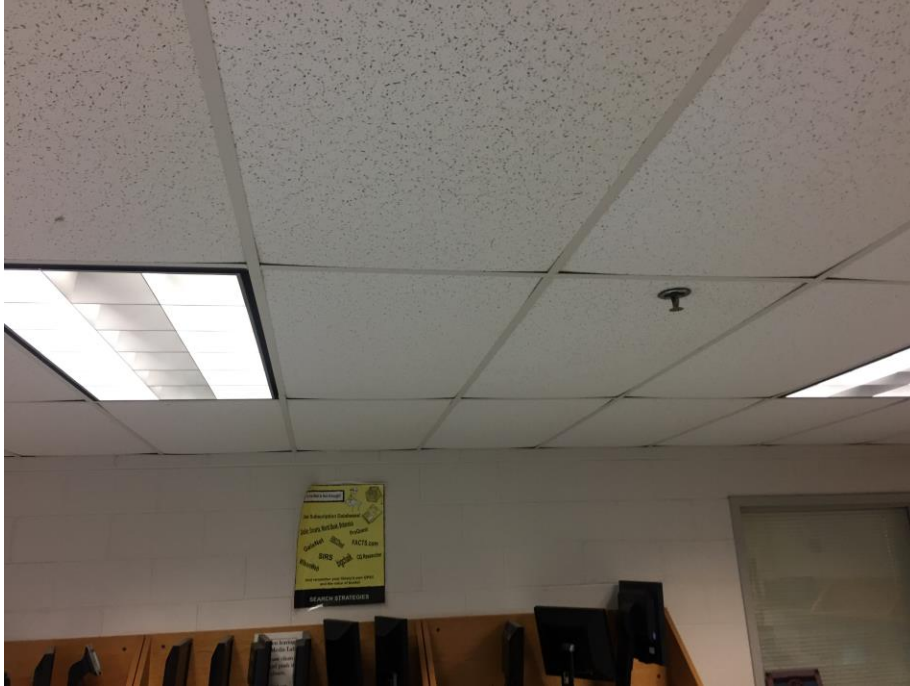
Most ceilings throughout the building are 2x4 acoustic ceiling tile mounted in a suspended grid system. Some staining of ceiling tiles was observed from dirty supply ducts and a few drip marks. Sagging ceiling tiles are prevalent throughout the building. This could be a result of humidity, but is probably due to the specified ceiling tiles are not rigid enough for a 2x4 ceiling grid, 2 x 2 ceiling grids can avoid this issue. Tiles are not in need of immediate replacement, but a long term replacement program should be planned.

Example of sagging ceiling tiles

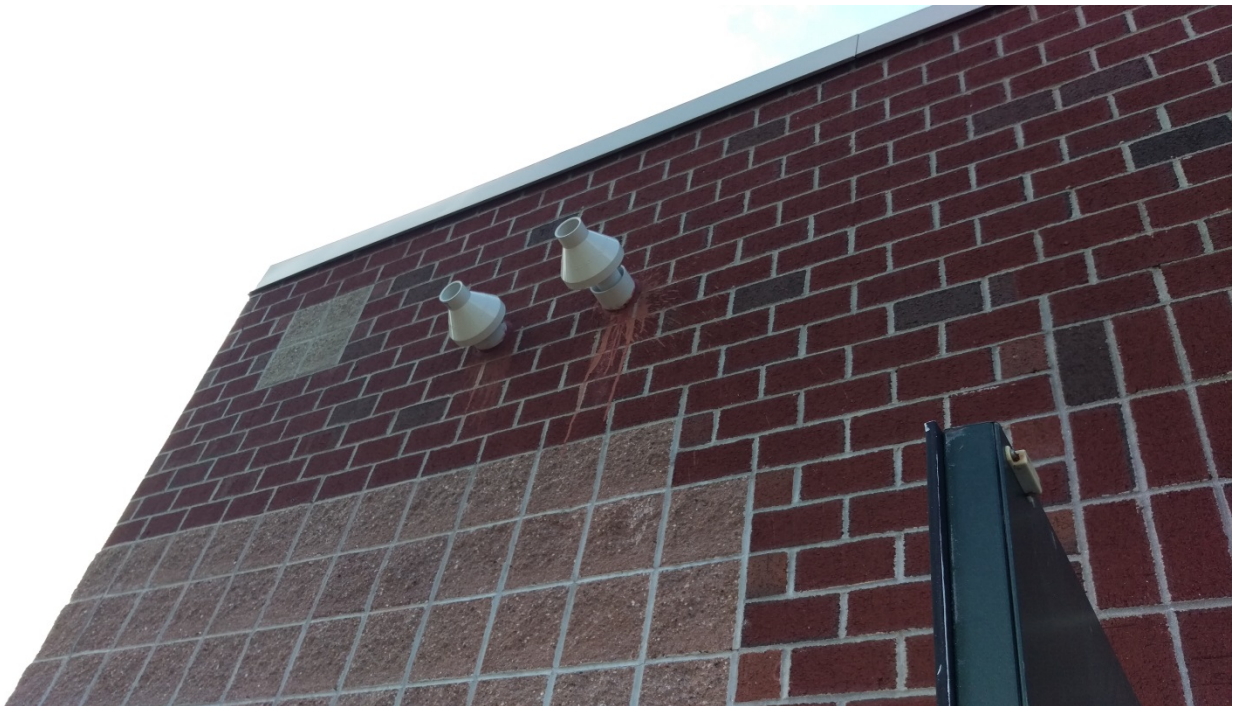
Domestic hot water is provided by two Lochinvar propane fired condensing water heaters. These water heaters each have a capacity of 90 gallons. These hot water heaters were installed in early 2016. We observed an issue with the exhaust of one of these units where it had been damaged due to ice falling off the roof. This combined exhaust/intake should be replaced.

Photo #4 Damaged Domestic Hot Water Intake/Exhaust

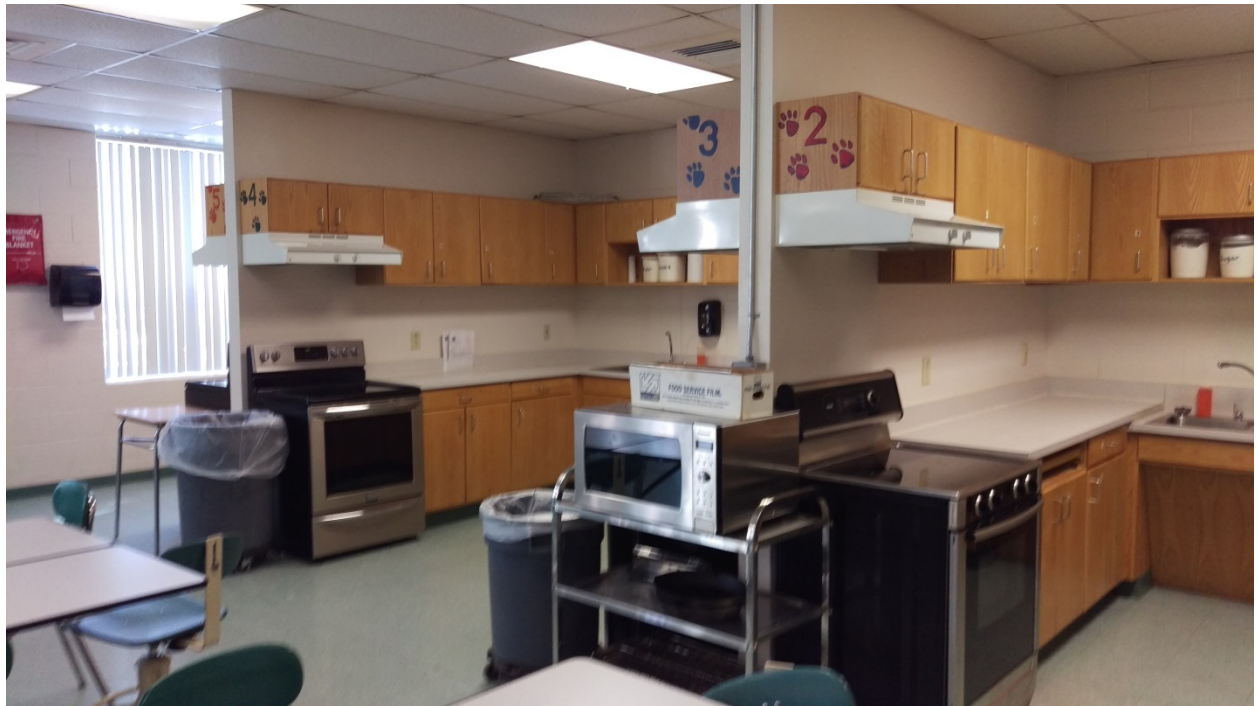
Photo #5 Range Hoods in FACS Space

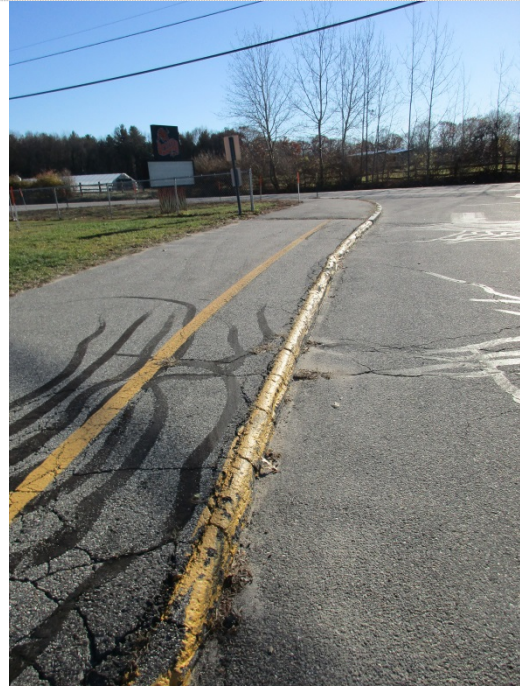
Pavement deterioration at driveway, curb, & sidewalk.

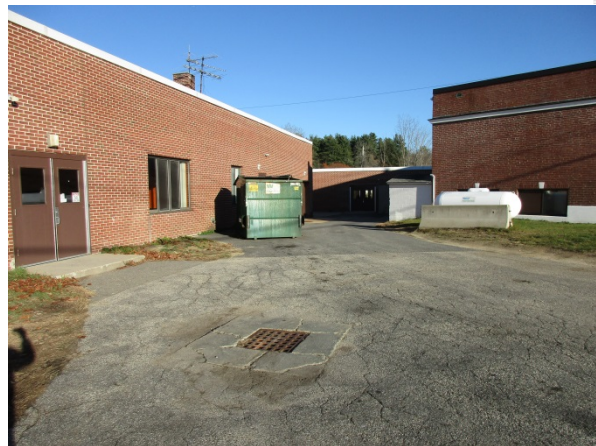
Failing pavement & cracked concrete at catch basin. Note dumpster placed on asphalt & no concrete approach apron.

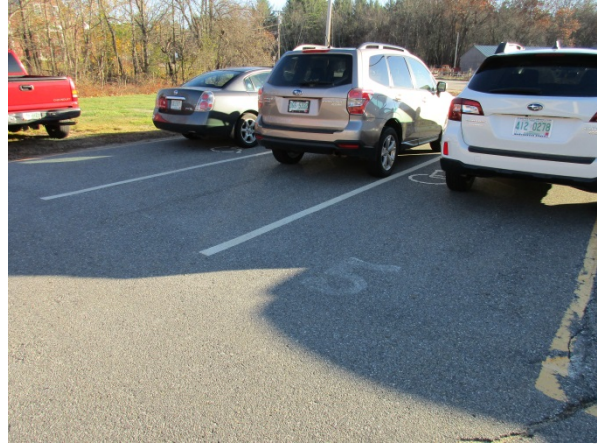
Parking spaces at dead end lot on south side. Note accessible parking logo painted on the surface of space 5.

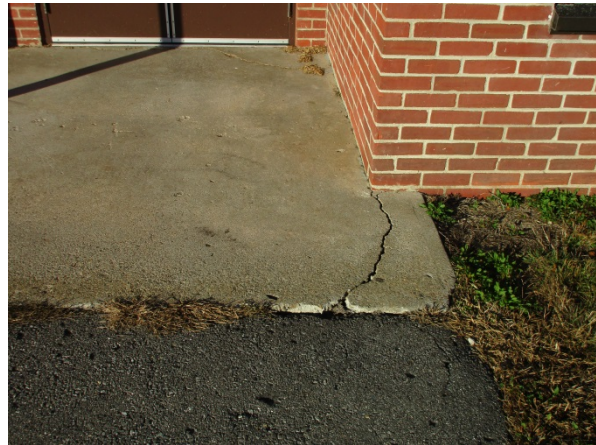
Example of crack in concrete pad requiring attention.

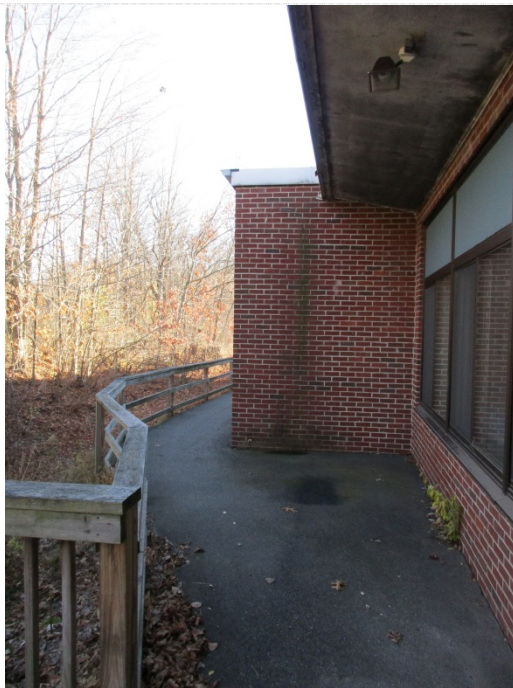
Roof runoff spilling onto sidewalk.

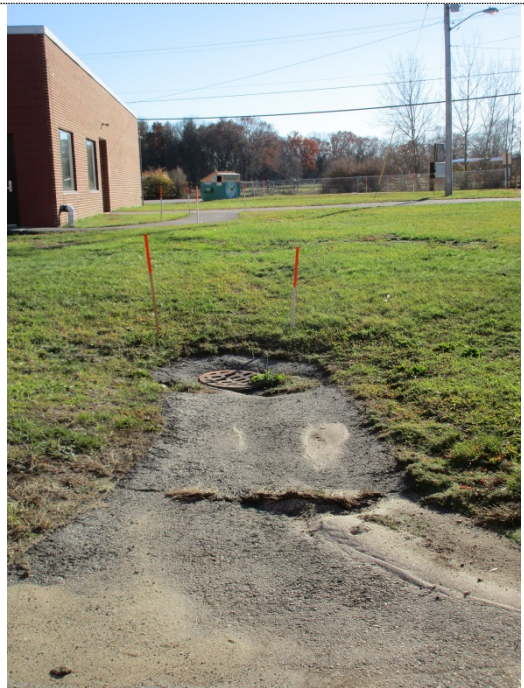
Accumulated sediment that flushes to catch basin.

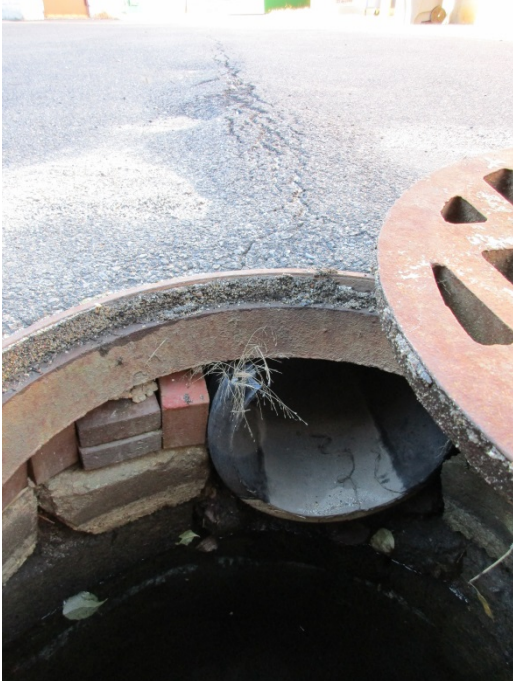
Shallow culvert at loading area. Note loose-laid bricks & non-watertight seal around culvert.

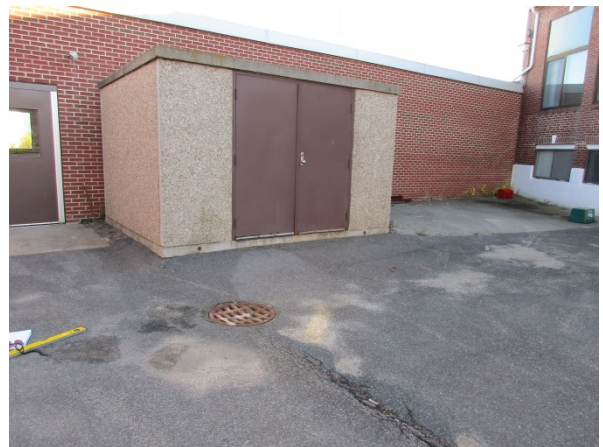
Crack leading from catch basin grate indicates displacement of plastic culvert beneath.

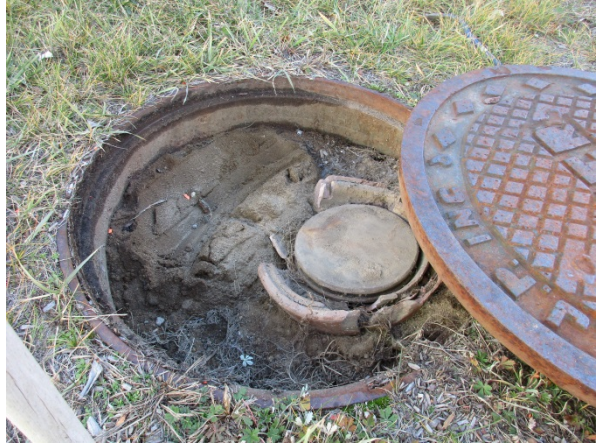
Broken cleanout cover support.

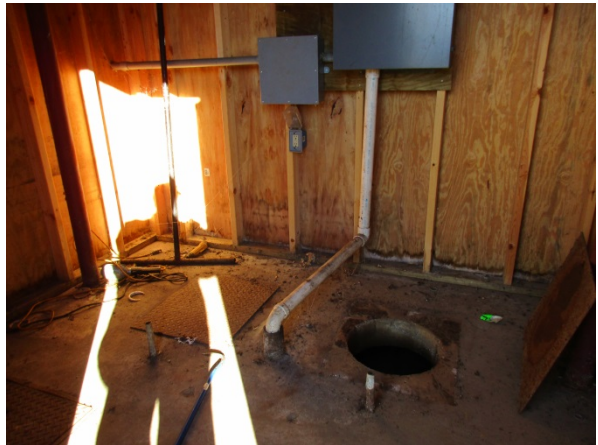
Pump station interior (trench field system). Note loose-laid covers over access holes.

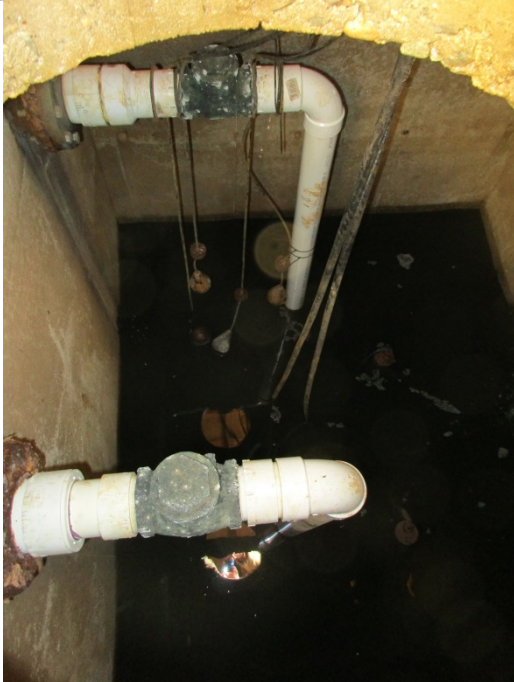
Wet well interior- no guide rails or lifting chains.

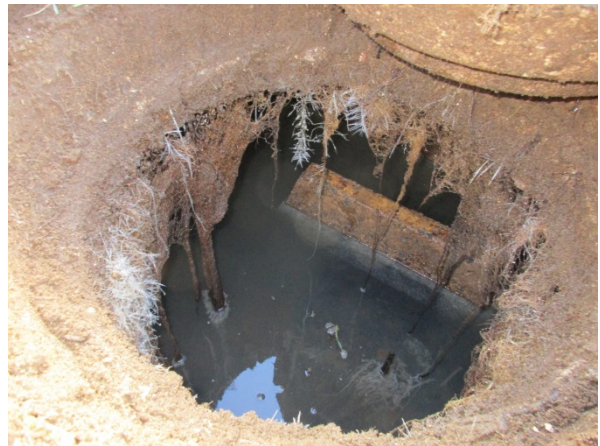
Roots at distribution box interior, trench field system.

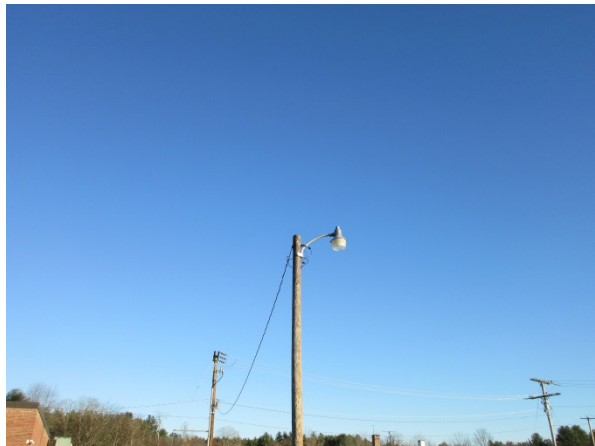
Typical site lighting- replace with high-efficiency luminaires & add additional fixtures for greater illumination.

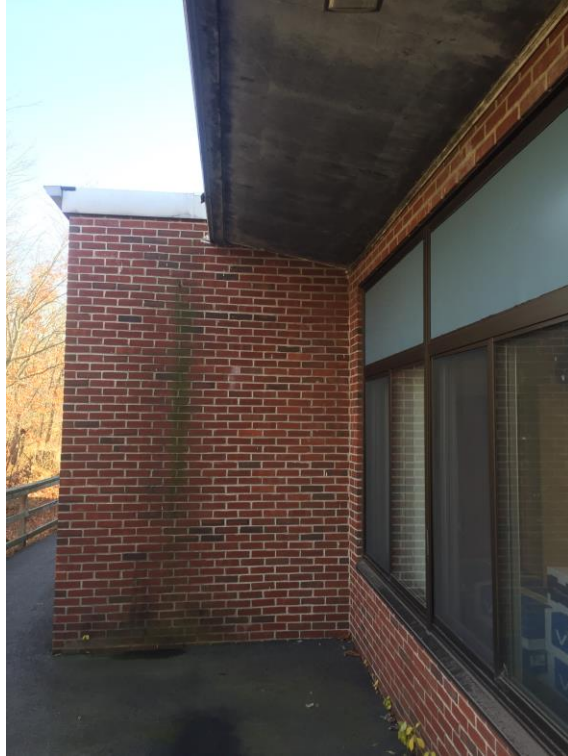
East Wall Brick Staining from Roof Runoff

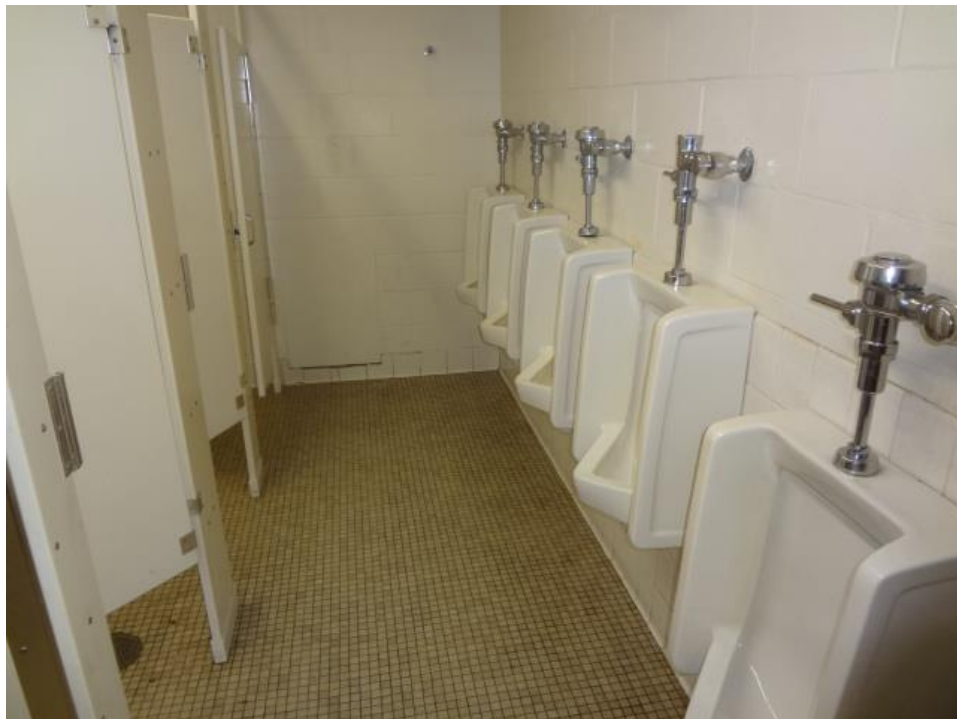
Restroom floor in need of replacement

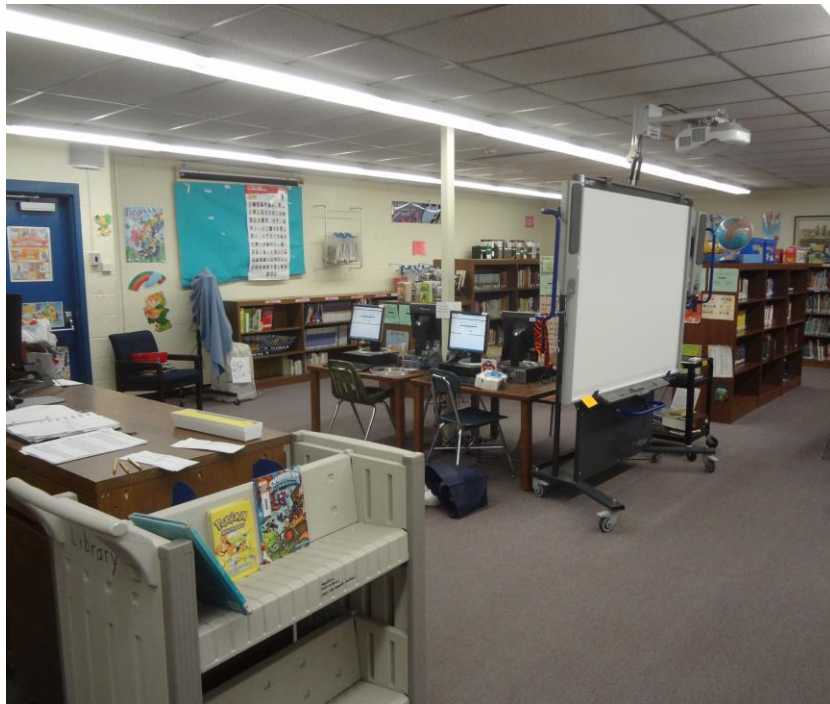
Carpet in need of replacement

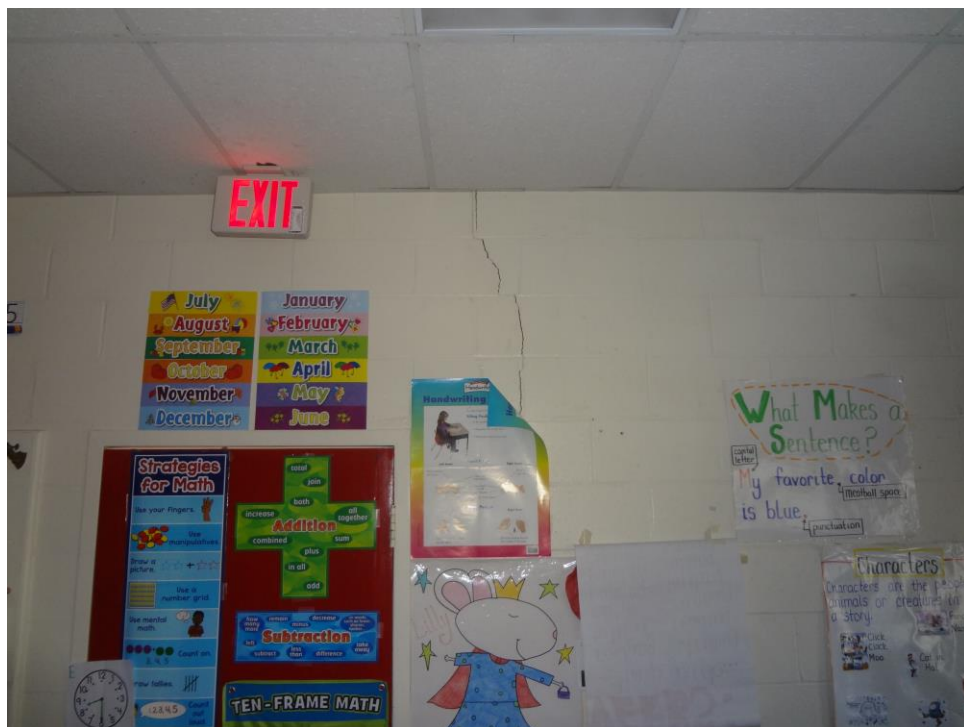
Non-structural cracking

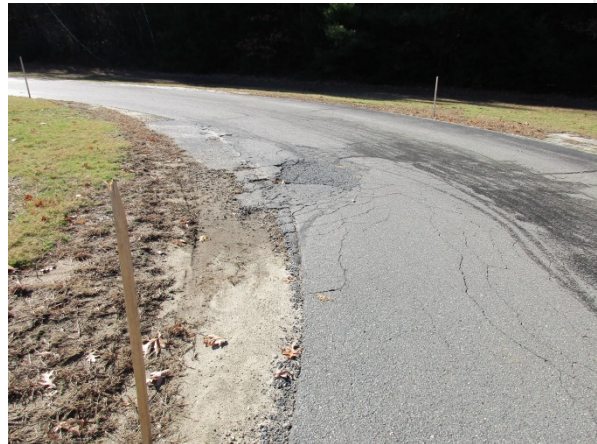
Pavement deterioraton.

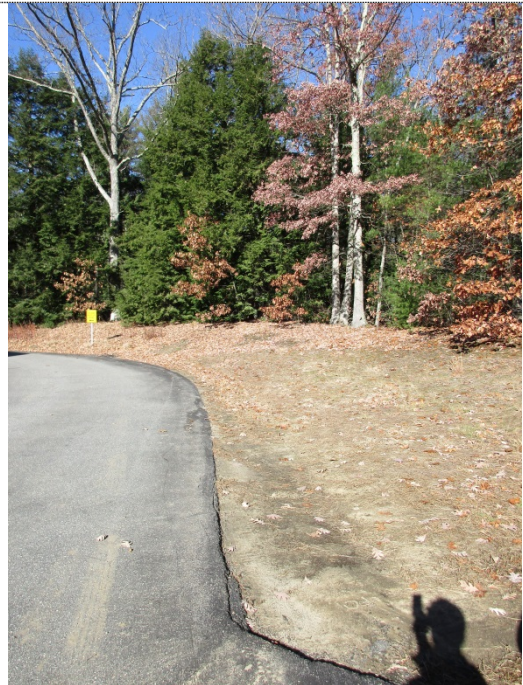
Regrade and revegetate swale to drain to catch basin.

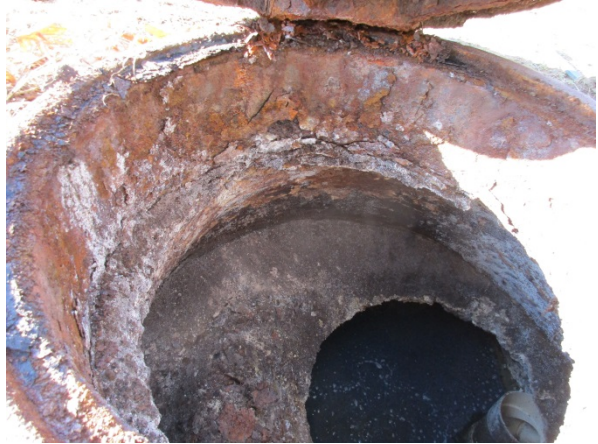
Corroded septic tank frame & cover

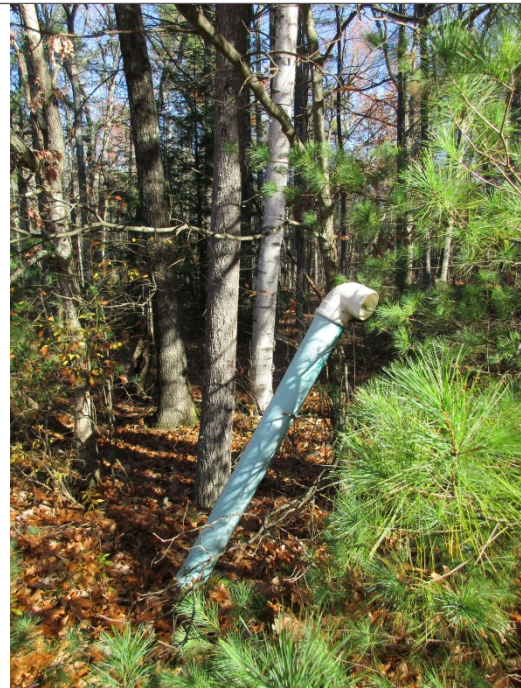
Pump station vent to reset.

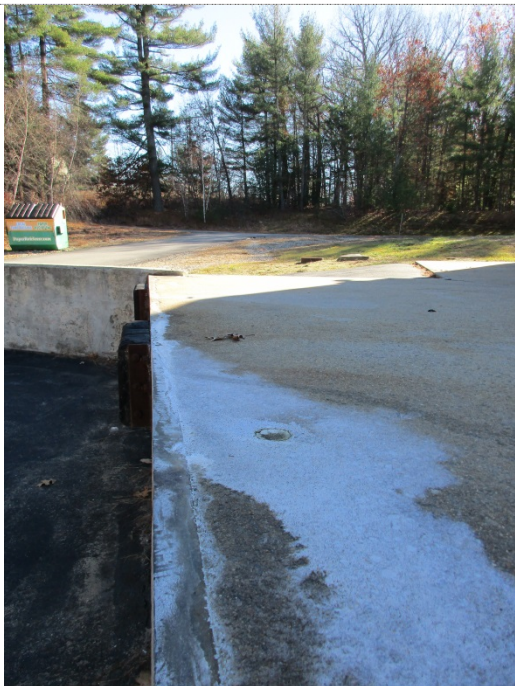
Replace railing along loading dock- note plugged holes where a railing was once installed.

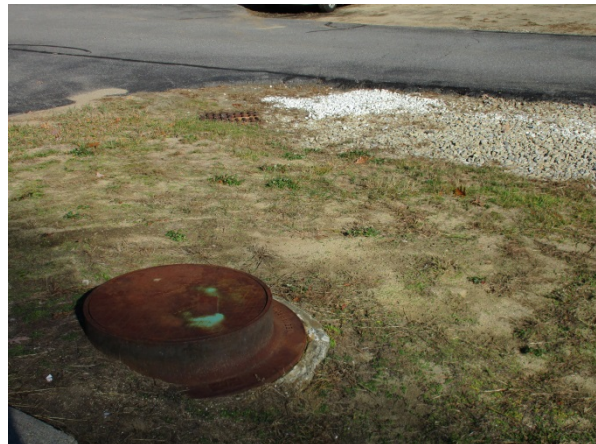
Erosion at oil tank access frame & cover.

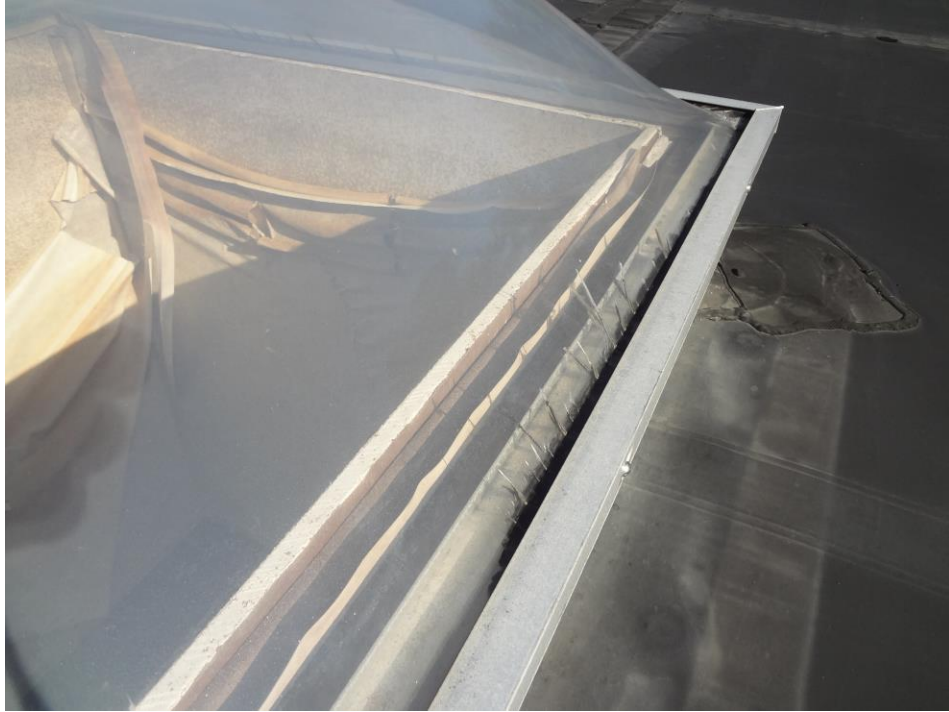
Cracking at Roof Skylight Polycarbonate
