## EVALUATION AND ASSESSMENT

LITCHFIELD SCHOOL DISTRICT

LITCHFIELD, NEW HAMPSHIRE

SEPTEMBER 27, 2017

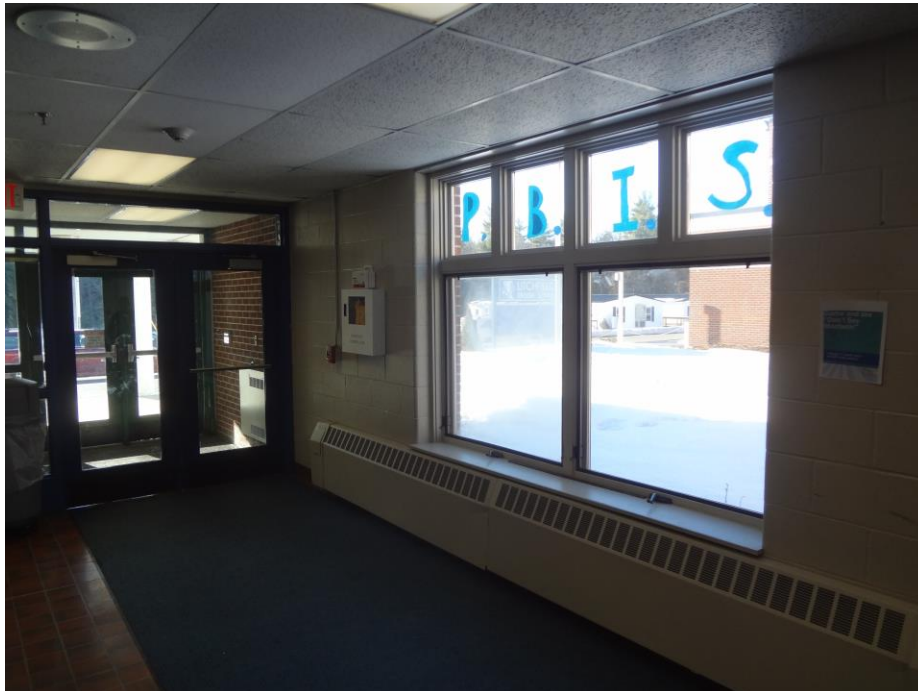
Window broken thermal seal

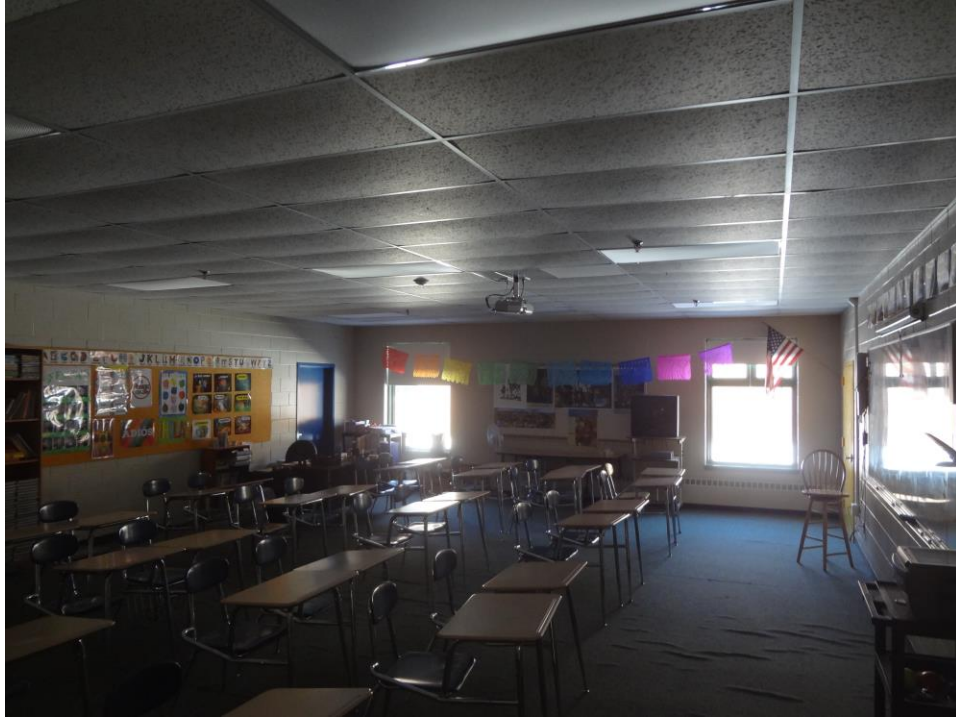
Example of carpet needing replacement

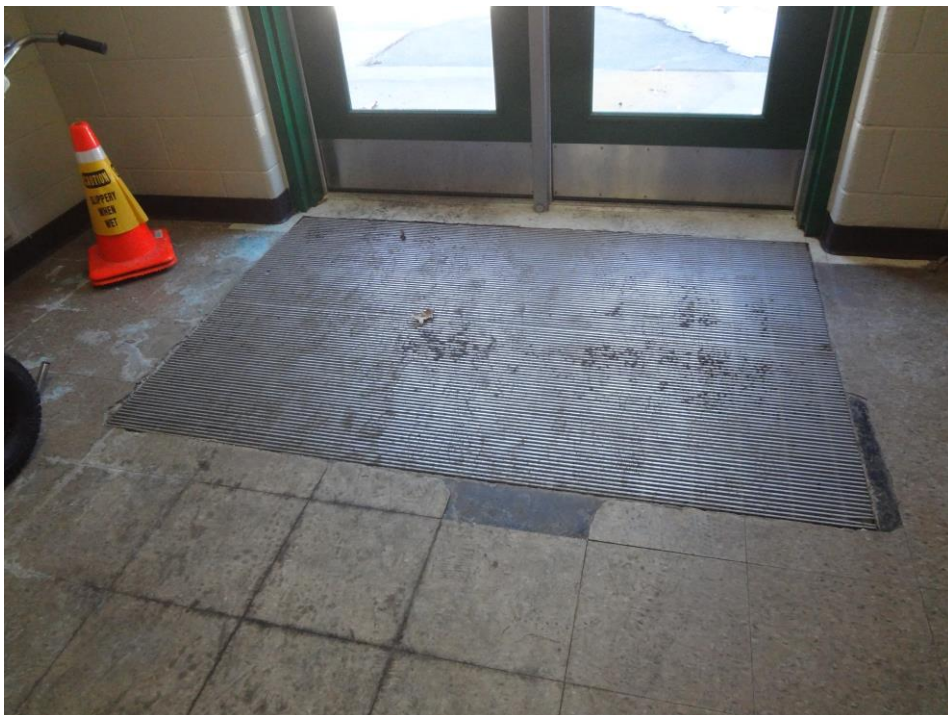
Example of foot grilles needing replacement and adjacent floor damage
