## EVALUATION AND ASSESSMENT

LITCHFIELD SCHOOL DISTRICT

LITCHFIELD, NEW HAMPSHIRE

SEPTEMBER 27, 2017

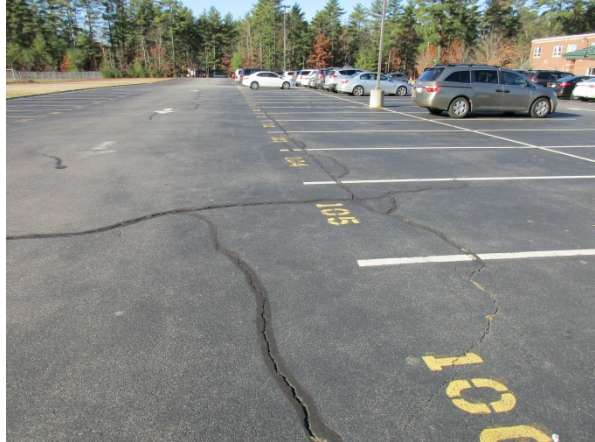
Pavement cracking

- Fill pavement cracks across the entire site with a bituminous sealant and sealcoat the asphalt surfaces.
- Replace bituminous curbing.
- Restripe the parking lots.

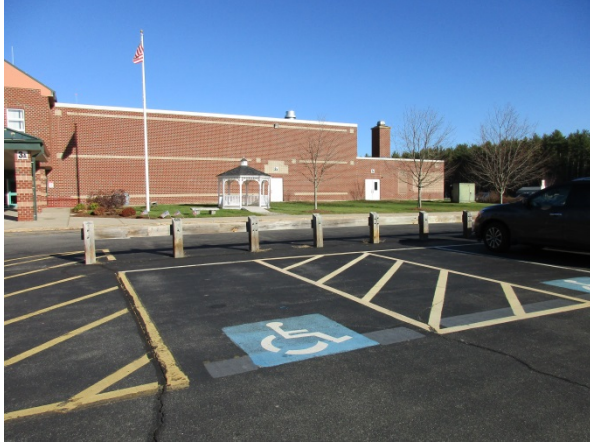
Accessible spaces w/ no signage

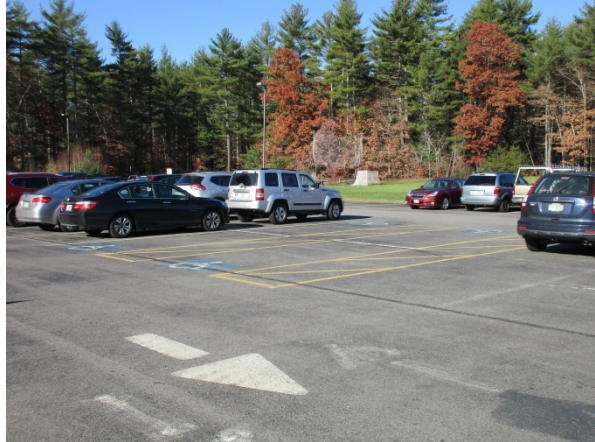
Accessible spaces w/ no signage. Note faded striping.

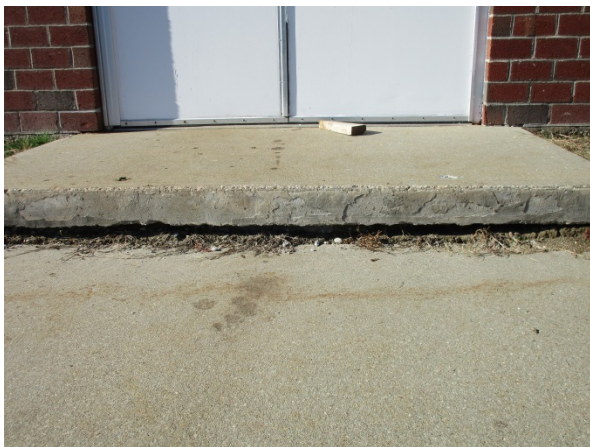
Erosion beneath concrete pad at door 26D

- Repair cracks and spalls in concrete surfaces and curbs.
- Provide an ADA compliant accessible path to all of the athletic fields.
- Remove and replace the concrete door pad at door 26D.

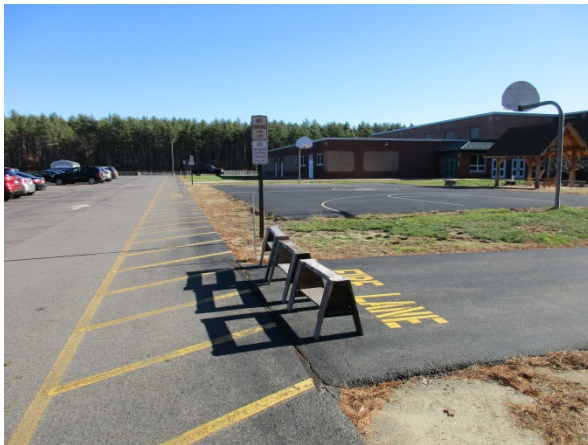
Sawhorses at service driveway

- Install a swing gate across the service entrance driveway at the northeast corner of the building.
- Repair cracked and broken pavement along the edges of driveways and parking lots. Place compacted crushed gravel at the shoulders of all paved areas to prevent undermining and edge failure.

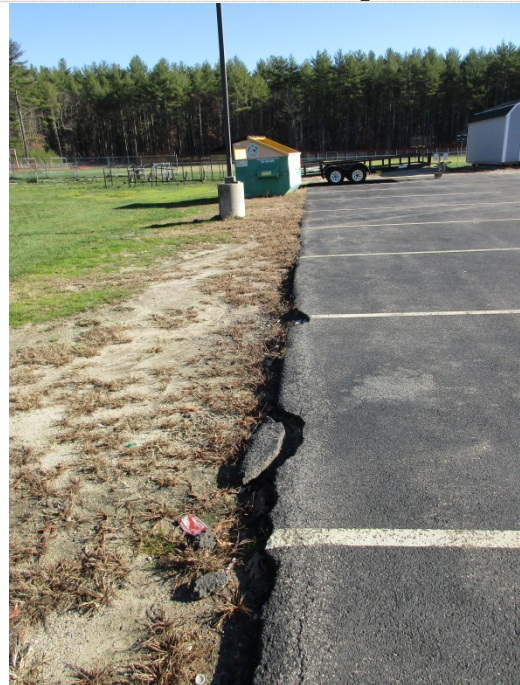
The parking lot slopes northward and where the runoff flows off the pavement it is eroding the ground, causing undermining and deterioration of the pavement edge.

Erosion & undermining at edge of pavement. Note lack of fence separating vehicles from athletic field.

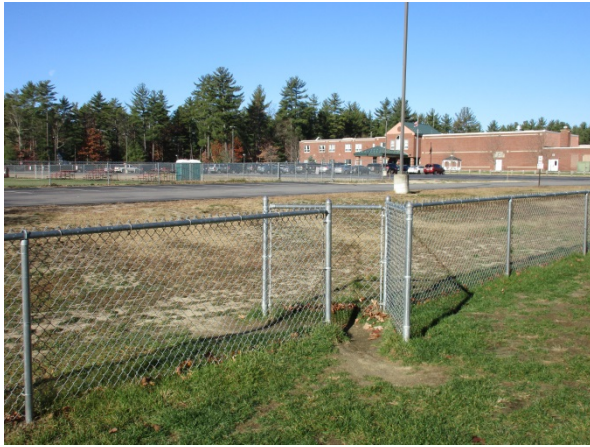
Nonaccessible entrance to fields (typical).

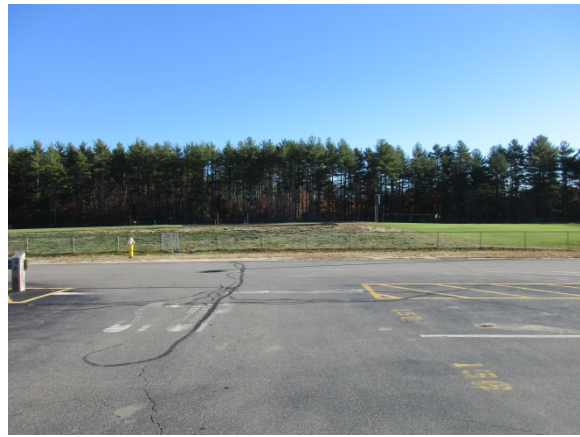
The primary parking lot is located on the south side of the school. There are 199 delineated parking spaces, four of which are reserved as accessible (there are additional spaces on the north side and will be discussed below). Two of these accessible spaces are not signed. The pavement is in fair condition with some cracking, indicative of normal aging and not due to a failure of base gravels. Along the south end of the lot, there is a bituminous curb in poor condition. The striping is faded and difficult to detect in some areas. At the southeast corner of the lot, where it intersects with an onsite driveway, there is a painted stop bar but no stop sign.

Install stop sign at intersection.

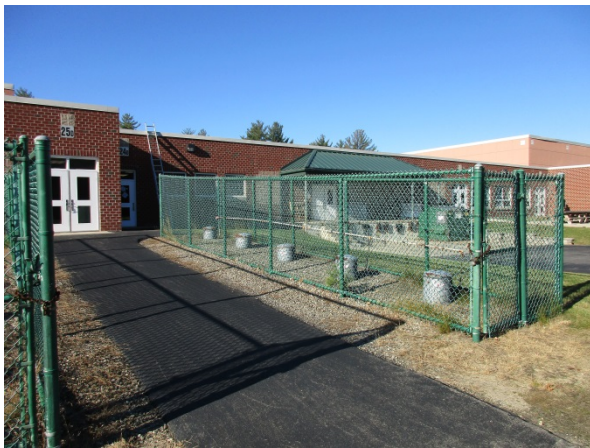
At door 25D there is a gap between the door pad and the asphalt sidewalk of 1-2 inches in width. This door pad has two significant patches of spalling and there is a large crack in the paved sidewalk angling away from the door pad.

Steep egress sidewalk at door 25D.

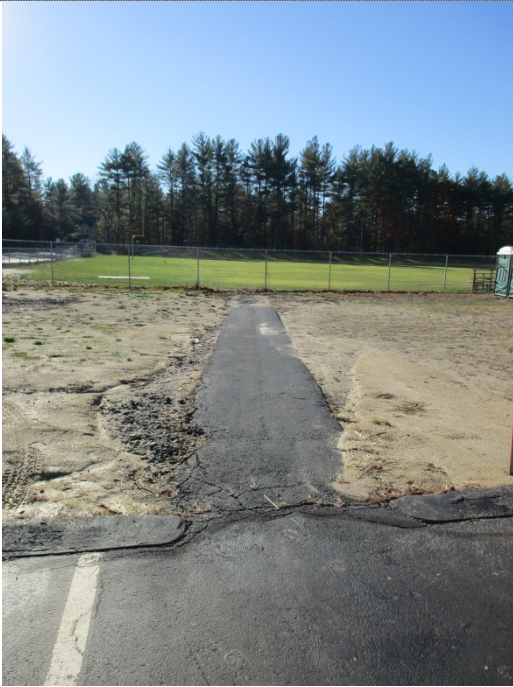
The parking lot on this side of the building slopes away from the building in a southerly direction. Bituminous curbing channels runoff toward two asphalt swales leading to precast concrete dry wells. The terrain on either side of these basins and swales is primarily bare earth, with some sparse weeds. Since the area slopes toward these inlets, they collect a lot of sediment, which can reduce the infiltration capacity of the dry wells. The easternmost structure had some standing water in it, which indicates the porous material beneath and surrounding it is partially clogged. The dry well at the west end of the site was dry but is at risk of becoming clogged because of the bare earth surrounding the inlet.

Asphalt sluice to dry well. Note poor vegetative cover on adjacent terrain.

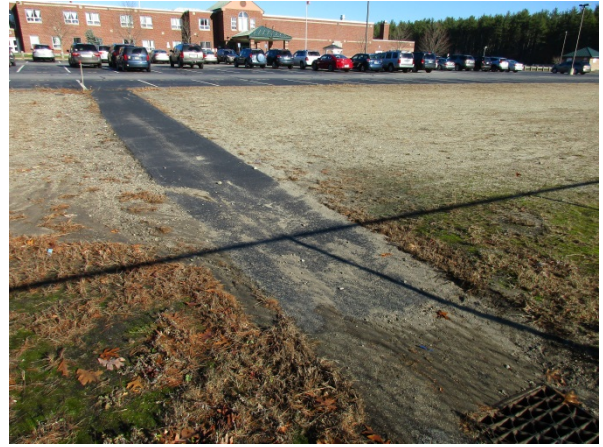
Accumulated sediment on paved sluice to dry well.

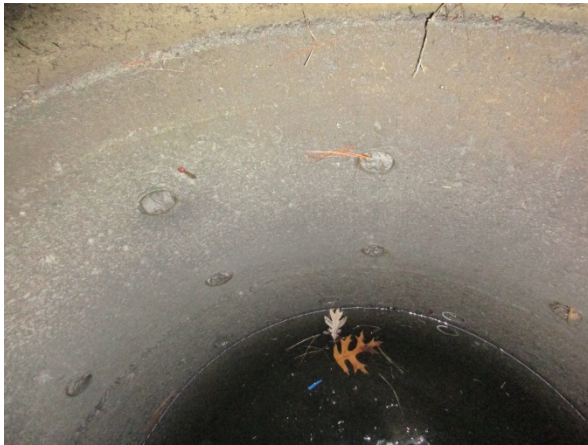
Clogged dry well outlets.

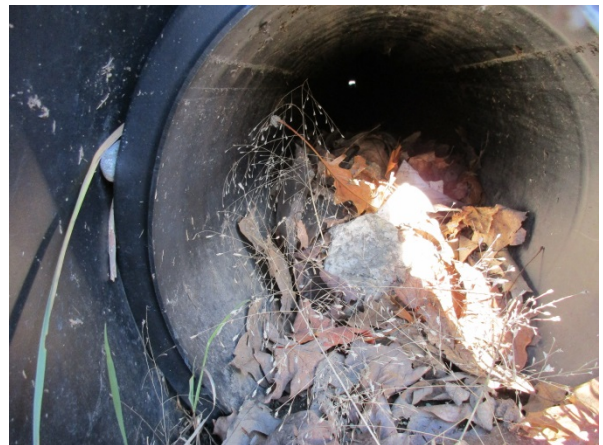
The asphalt access to the track and the concession stand bisects the vegetated swale noted above and there are three plastic culverts connecting the two halves. These culverts are partially clogged with leaves and other debris. The dry well at the north end of this swale had water in the sump, indicating it may be clogged with fine sediments.

Debris in culvert.

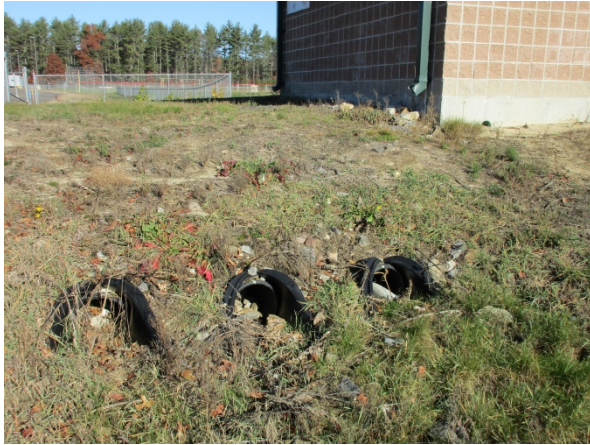
Obstructed culverts.

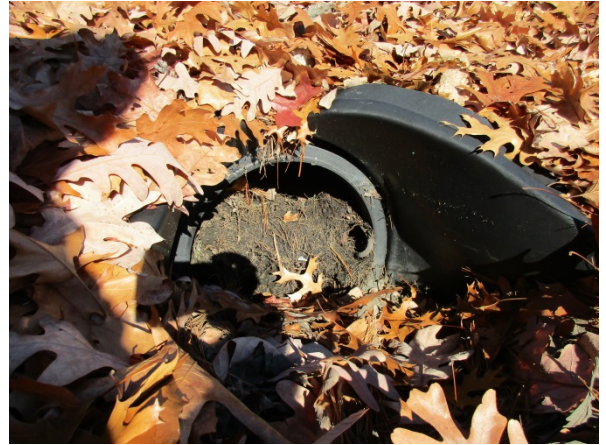
Obstructed culvert.

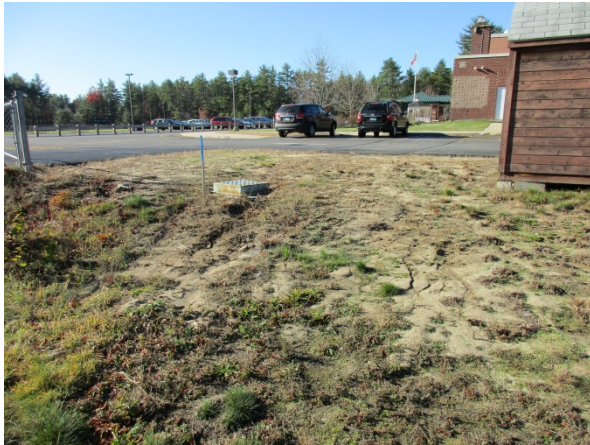
Erosion & sparse vegetation at drainage swale.

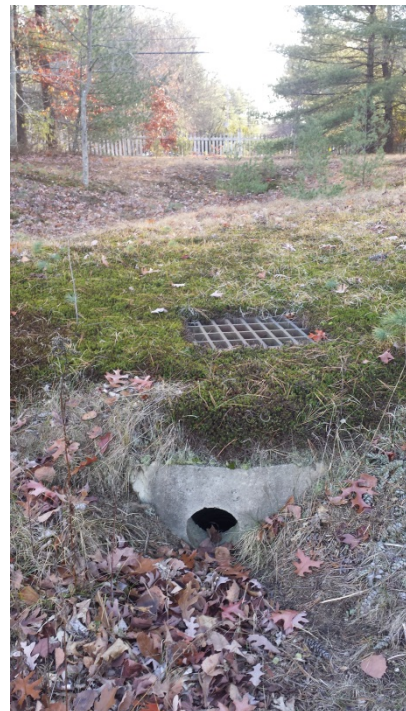
Unscreened opening to catch basin.

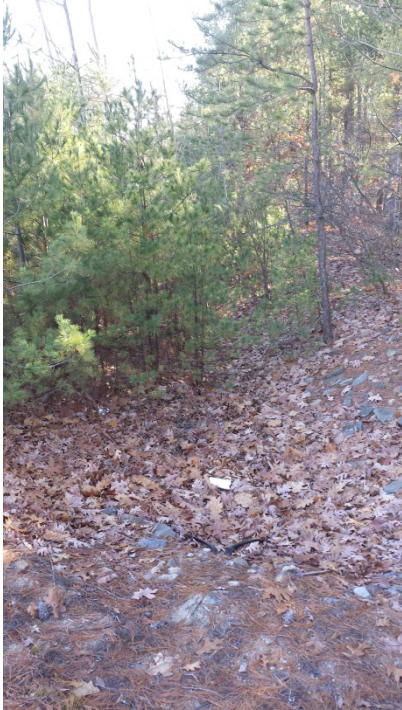
A vegetated drainage swale runs along the west side of the parking area, receiving runoff from building roof drains and the asphalt driveway/parking spaces. It has a lot of leaves and other debris in it that threaten to clog the drain outlets and reduce the ability of the swale to infiltrate and transmit rainfall and snowmelt.

Overgrowth in drainage swale.

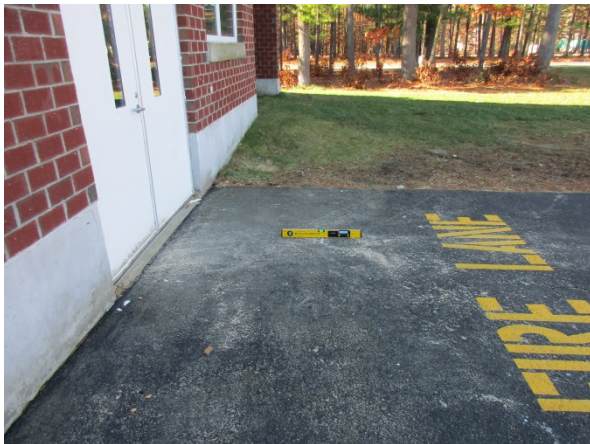
Site of possible ponding/ infiltration at service entrance doors.

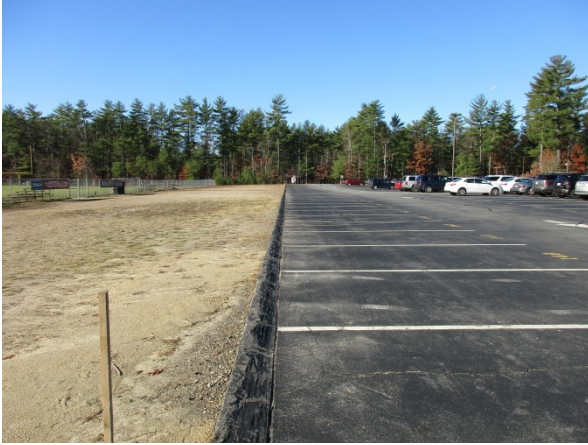
Bare gravel on south side of parking lot.

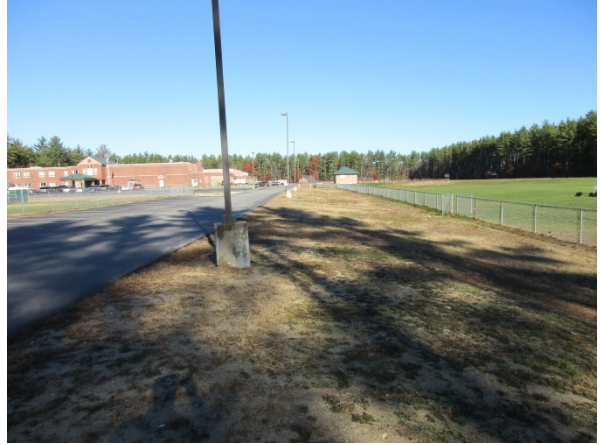
Sparse cover on driveway side slope & in swale.

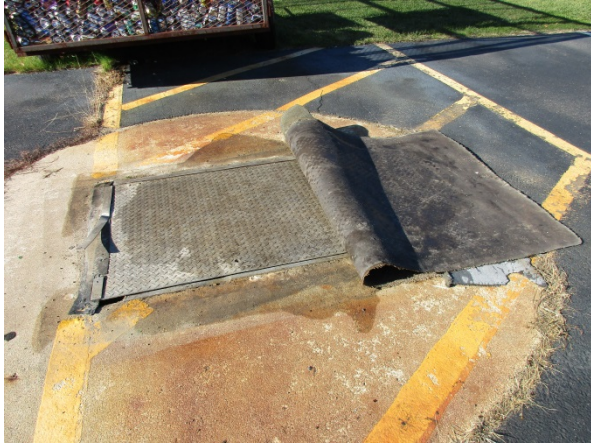
Damaged pump station hatch frame.

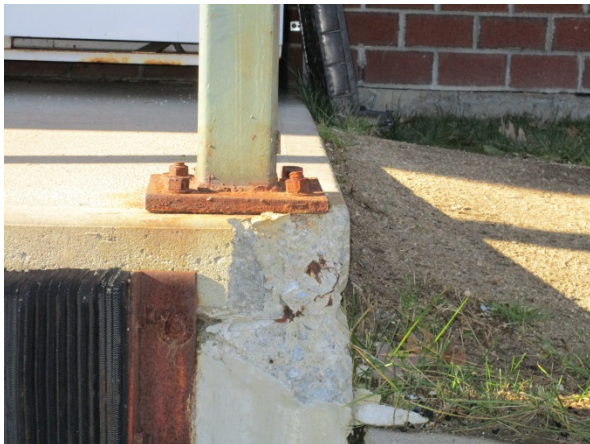
Concrete deterioration at loading dock.

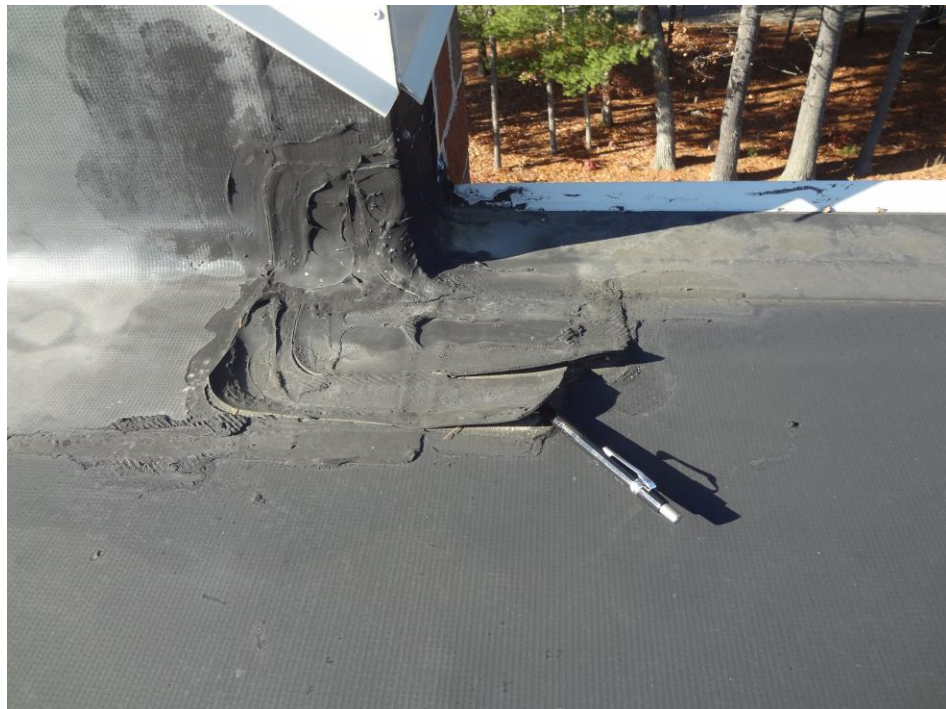
EPDM Roof Seam

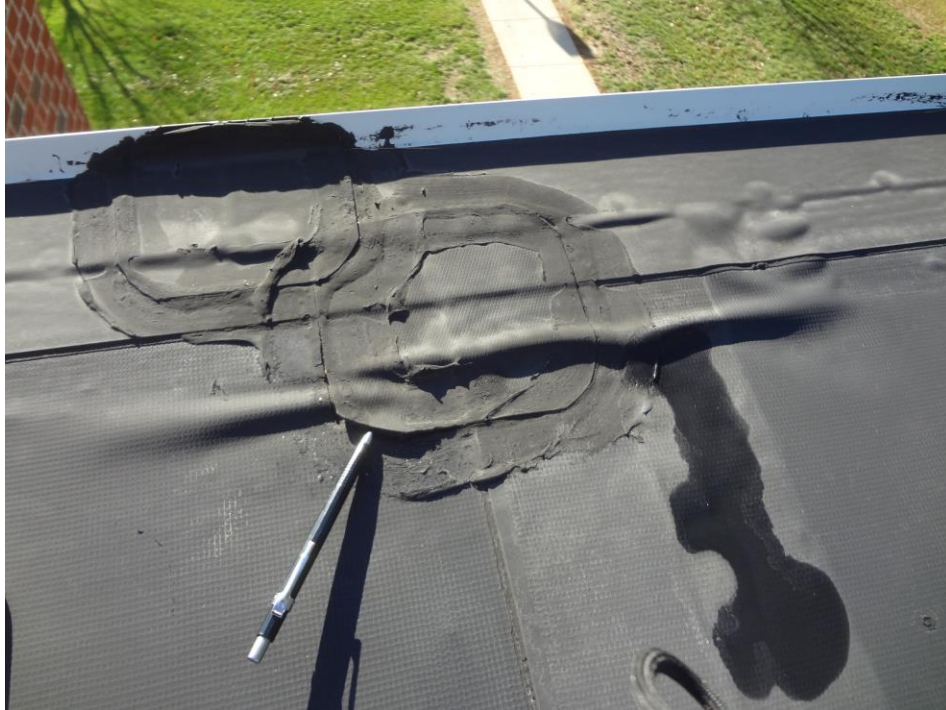
EPDM Roof Seam

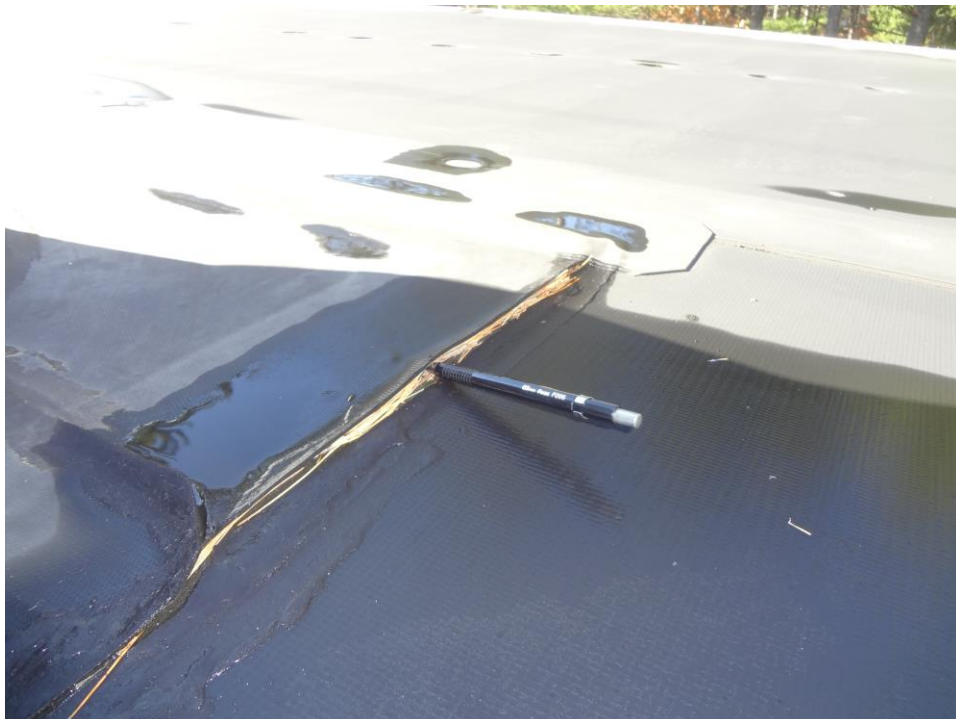
EPDM Roof Seam

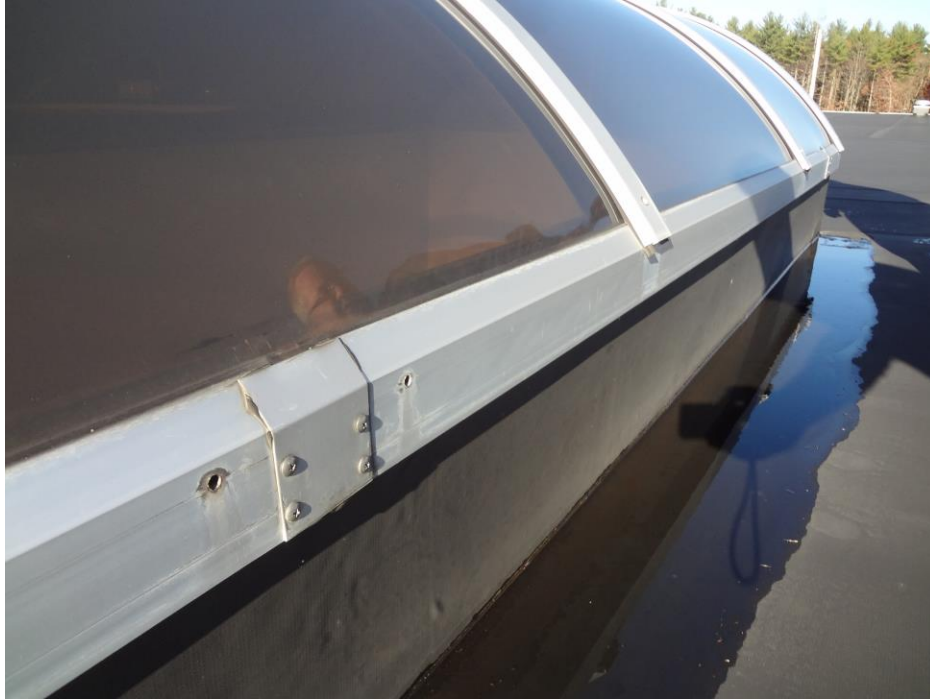
Skylight Frame

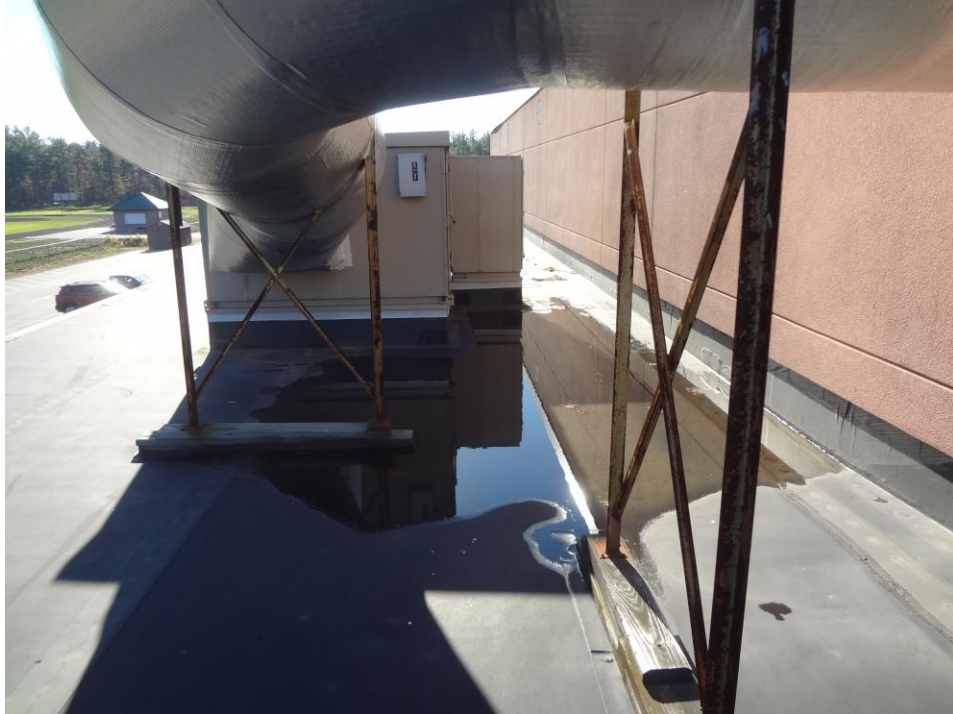
Ponding at HVAC Unit Adjacent to the Gymnasium

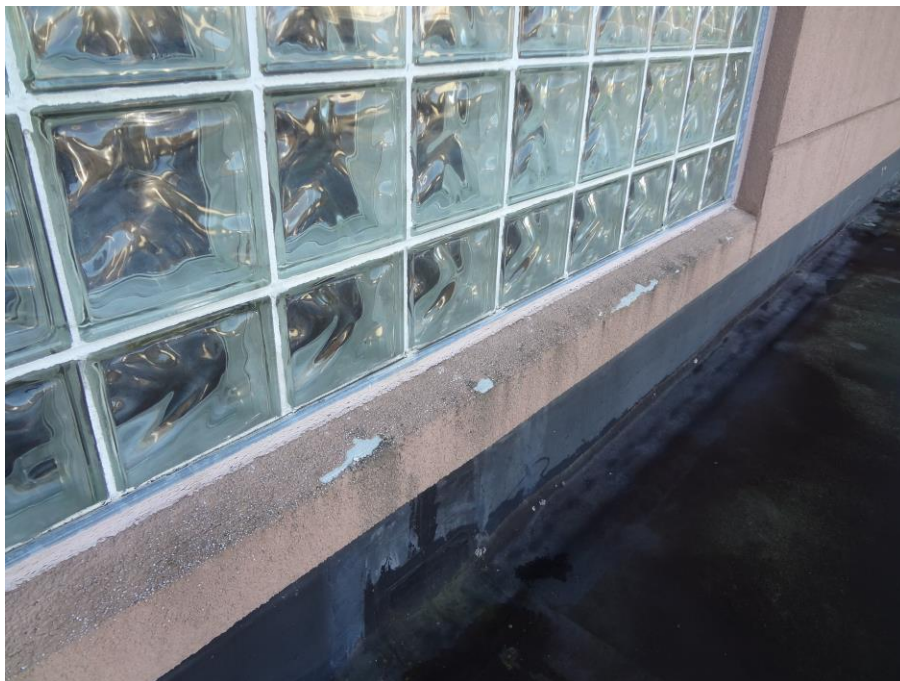
EIFS at Window Sill on North Side of Gymnasium

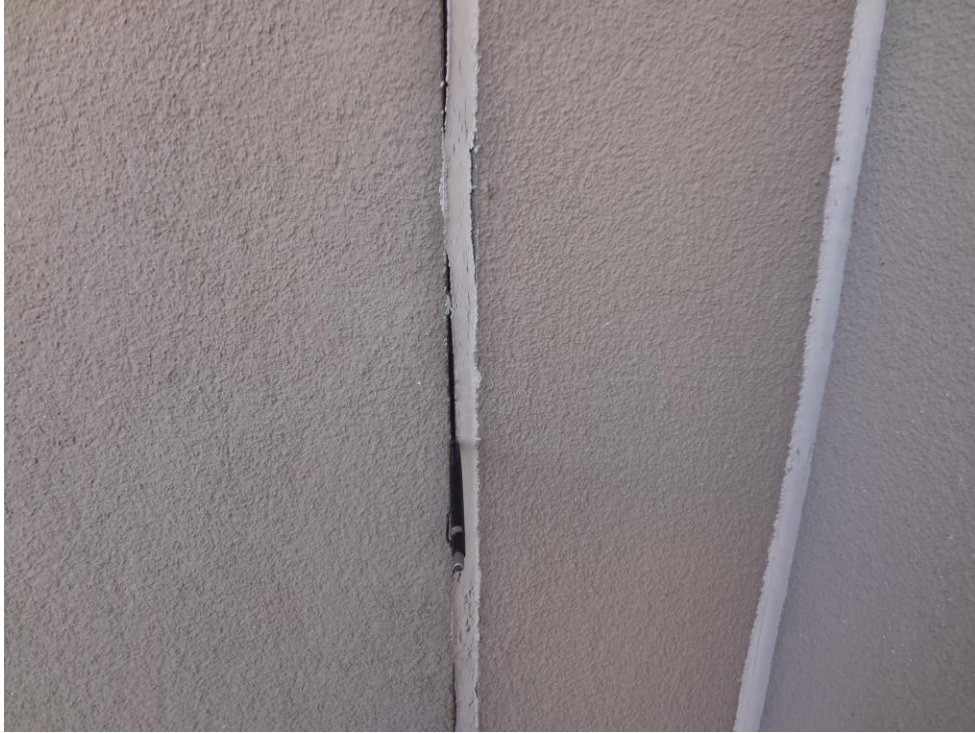
Sealant in EIFS

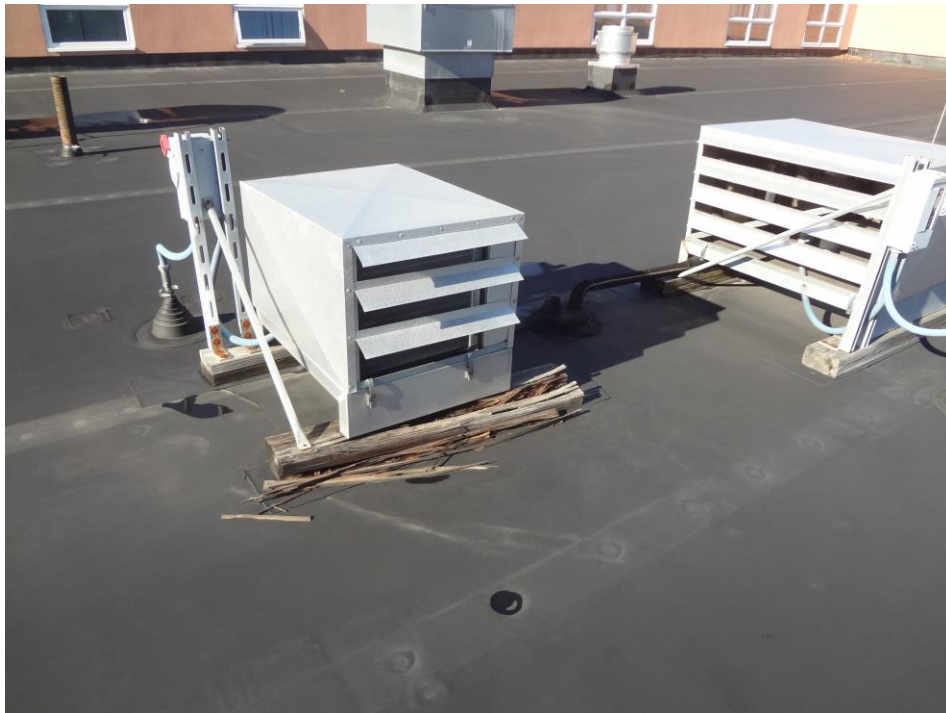
Wood Sleepers at HVAC Unit

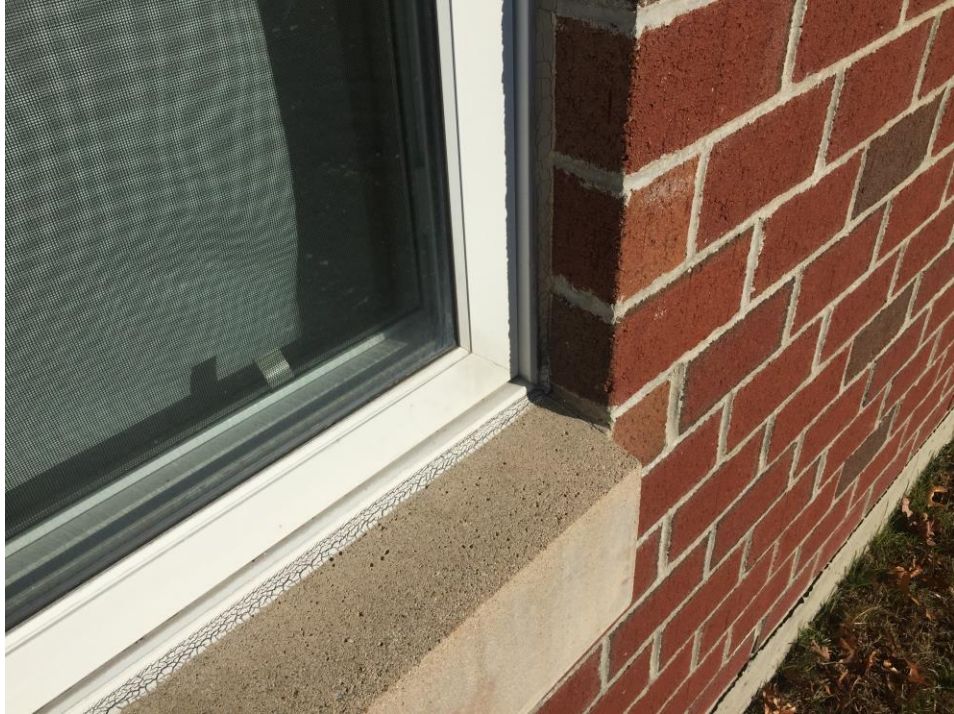
Sealant at Window

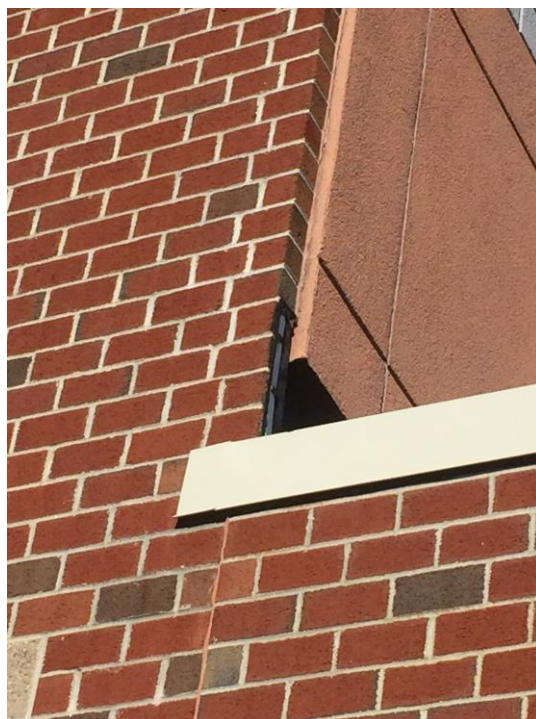
High to Low Transition

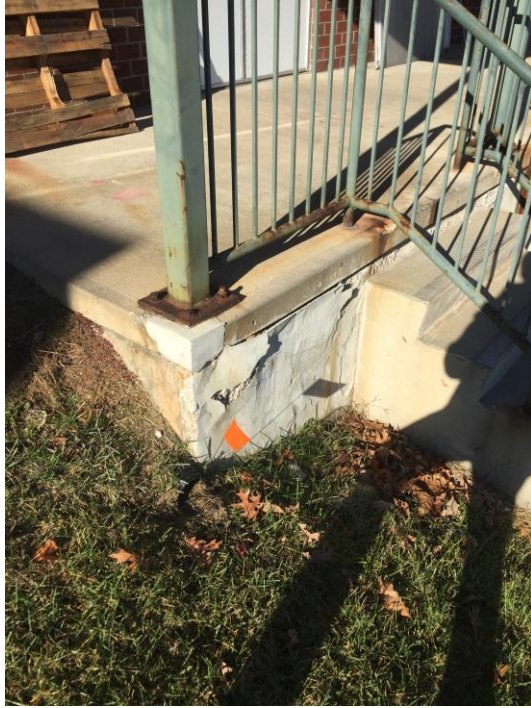
Railing and Foundation at Loading Dock

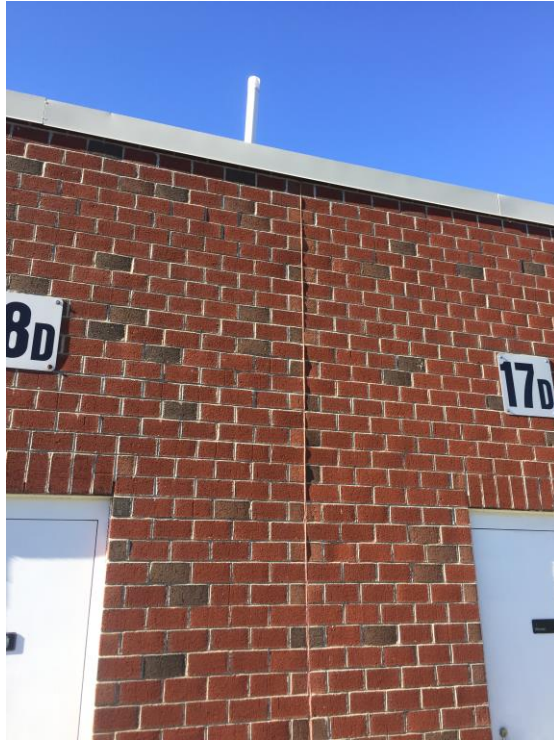
Sealant in Brick Wall

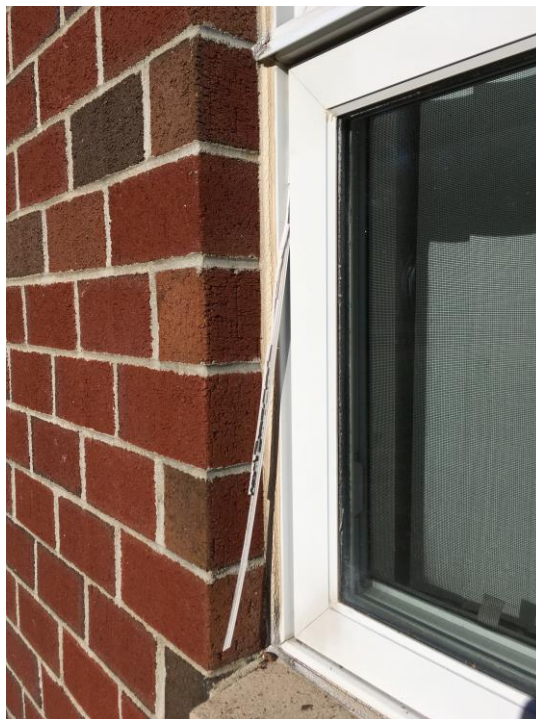
Window Weather Stripping

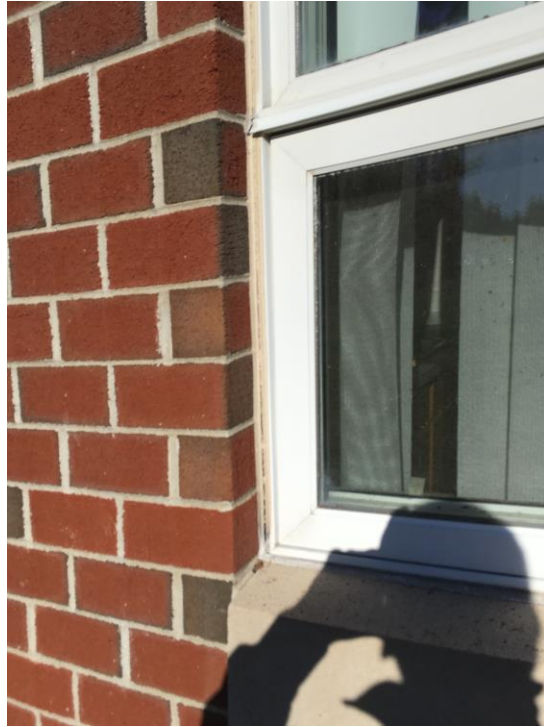
Window & Door Sealant

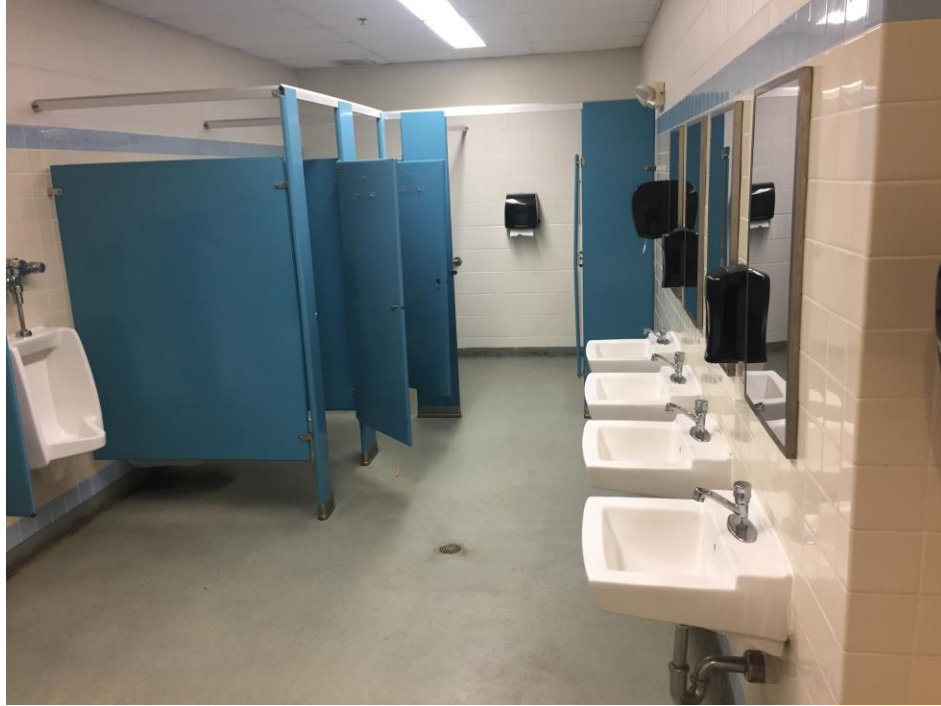
Waxed seamless flooring

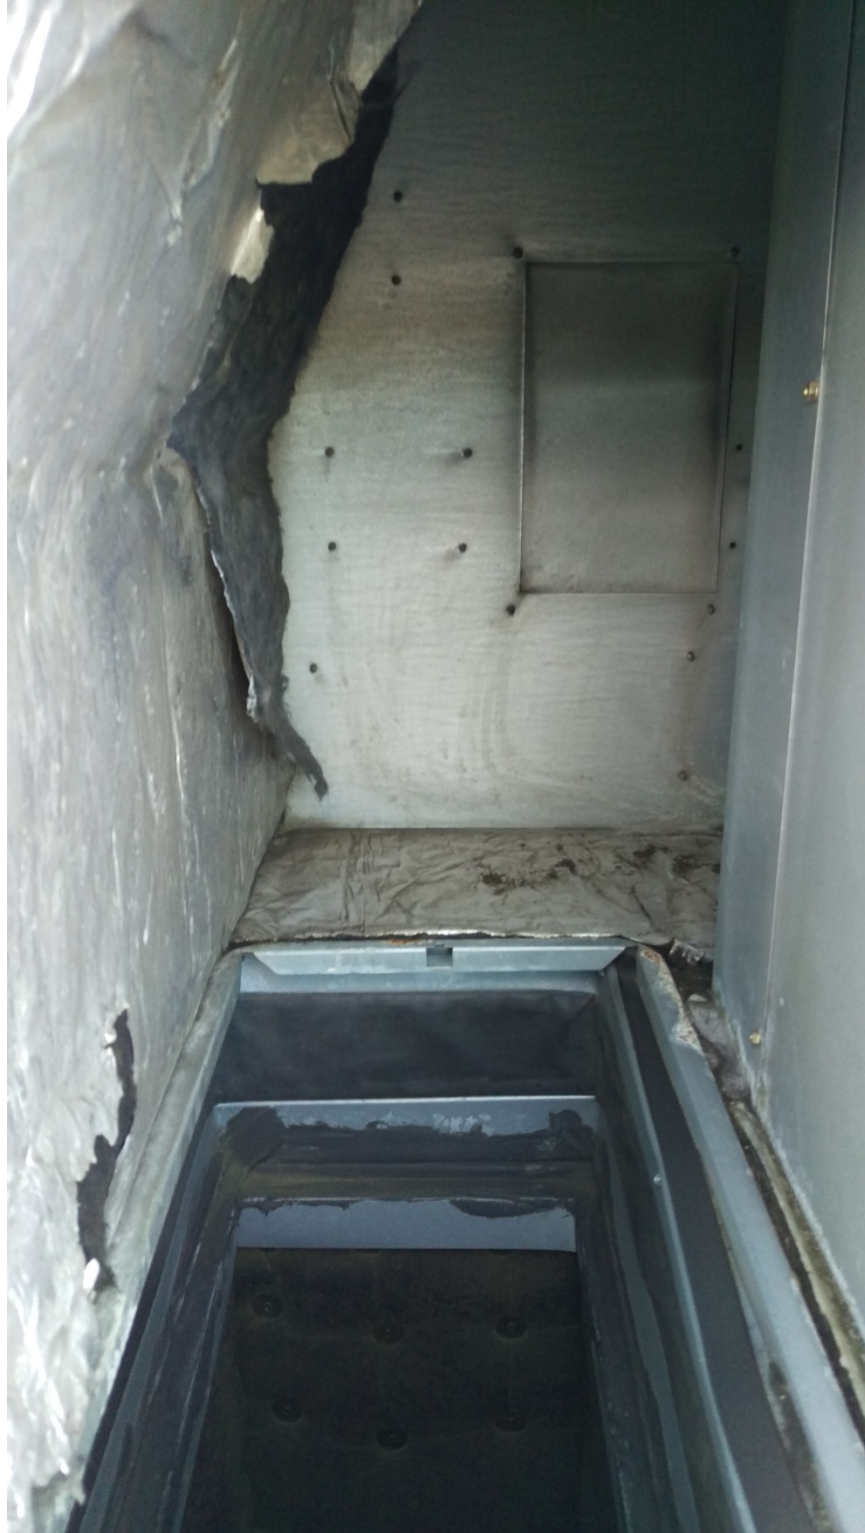
Photo #2 Delaminating Insulation Inside Rooftop Unit

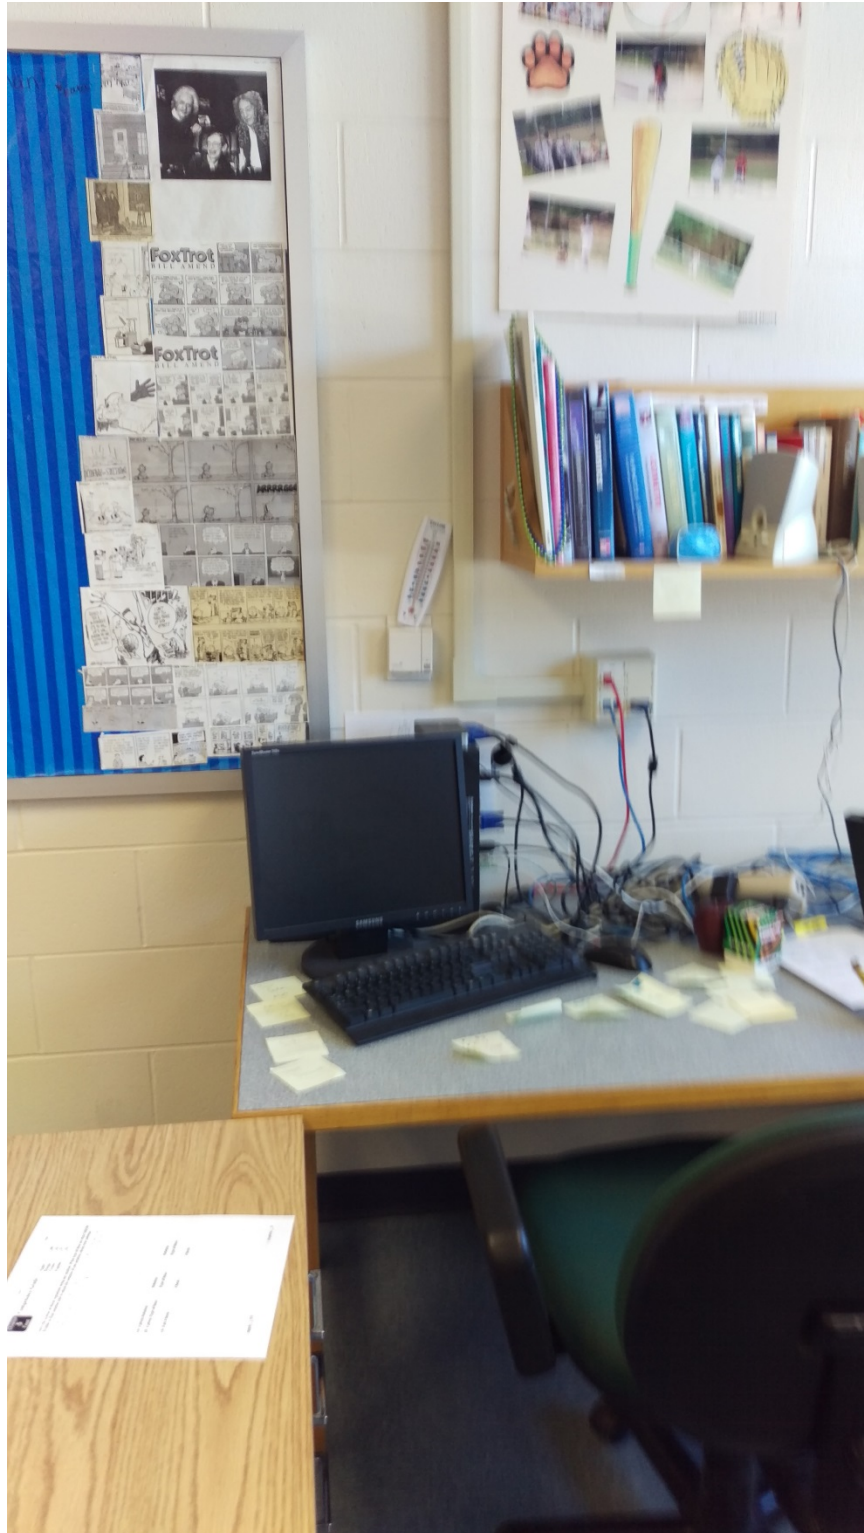
Photo #6 Temperature Control Thermostat Above Computer

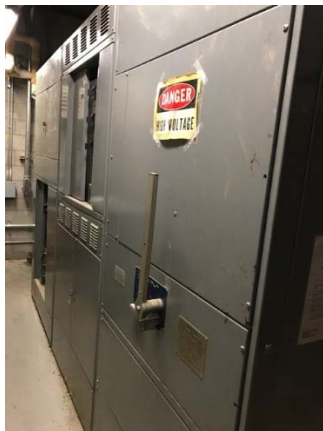
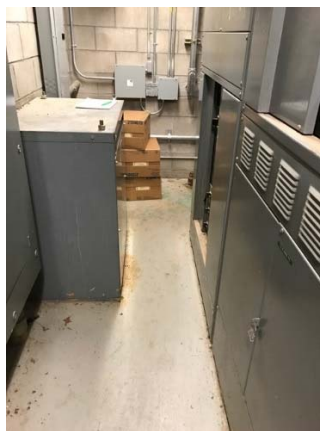
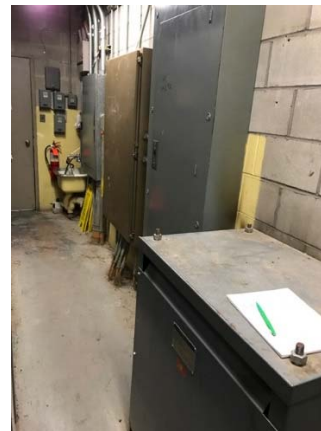
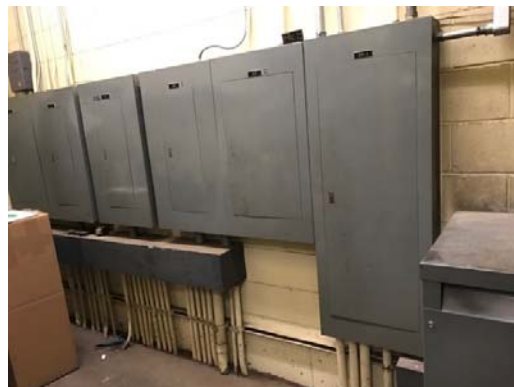
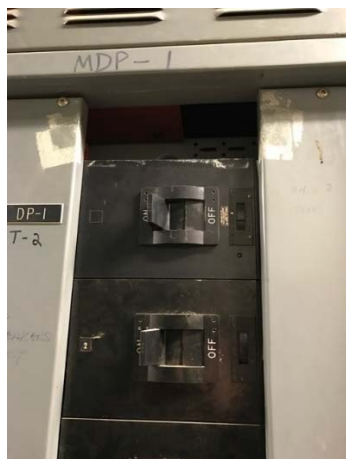
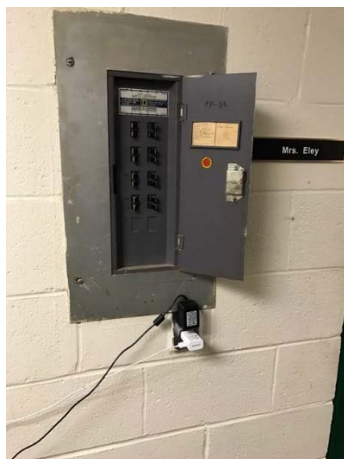
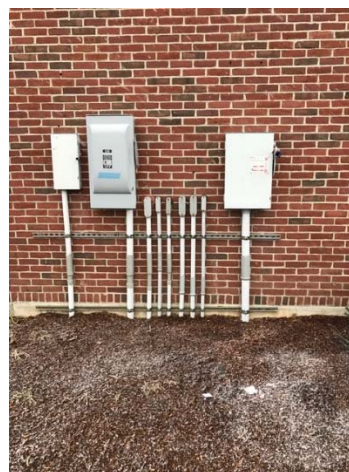
The facility's electrical distribution equipment consists of originally installed (1978) 120/208 and 277/480 volt distribution panelboard and dry-type transformers. The panelboards were manufactured by Square D, have surpassed their expected life and should be replaced.

The facility's distribution equipment and panels were manufactured by Square D and have surpassed their useful life and should be replaced.

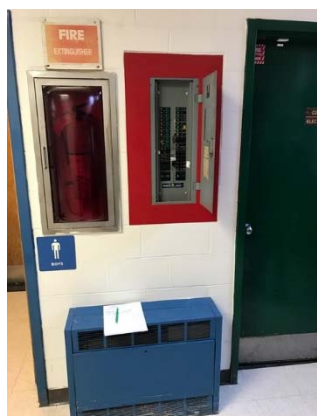
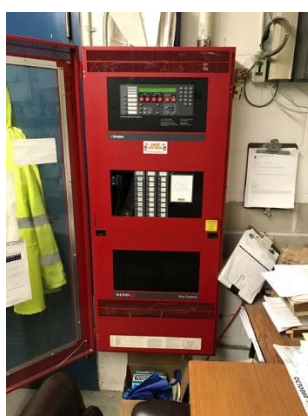
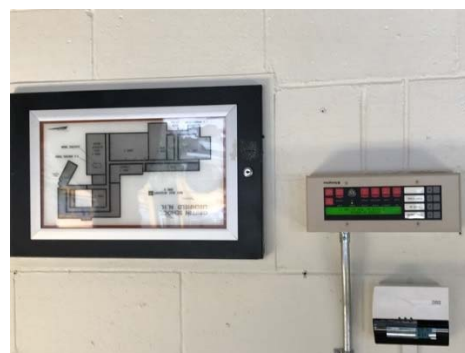
The fire alarm system consists of an addressable Simplex 4100U Fire Alarm control panel located in the main lobby, a graphic annunciator also in the lobby, manual pull stations at all exit doors or exit staircases, smoke detectors in corridors, elevator-recall-smoke detectors, speaker/strobe devices in all public bathrooms, strobe-only devices in bathrooms and conference rooms.

The system is working adequately and there have been no reported issues. The system is 12 years old. The devices should be tested to check for proper functionality. The overall system has an approximate 13 years of remaining expected life.

The existing addressable Simplex 4100U Fire Alarm control panel should be retained. The devices should be replaced with new addressable devices as needed, as they begin to fail. Otherwise, the fire alarm is in good working condition. The entire system should be upgraded/replaced in 13 years.

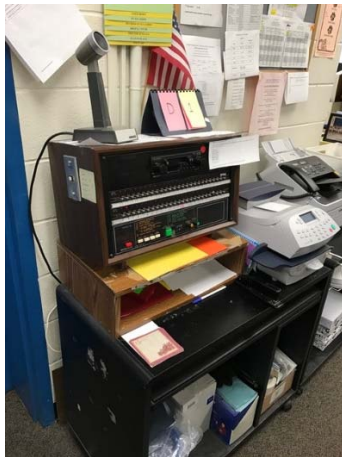
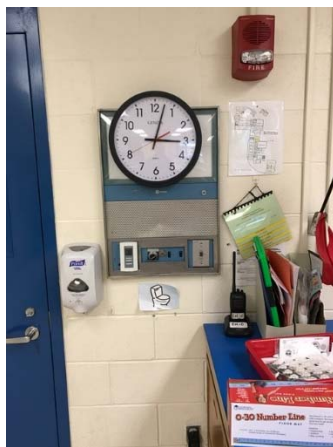
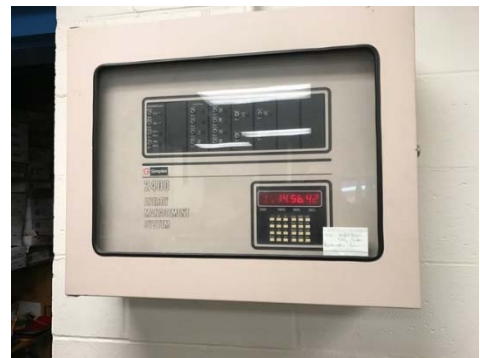
Simplex System 2400 reported to be working adequately.

The speakers and clocks are in good working condition. The entire system should be replaced in approximately 20 years.

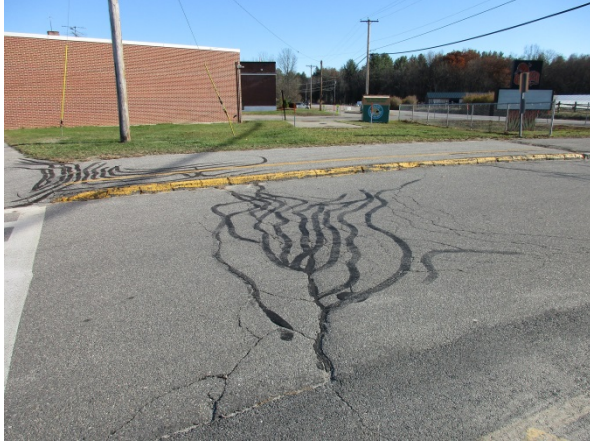
Pavement deterioration at driveway, curb, & sidewalk.

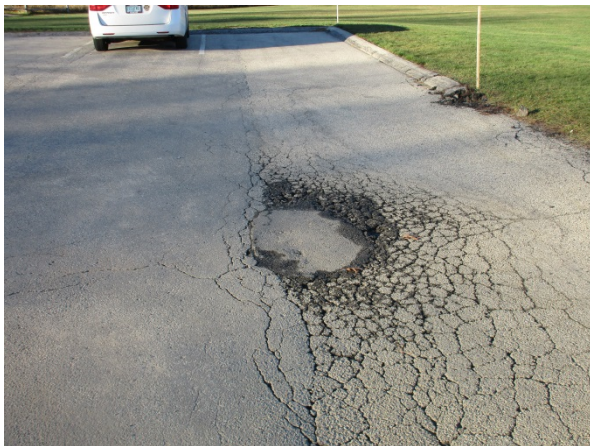
Cracked, broken pavement, indicating base gravel failure.

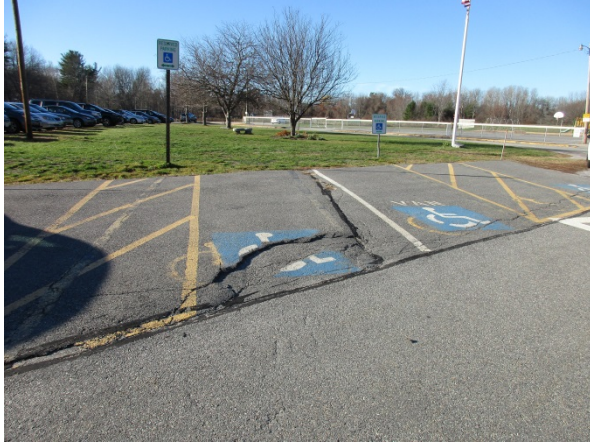
Non-compliant accessible spaces. Note poor condition of asphalt & signage.

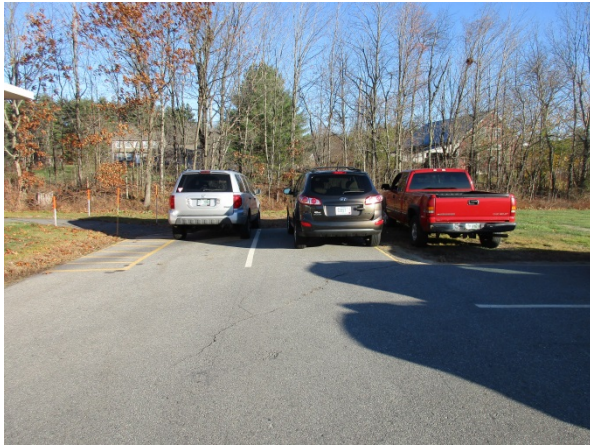
Dead end parking lot on south side of school.

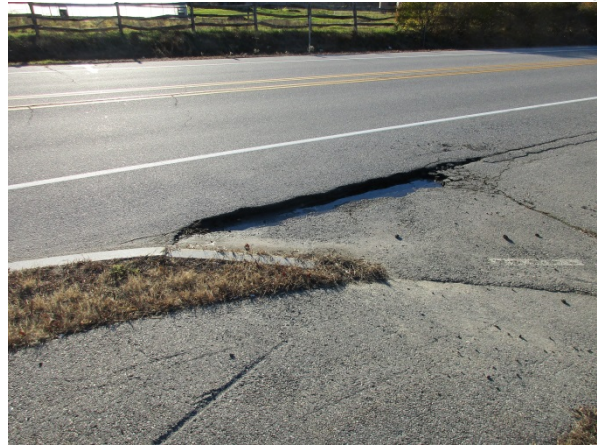
Pothole at intersection of Route 3A & parent drop-off loop.

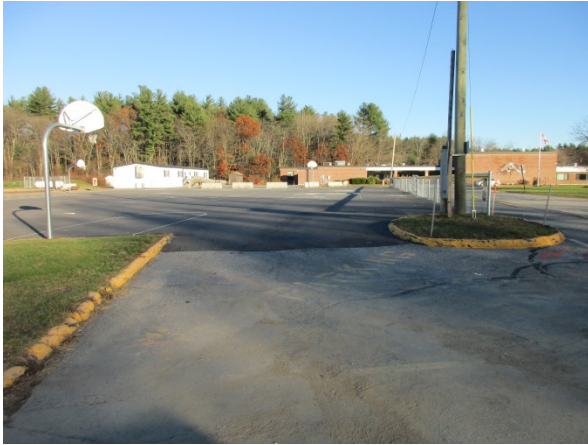
Vehicle opening to playground- install latching gate to control access.
