## EVALUATION AND ASSESSMENT

LITCHFIELD SCHOOL DISTRICT

LITCHFIELD, NEW HAMPSHIRE

SEPTEMBER 27, 2017

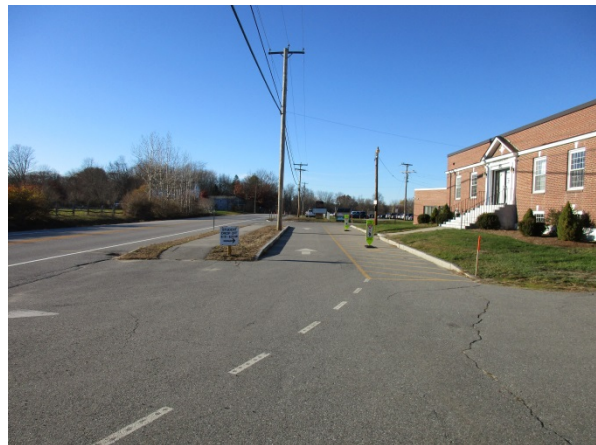
Parent drop off loop- capacity for small number of vehicles..

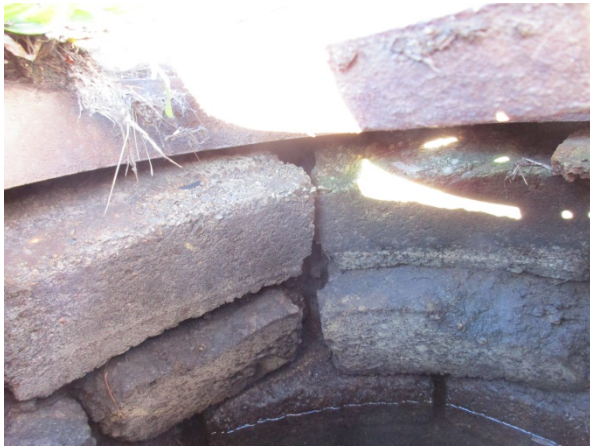
Loose-laid masonry blocks forming catch basin sidewall. Structurally insecure and allows for groundwater infiltration.

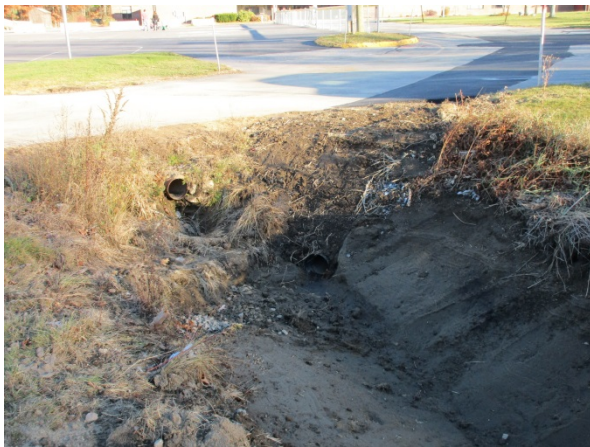
Drainage swale at west end of parking lot. Note lack of vegetation and elevated culvert outlet.

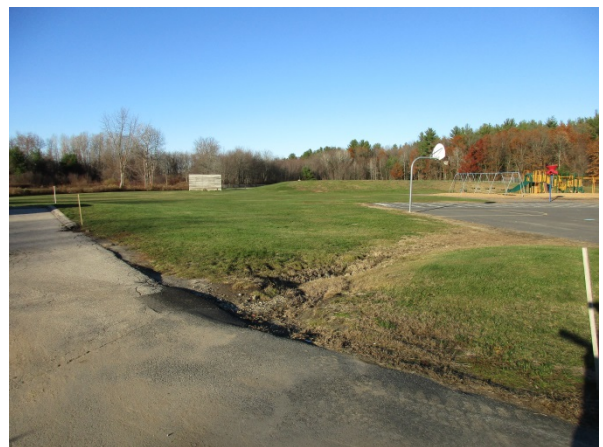
Eroded swale capturing playground runoff.

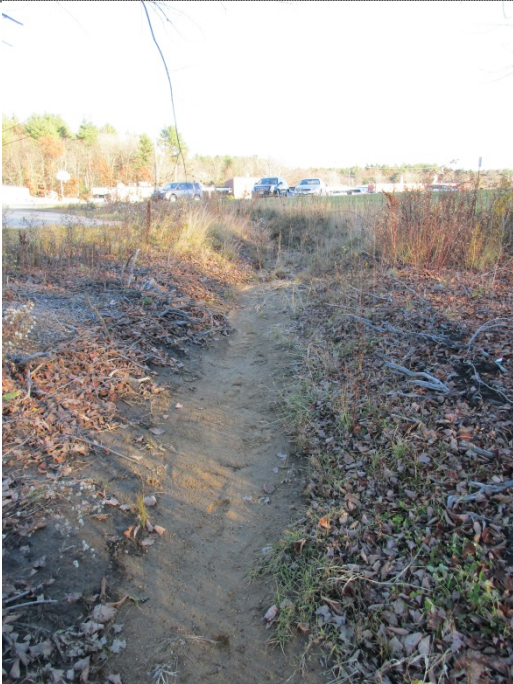
Sediment in drainage swale at west end of parking lot. Tall grass should be maintained at 4-6" length.

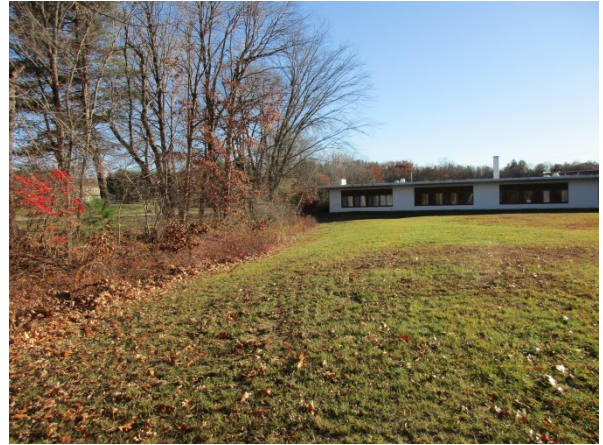
Overgrowth in drainage swale at east end of site.

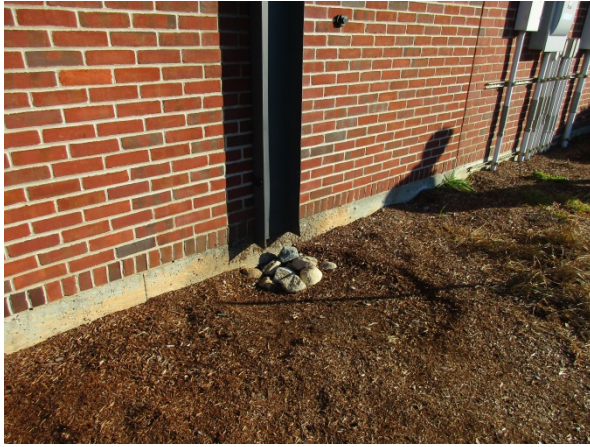
Soil displacement at roof leader outlet.

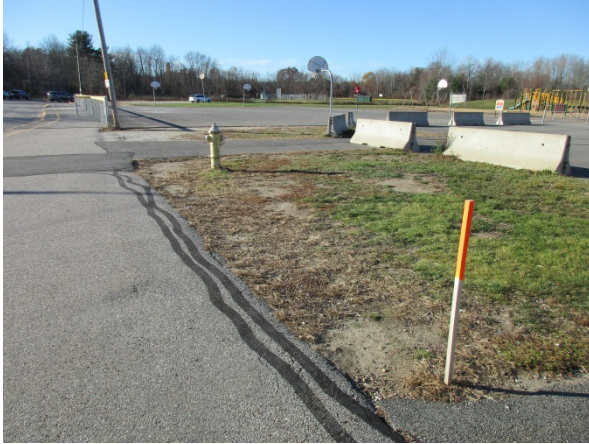
Sparse grass cover- typical example.

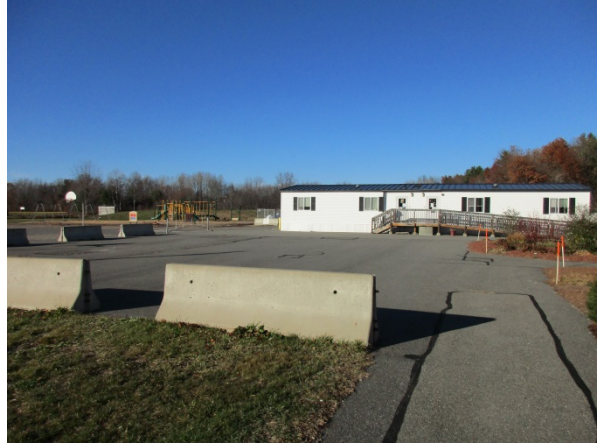
Excess pavement that could be restored to a grass-covered area.

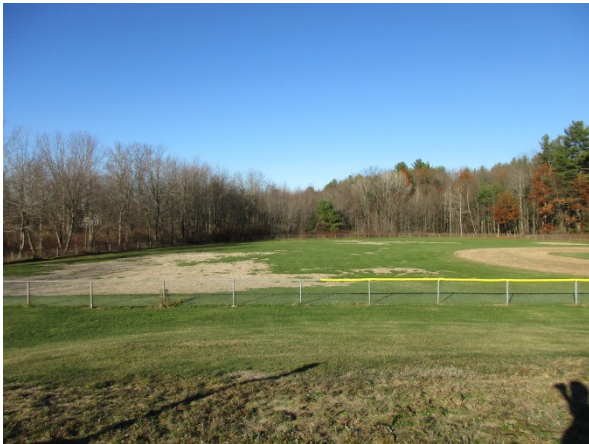
Sparse grass cover at ballfield.

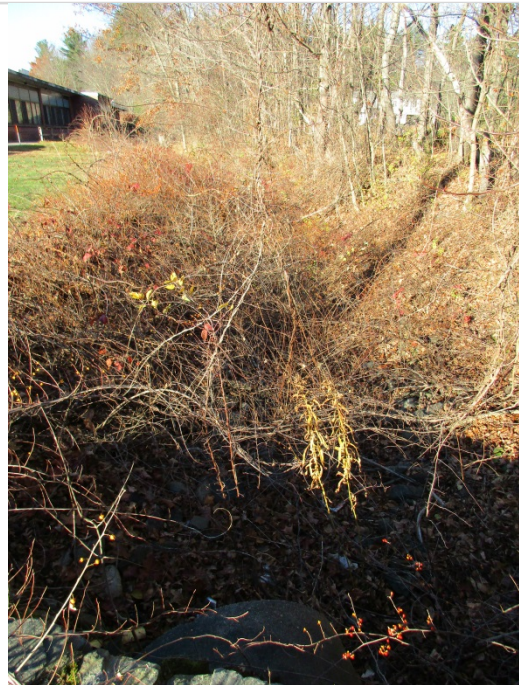
Overgrowth at drainage swale.

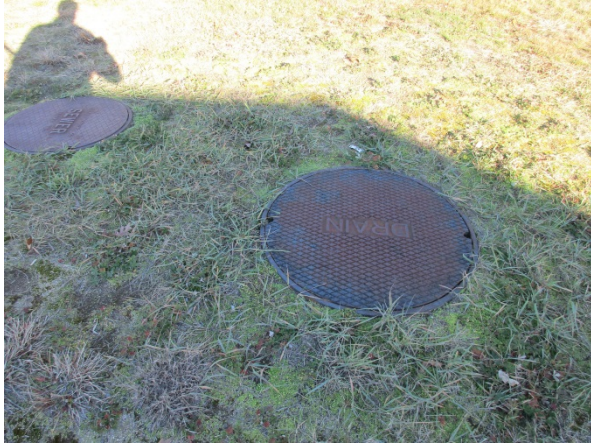
Septic tank cover reading 'DRAIN' (typ. For 2).

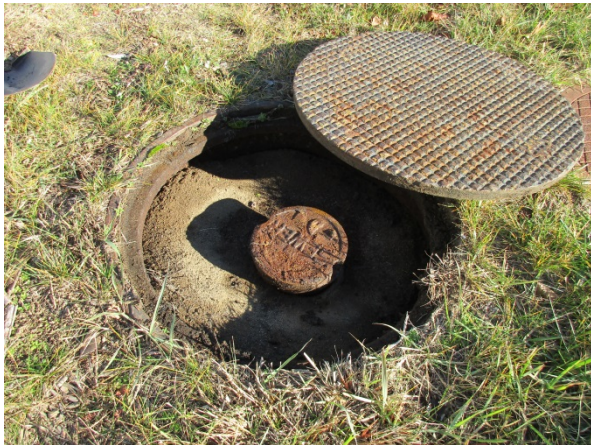
Elevated cleanout cover- prevents larger cover from setting securely in frame.

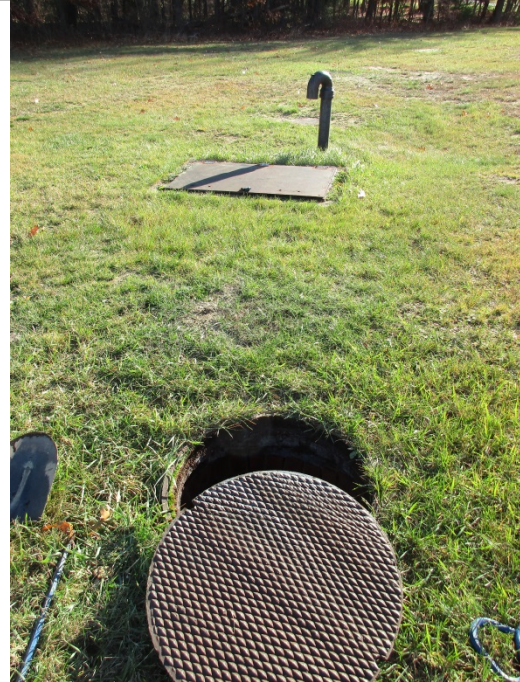
Access hatch (rectangle beyond) to pump station wet well (stone & pipe system).

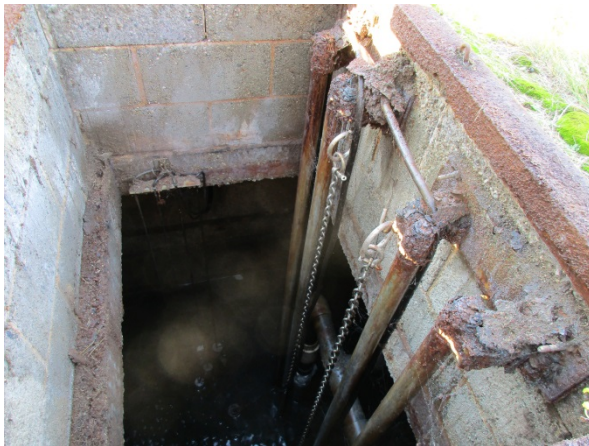
Corroded guide rails & brackets, stone & pipe system pump station.

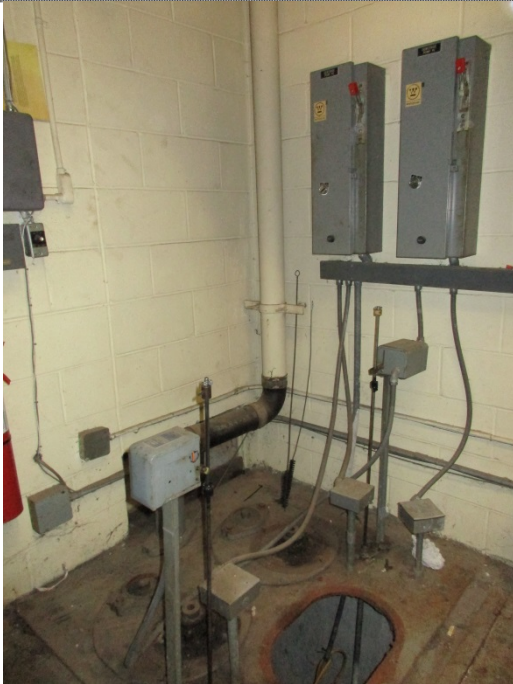
Grinder pump controls & wet well, inside mechanical room.

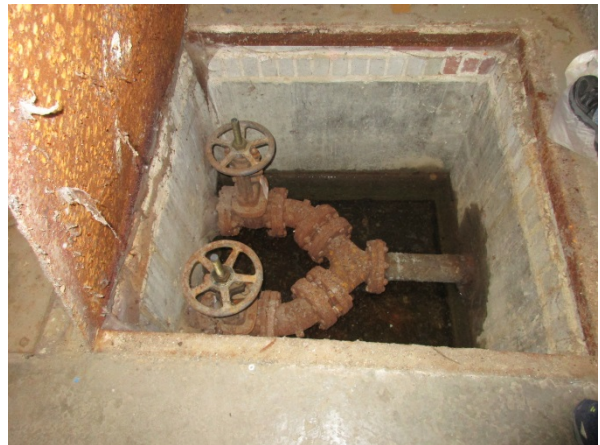
Grinder pump valve pit. Note presence of groundwater.

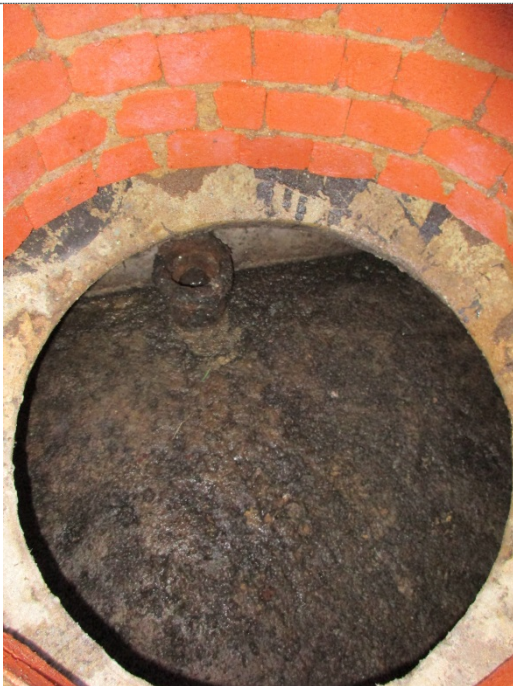
Grease accumulation at inlet of septic tank adjacent to stone & pipe pump station.

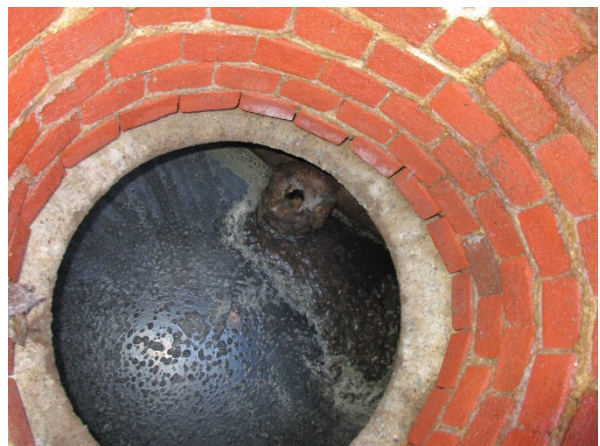
Grease accumulation at outlet pipe of septic tank adjacent to stone & pipe pump station.

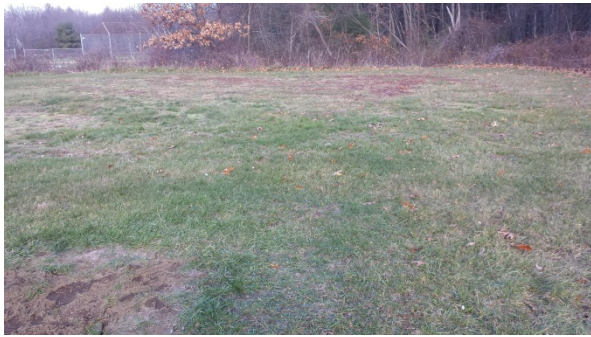
Sparse vegetation at trench system leach field. Note dense woody vegetation around the perimeter on the side slopes.

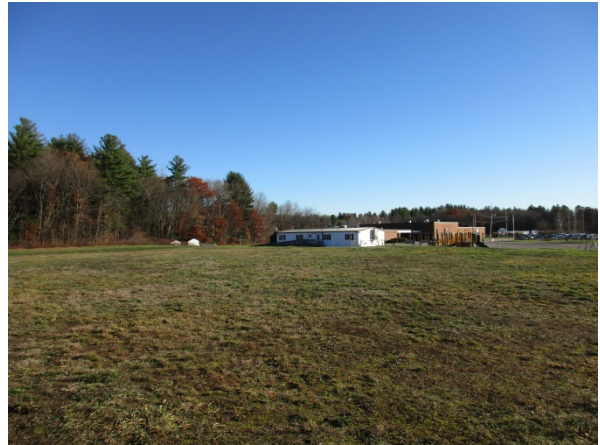
Sparse vegetation at stone and pipe system leach field.

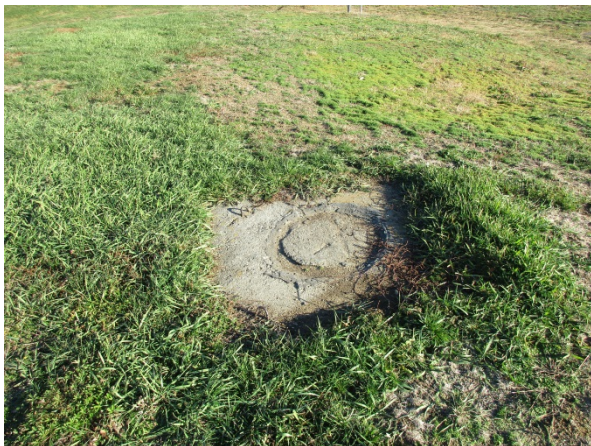
Distribution box at stone and pipe field that is sealed shut.

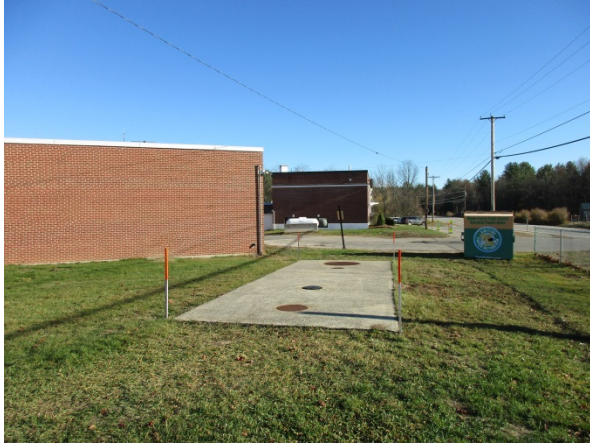
Underground oil storage tank. Mount audible overfill alarm to masonry wall. Note dumpster set on grass surface in background.

Dumpsters	Dumpsters at the site are set on asphalt or grassed surfaces. The approaches to the dumpsters are asphalt.	Install concrete pads on which to set the dumpsters and include concrete approach slabs. Consider installing an opaque enclosure to provide visual screening and containment for spilled debris.	3	(?)	>5 years	20 years	\$12,000
Site lighting	A 2006 site assessment identified an inadequate number of site luminaires, and those that are there are inefficient. Site lighting hasn't been modified or enhanced.	Replace existing site lighting with high efficiency LED lighting. Have a site lighting design completed to determine what additional luminaires are required.	3	(?)	2-5 years	20-30 years	\$60,000
<b>SUB-TOTAL</b>							<b>\$296,950</b>

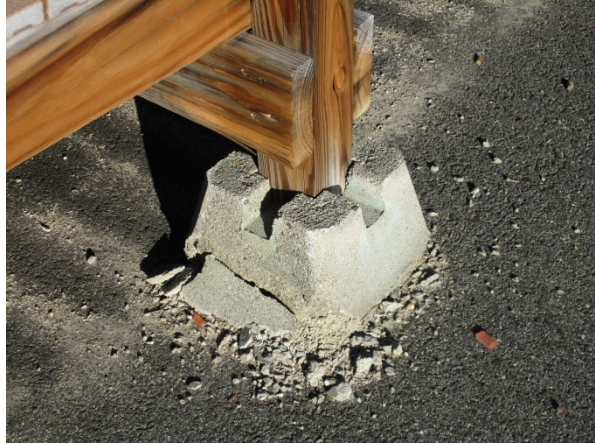
Deteriorating ramp footing at portable classroom.

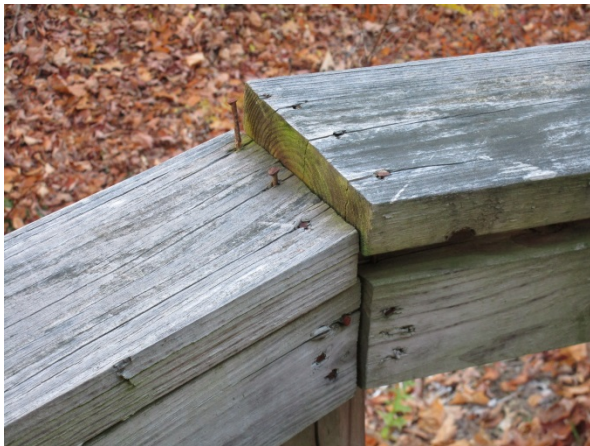
Wood railing on east side of school- note exposed nail heads & displaced/ warped wood members.

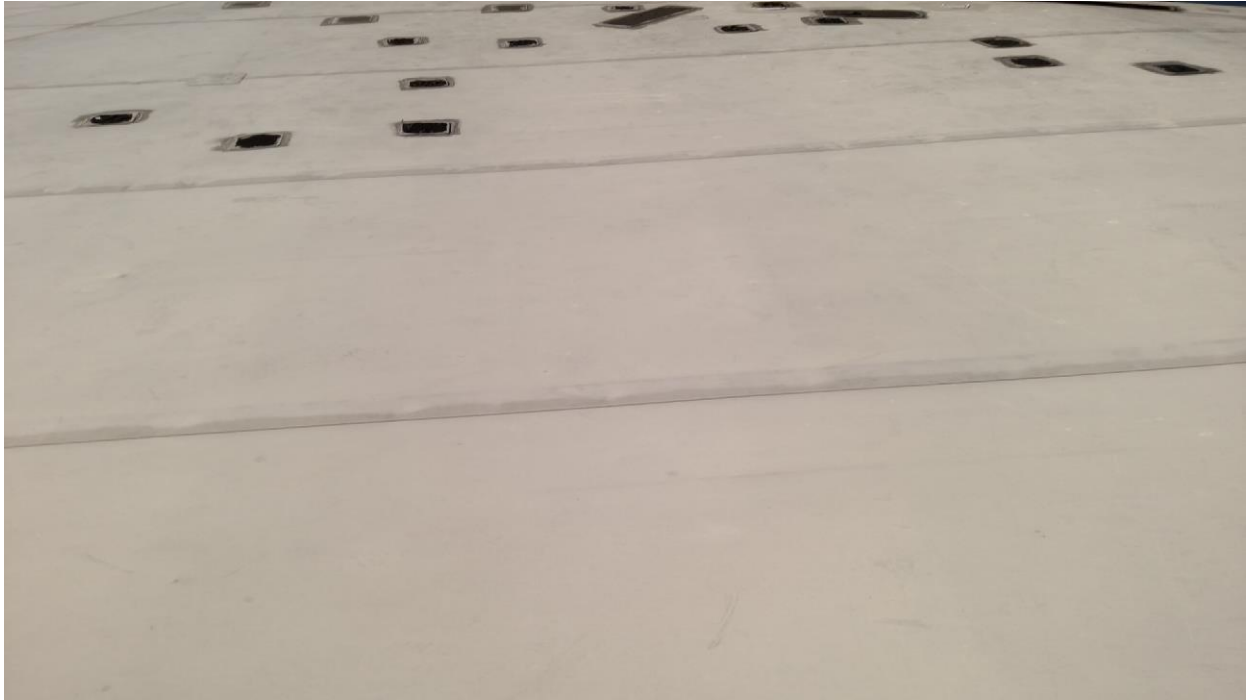
Patches at PVC Membrane

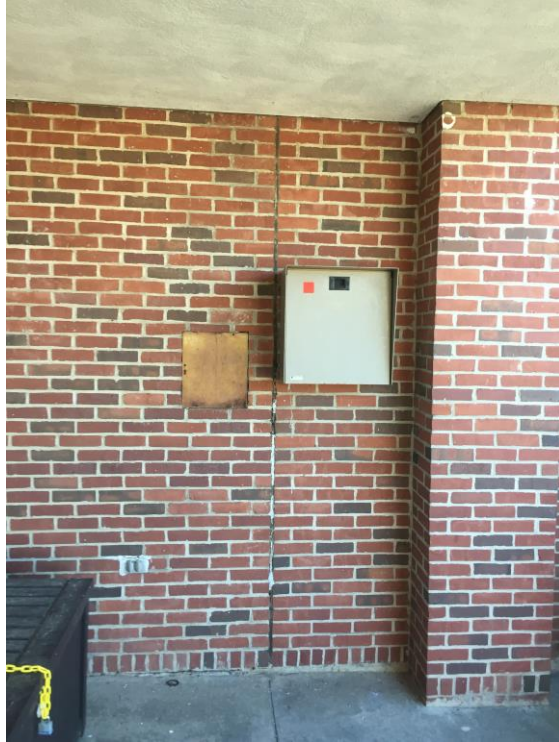
Sealant Joint at Brick Veneer

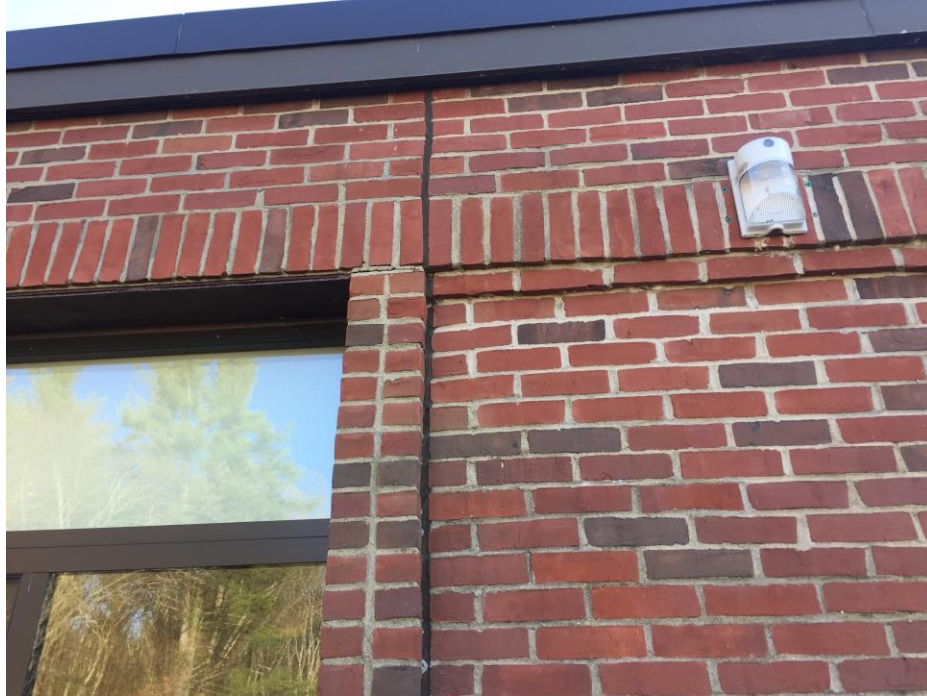
Sealant Joint at Brick Veneer

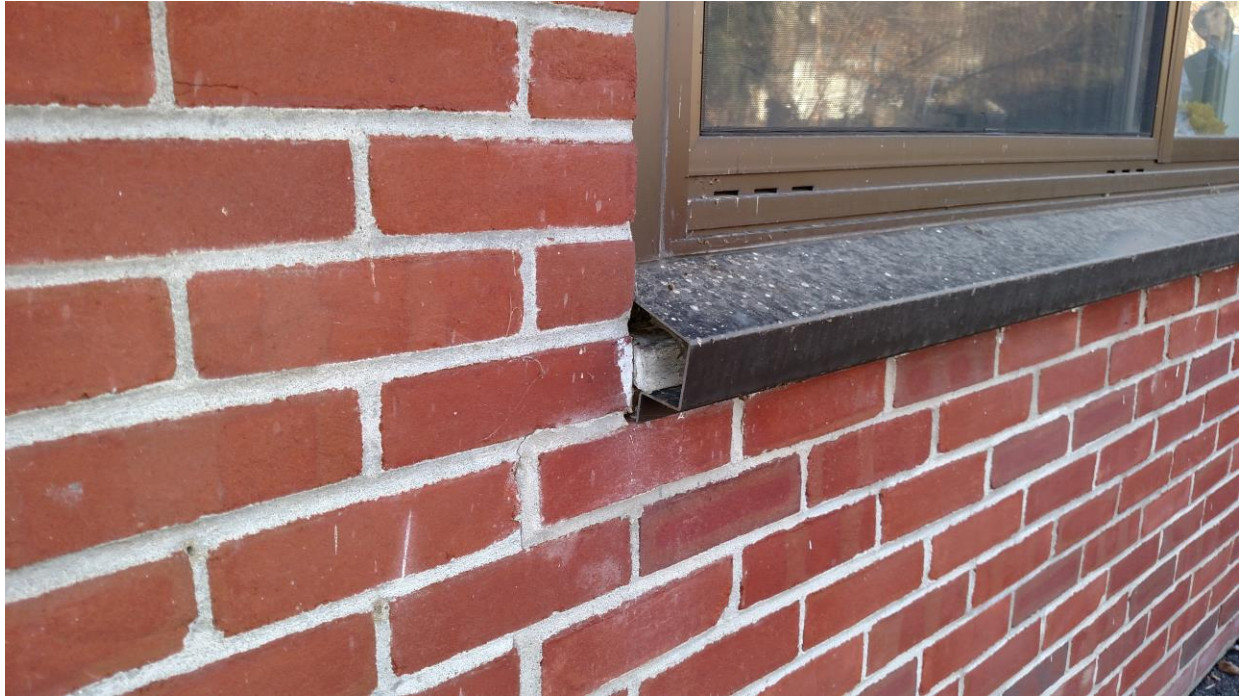
Opening in Sill of Window Frame

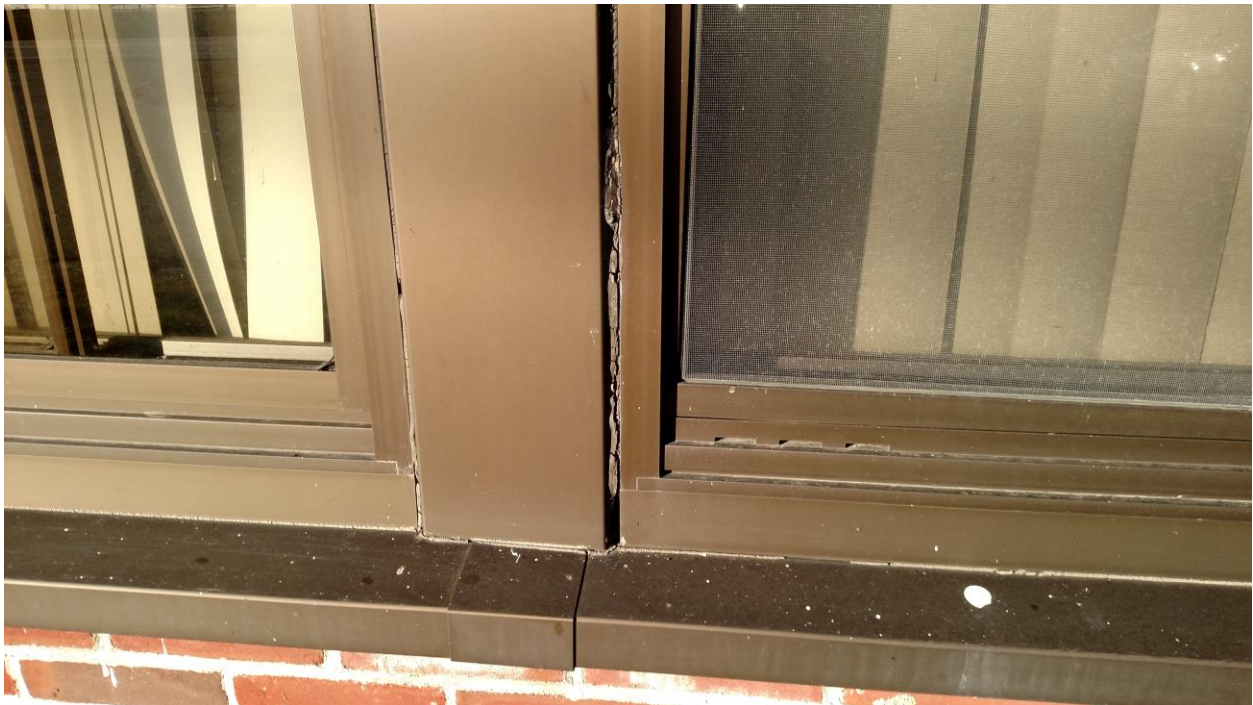
Sealant at Window Frames

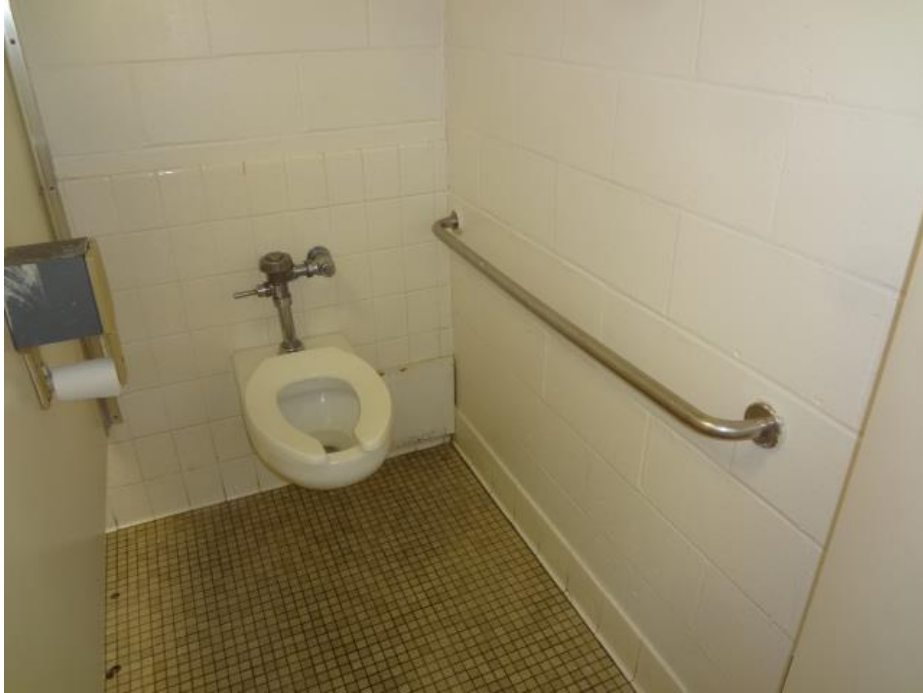
Inaccessible toilet stall

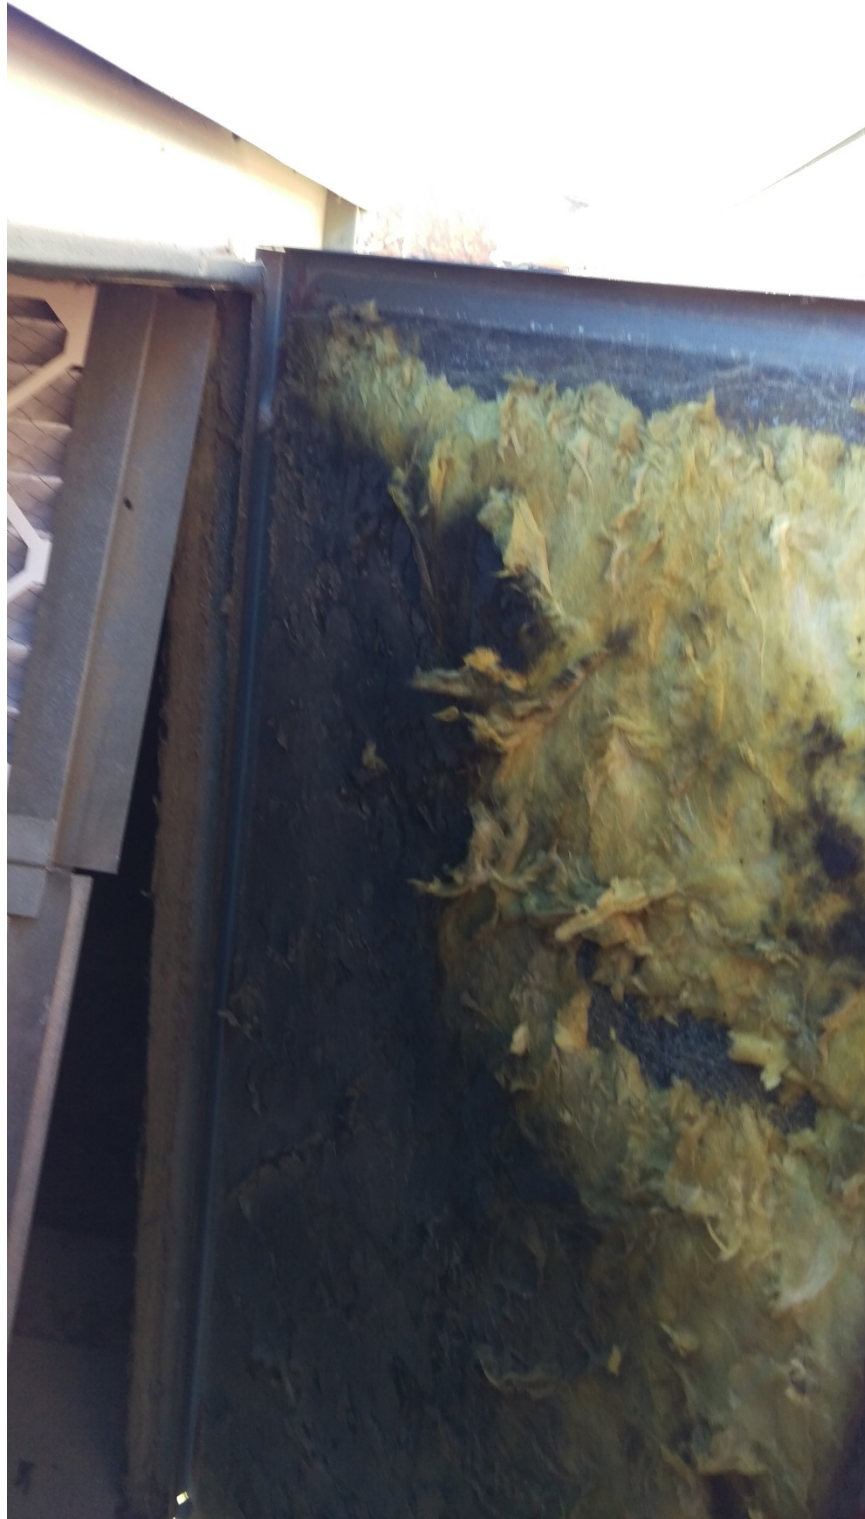
Photo #2 Interior Insulation in Trane Rooftop Unit

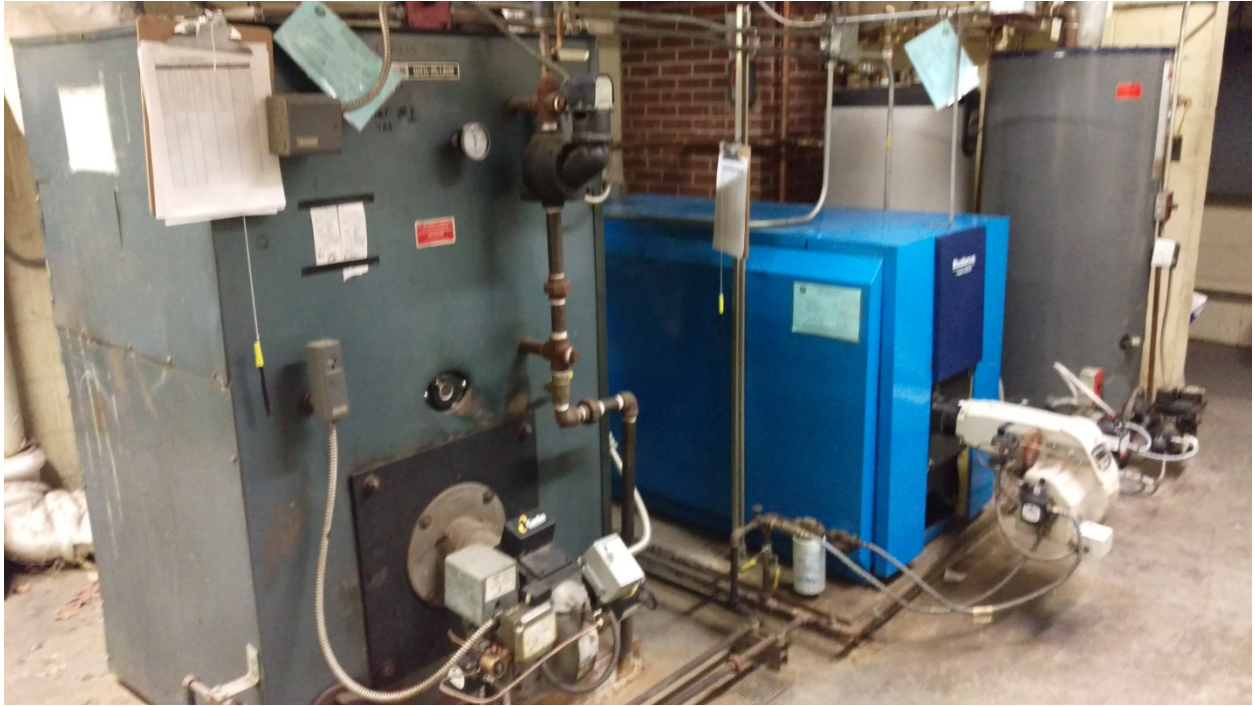
Photo #3 Weil McLain (1989) and Buderus (2009) Boilers

Boilers	Two of the three boilers have 15 years or less of service. Remaining boiler has served its useful life. Combustion air systems do not meet code requirements.	Replace 1989 Weil McLain boiler. Rework combustion air systems to meet code	2,3	1989	2	30	\$70,000
Exhaust Fans	Rooftop exhaust fans have exceeded their useful life. Many were not operating during our site work.	Replace aging exhaust fans	3	-	-	-	\$84,000
Nurse's Office Odor	Sewer odor noted during site investigation in Nurse's Office.	Completely seal floor drains in former shower area (now storage) in rear of Nurse's space.	3	-	-	-	\$5,000
<b>SUB-TOTAL</b>							<b>\$959,000</b>

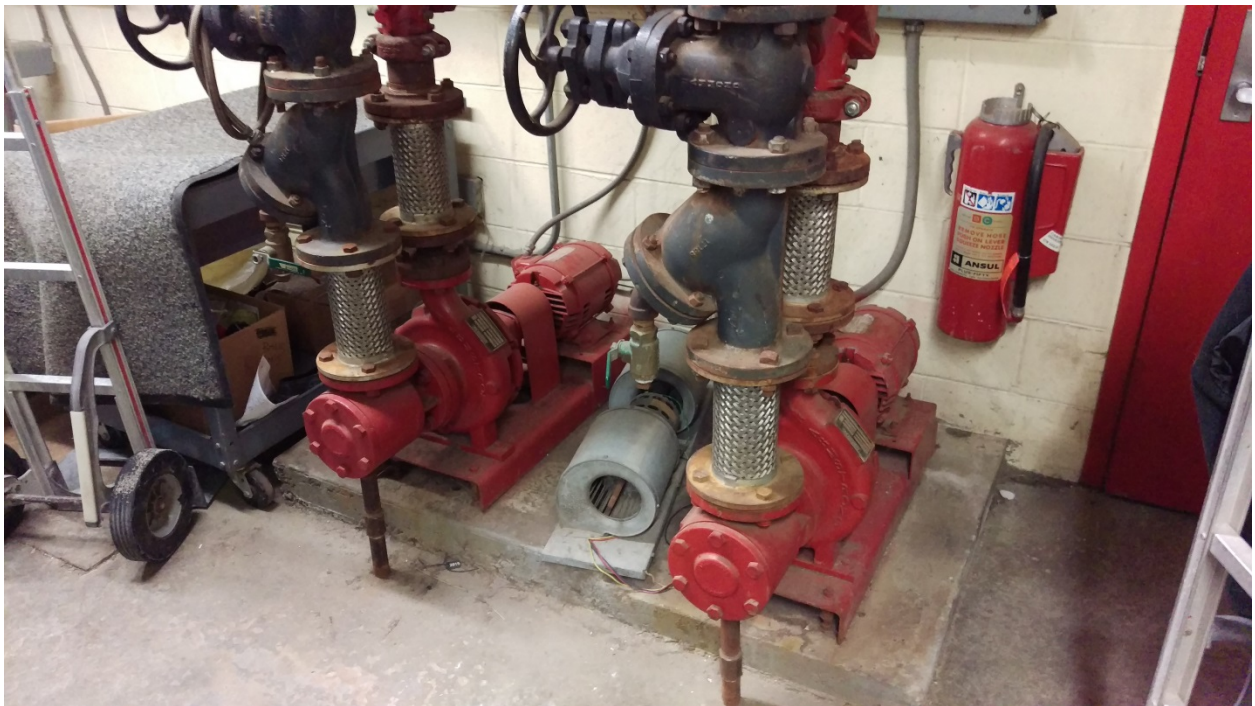
Photo #4 Main Heating Hot Water Pumps

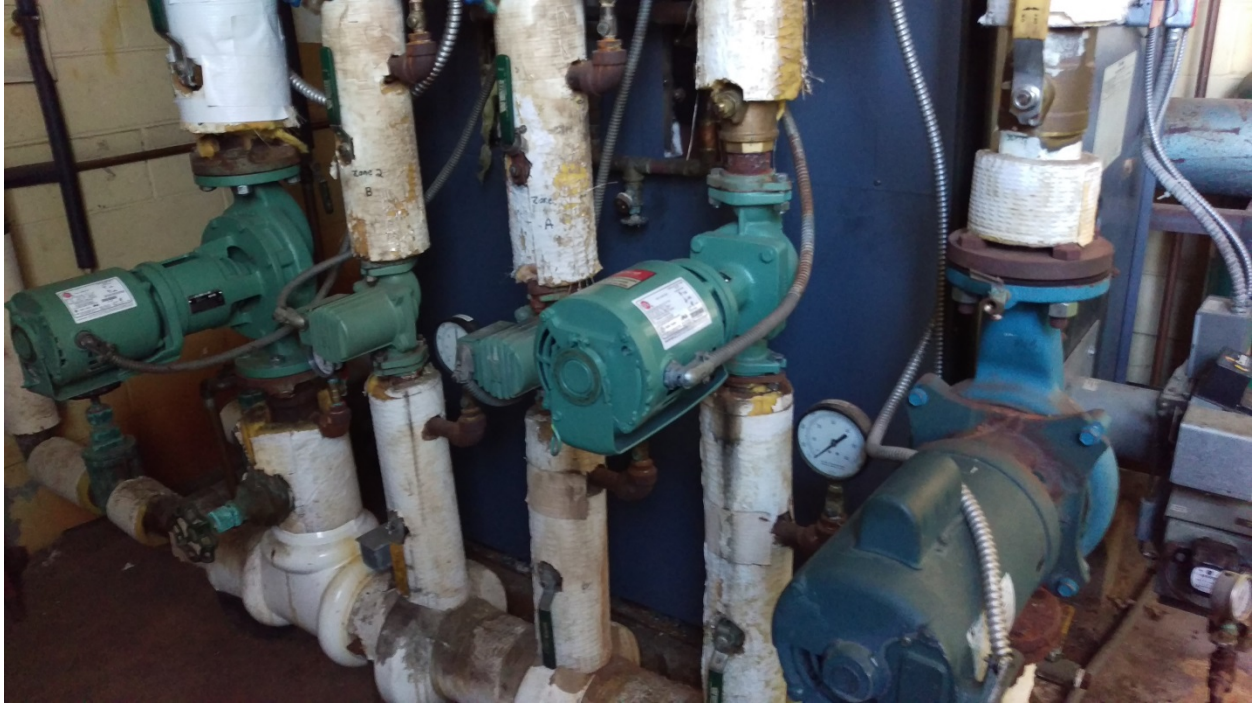
Photo #5 Pumps in Secondary Boiler Room

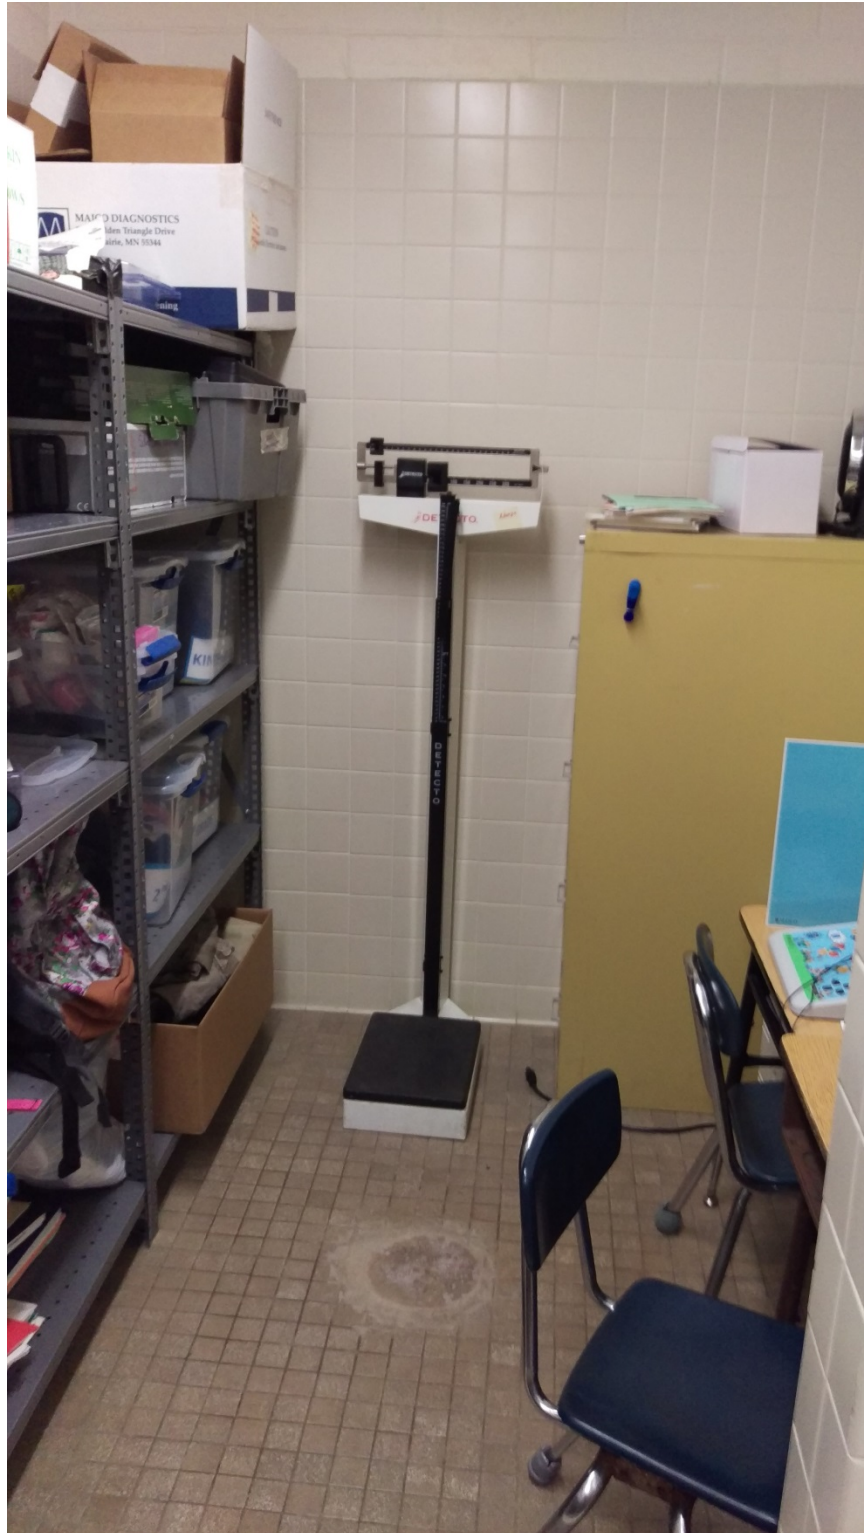
Photo #6 Partially Sealed Floor Drain in Nurse's Office

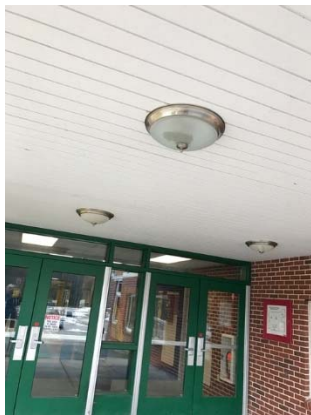
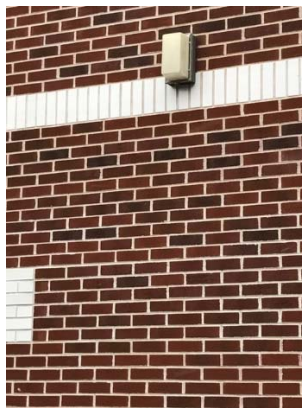
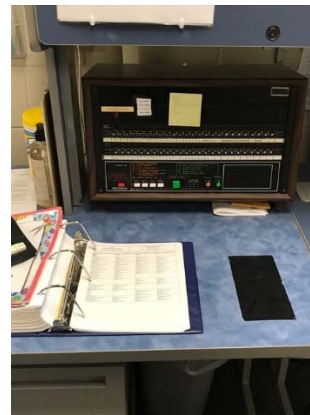
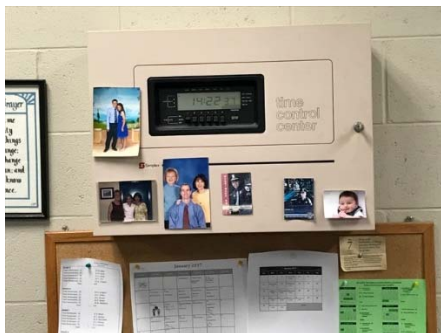
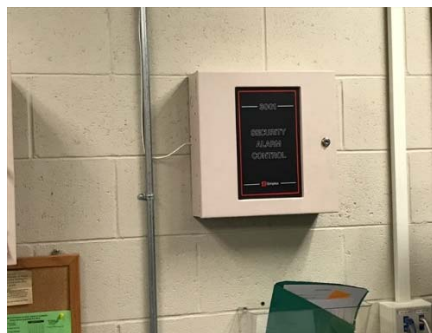
Ceiling decorative fixtures under canopy and mini-wall packs.

The decorative fixtures under the canopy and the wall-mounted mini-wall packs should be replaced with new energy-efficient LED fixtures.

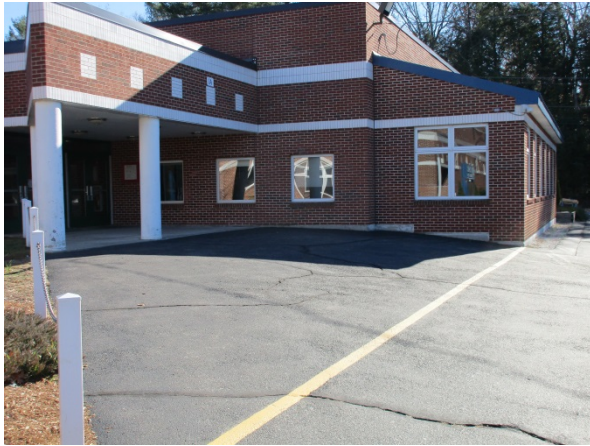
Pavement cracks & steep slope.

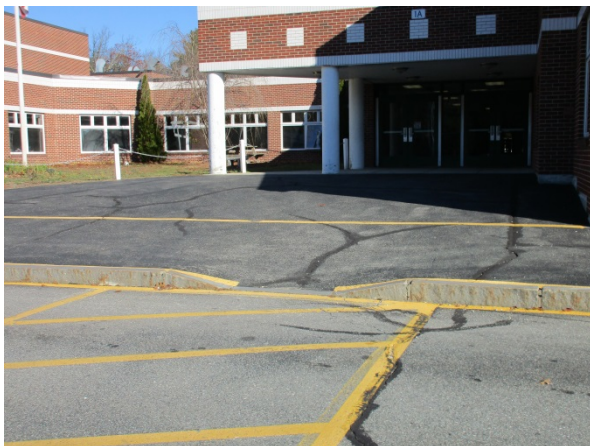
Tipdown, noncompliant w/ ADA.

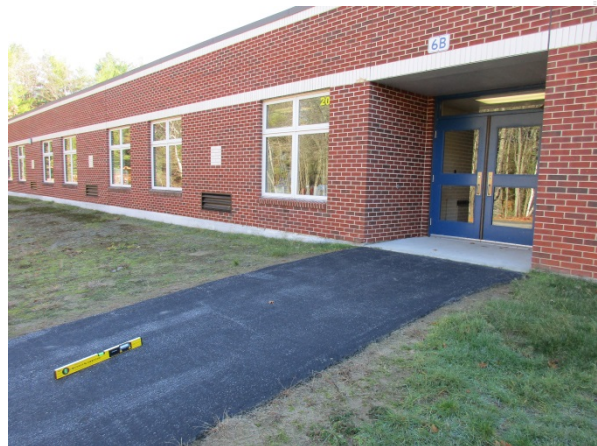
Steep egress on north side.

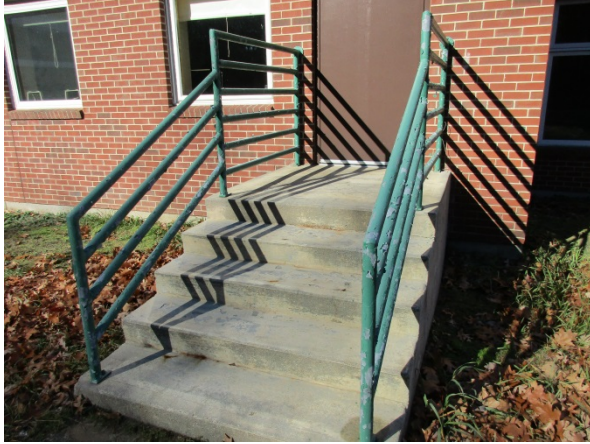
Handrails at door 15D, not compliant w/ ADA

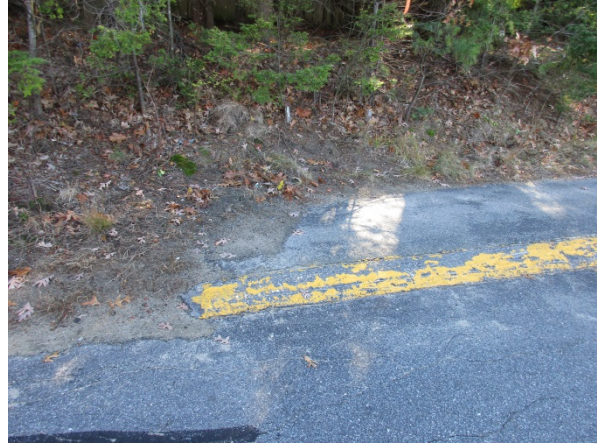
End of sidewalk along McElwain Dr.

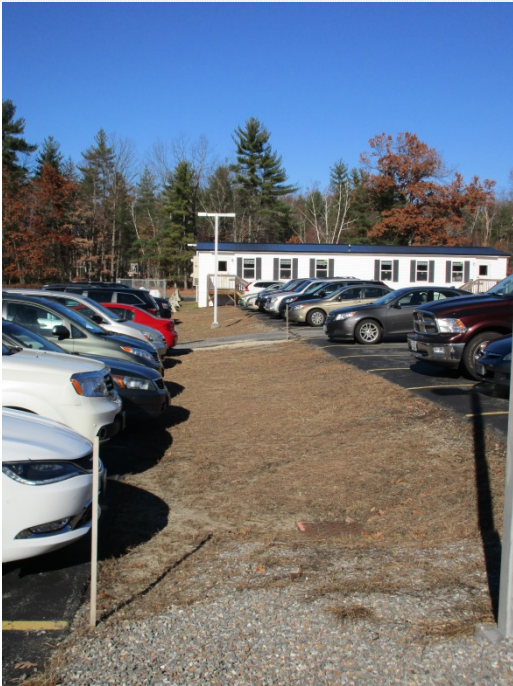
Slope between parking areas. Note lack of vehicle barrier, sparse vegetation, & erosion.

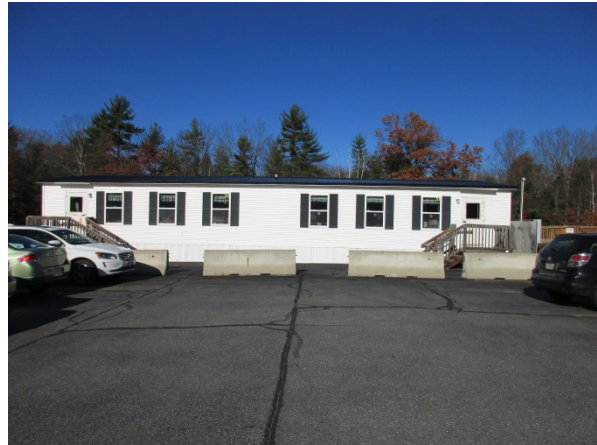
Dead end parking lot.

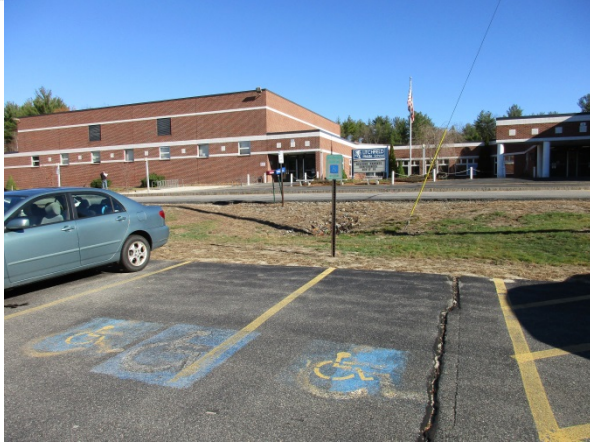
Two of the accessible spaces. The existing sign is too low, & each space should have a sign. Note the lack of an access aisle for the space at the left of the frame.

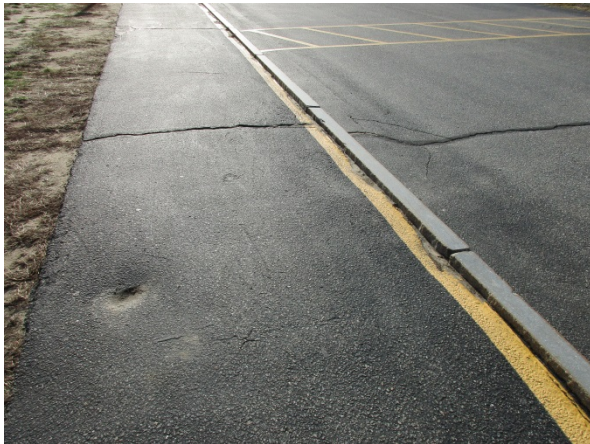
Settlement at sidewalk on west side of school.

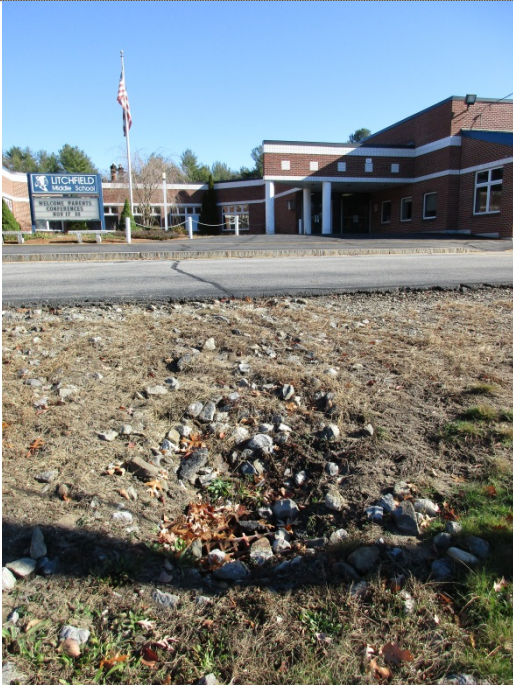
Erosion on slope off edge of pavement.

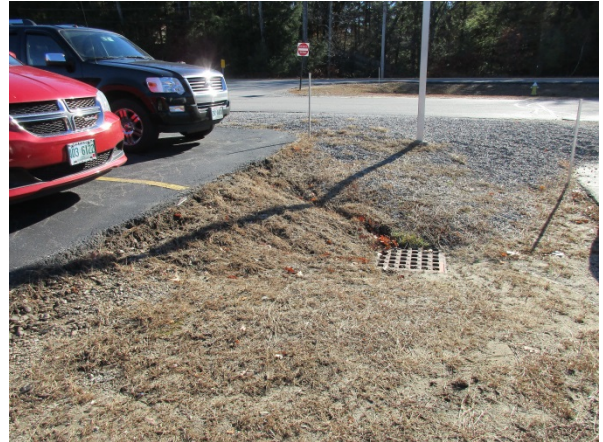
Slope erosion between parking lots. Note pea stone getting flushed to inlet.

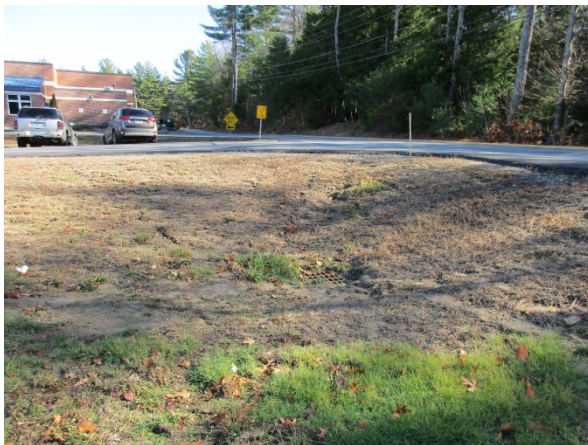
Sparse cover & erosion at detention pond.

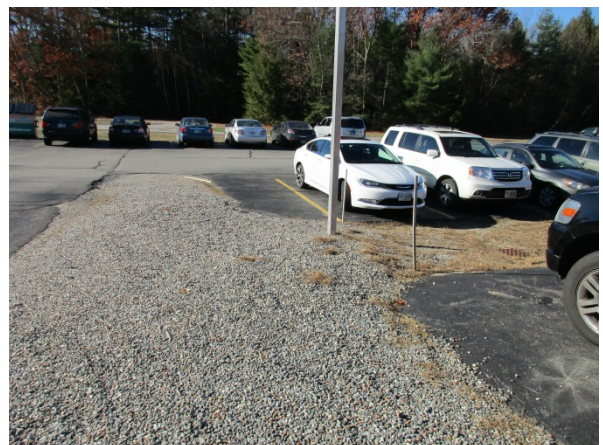
Pea stone at parking lot.

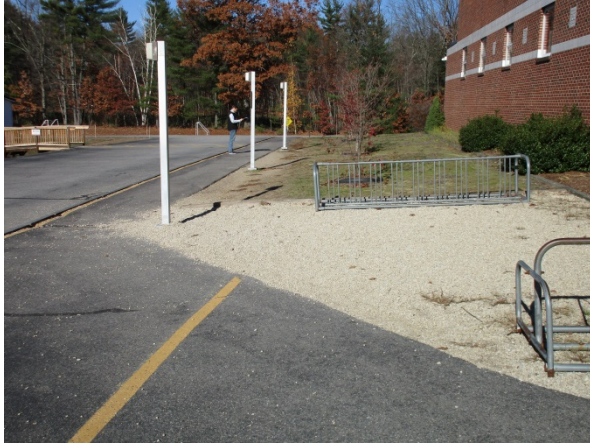
Pea stone at the bicycle rack- note displacement onto sidewalk.

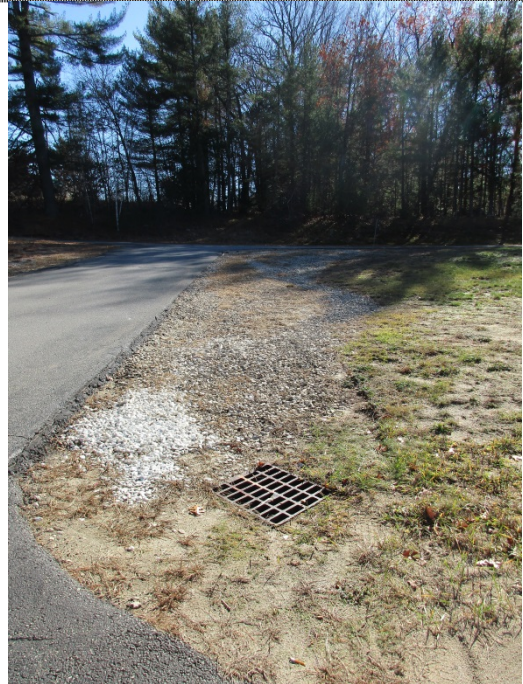
Pea stone washing into catch basin.

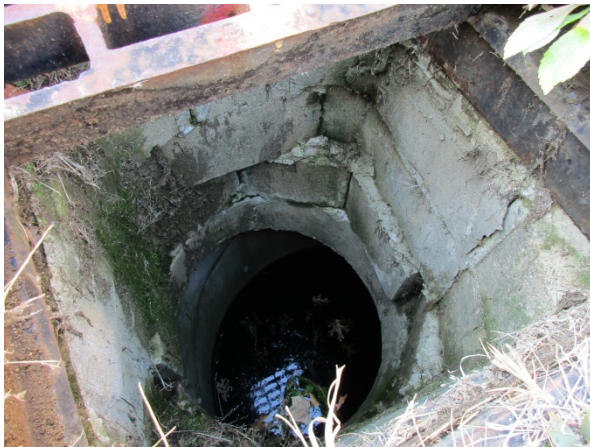
Deterioration cone section at catch basin.
