## EVALUATION AND ASSESSMENT

LITCHFIELD SCHOOL DISTRICT

LITCHFIELD, NEW HAMPSHIRE

SEPTEMBER 27, 2017

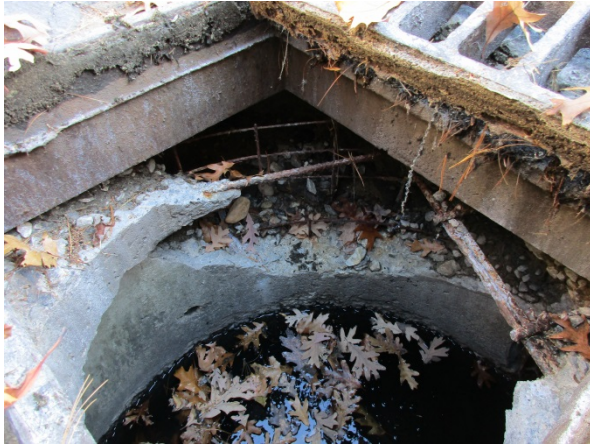
Catch basin at loading dock (prior to replacement).

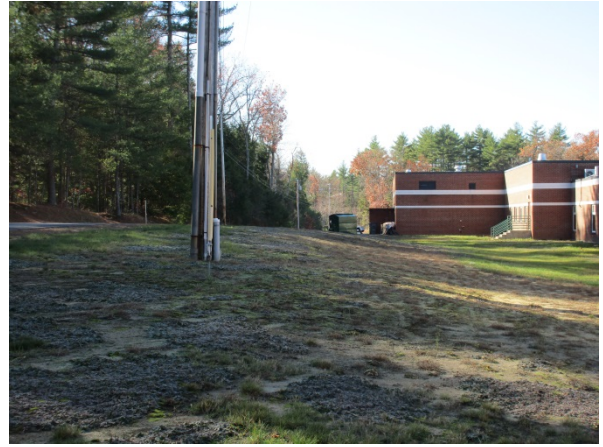
Lawn sloping toward school from driveway.

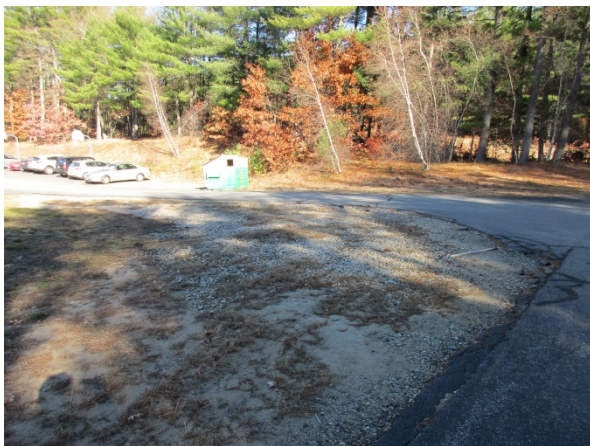
Erosion at edge of pavement.

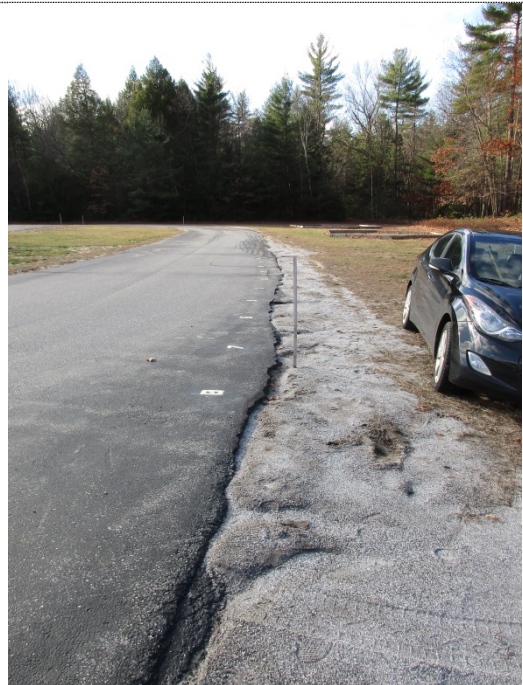
Erosion at edge of pavement.

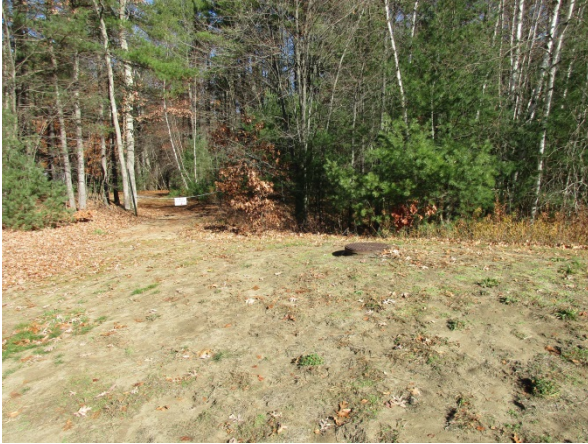
Sparse grass cover at septic tanks.

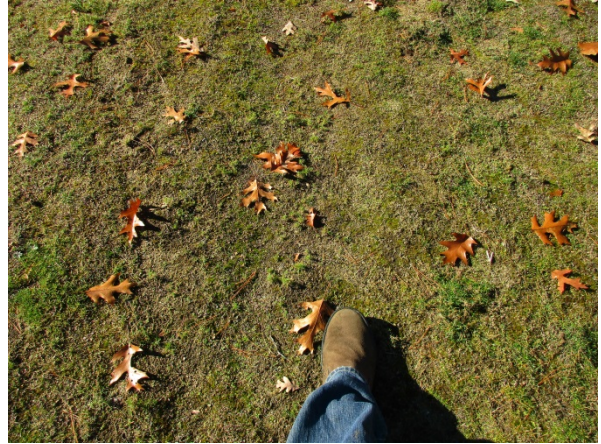
Sparse grass cover at leach fields.

COMPONENT	OBSERVATION	RECOMMENDATION	1-LifeSafety 2-BldgCode 3-Maint	YEAR INSTALLED	REMAINING USEFUL LIFE (Years)	TYPICAL USEFUL LIFE (Years)	OPINION OF COST FOR REPLACEMENT
Grass cover at the leach fields	Grass cover is very sparse- primary vegetation is weeds and moss.	Aerate and reseed the leach fields. Maintain a dense stand of grass over the top of the fields. Perform a soil analysis to customize a fertilizer program specific to the needs of these areas.	3	1986	<2 years	30 years	\$2,000
Control panel and alarms	Pump station control panel and the alarms are located inside the school.	Consider relocating the control panel and the alarms to an exterior location with a line of sight to the pump station wet well and so the alarms are highly visible.	2	1986 (?)	2-5 years	20 years	\$10,500
<b>MISCELLANEOUS</b>							
Dumpsters	Dumpsters at the site are set on asphalt or grassed surfaces. The approaches to the dumpsters are asphalt.	Install concrete pads on which to set the dumpsters and include concrete approach slabs. Consider installing an opaque enclosure to provide visual screening and containment for spilled debris.	3		>5 years		\$12,000

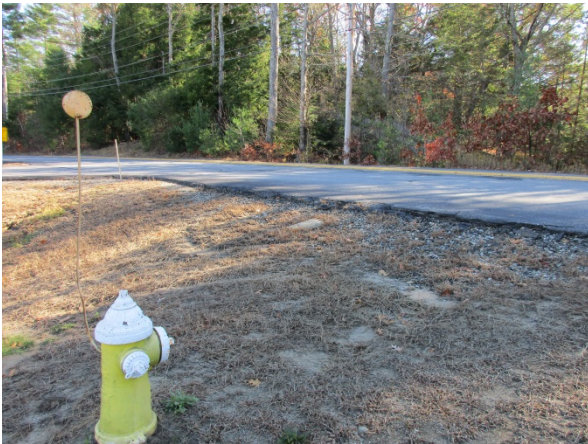
Erosion at edge of pavement & poor grass cover.

Erosion at edges of pavement	In multiple locations where runoff flows off the edge of pavement to abutting gravels, the ground is eroded and the pavement is undermined.	Place compacted crushed gravel at pavement edges across the site where erosion is a problem.	3		<2 years		\$2,500
<b>SEPTIC SYSTEM</b>							
Septic tanks	Access hatch covers do not sit securely in their frames and sediment spills through the gap and onto/into the septic tank below.	Replace the access frames and covers. Remove sediments from the top of the septic tanks so it doesn't spill into tank. Install concrete access covers at the openings cored in the tanks.	3	1986	<2 years	30 years	\$15,000
Pump station hatch	Does not have secondary fall protection. No warning label. Does not appear to be watertight.	Replace pump station hatch with one that is watertight. Provide secondary fall protection and proper signage warning of a hazardous environment.	2	1986	2-5 years	30 years	\$10,000

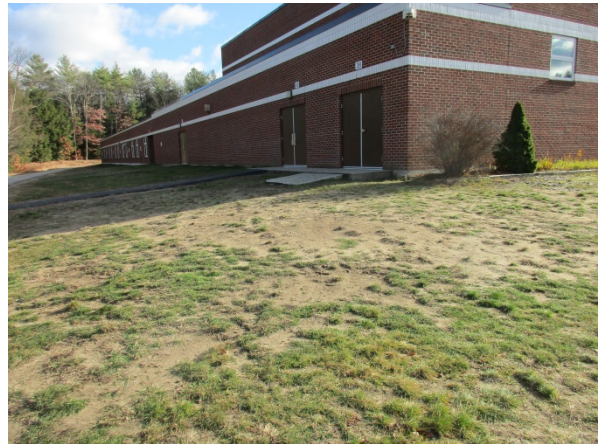
Sparse grass cover at lawn adjacent to school.

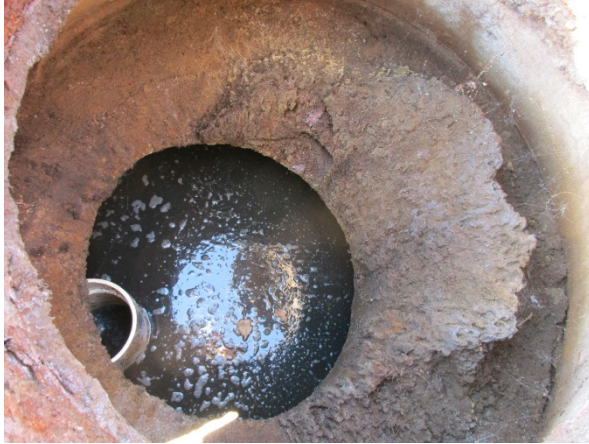
Sediment piled on top of septic tank, beneath access hatch.

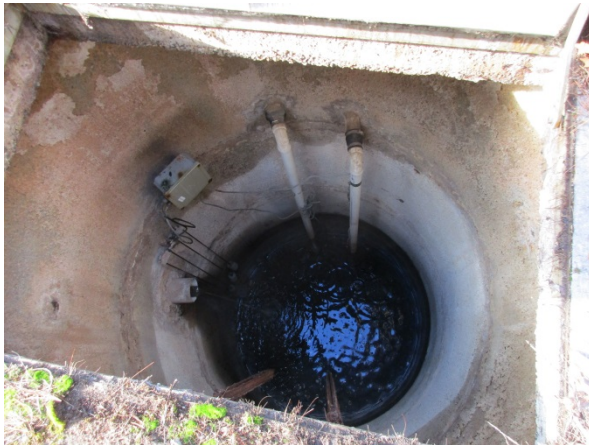
Pump station interior- note corroded guide rails & lack of secondary fall protection.

Pump guide rails and lifting chains	Existing guide rails have corroded beyond the point of being usable. Lifting chains are corroding.	Replace guide rails and lifting chains with stainless steel components.	2	1986	2-5 years	30 years	\$10,000
Pump station vent	Vertical exposed portion is loose and appears to be broken at its bend below grade.	Replace broken component of vent pipe so it is securely connected to the underground portion of the pipe.	2	1986	<2 years	30 years	\$500
Primary distribution box-east end of field	The concrete structure is not wrapped in a separation fabric, like the other distribution boxes. Soil is seeping into the box through the joints around the cover.	Place a geotextile separation fabric over the entire top of the distribution box and wrap the edges a minimum of 6-inches down each side.	3	1986	<2 years	30 years	\$500

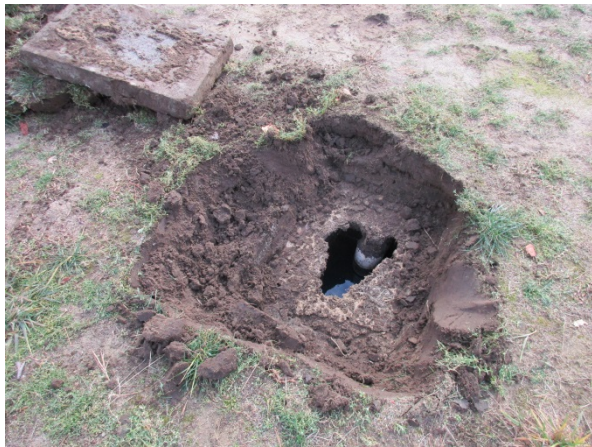
Interior of distribution box installed with no separation fabric.

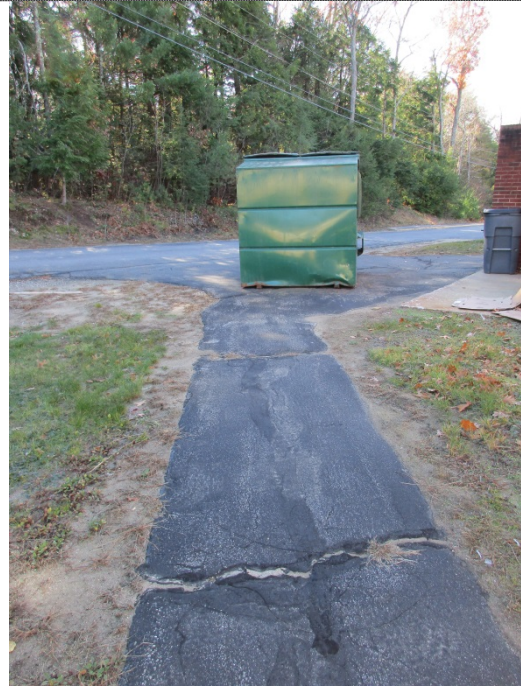
Dumpster obstructing sidewalk.

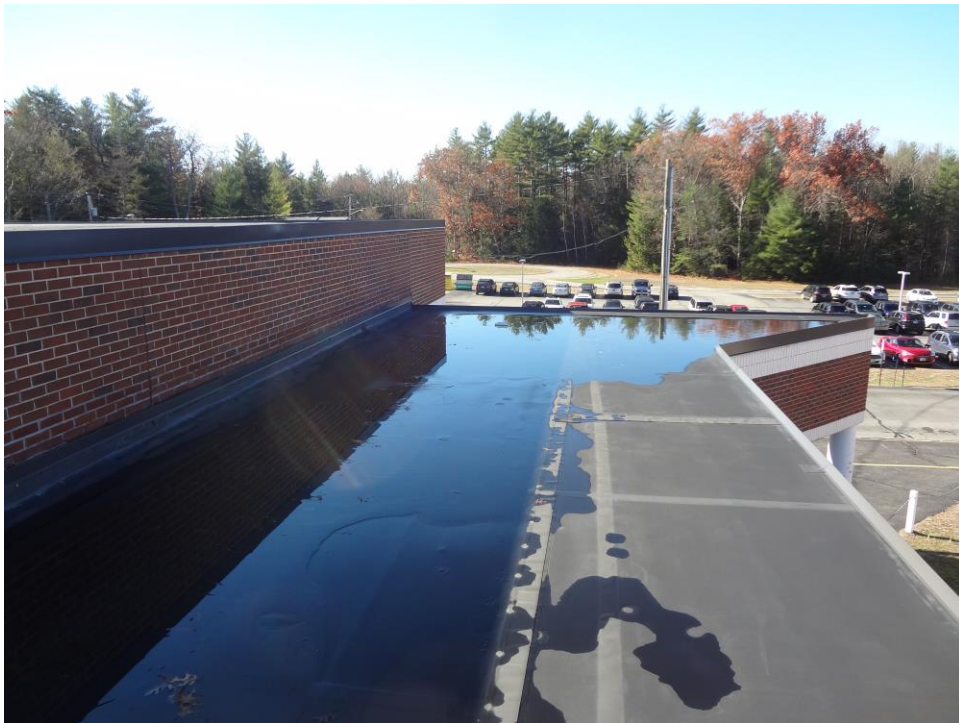
Ponding at Entry Low Roof

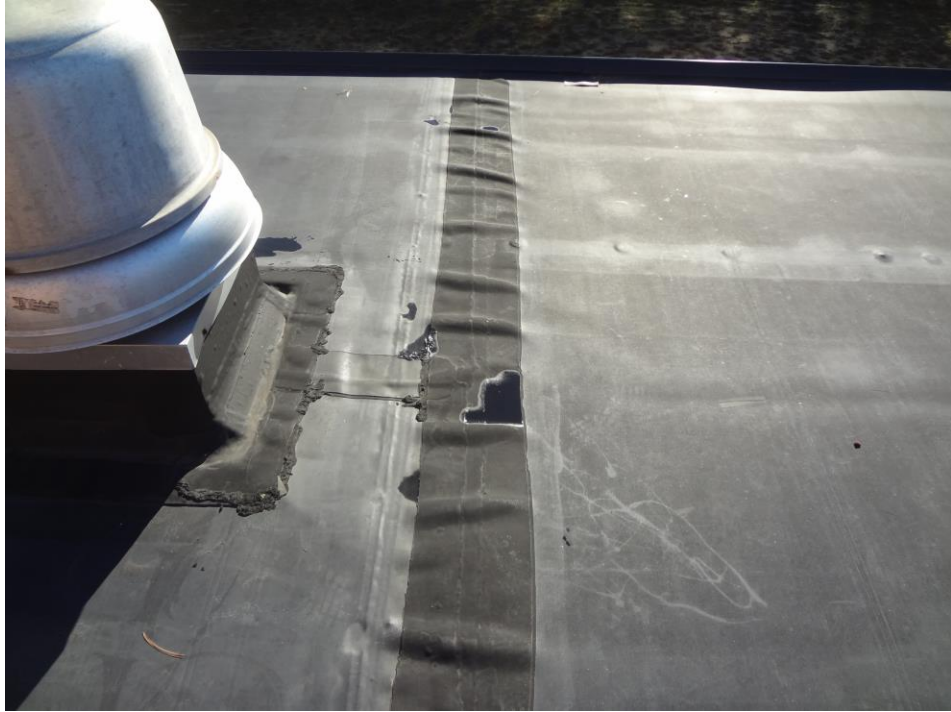
Roof Seam Repair

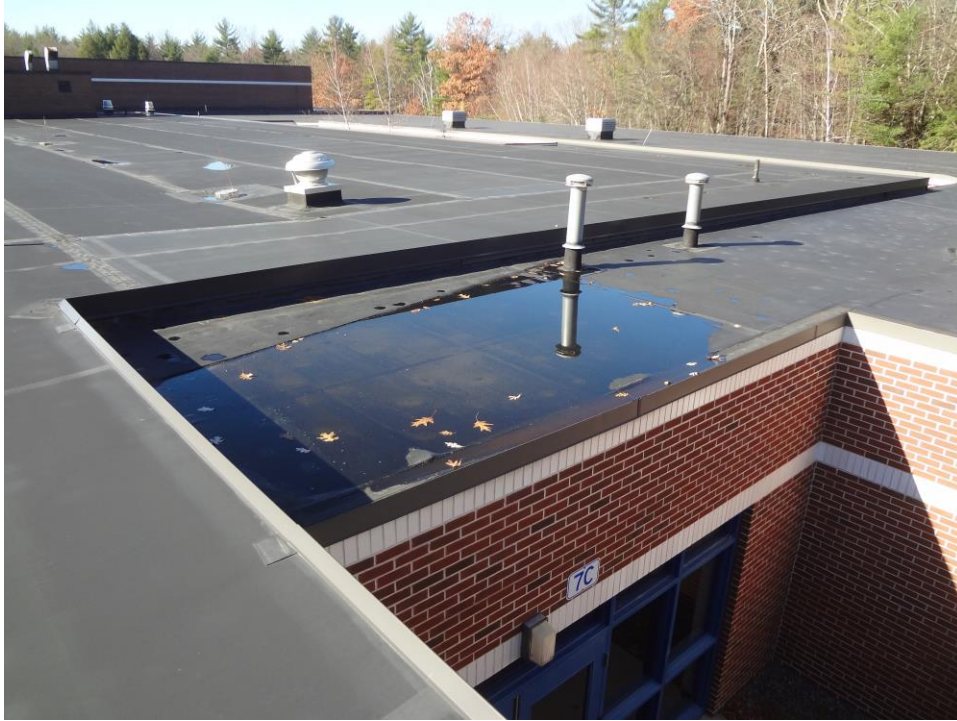
Ponding at Low Roof

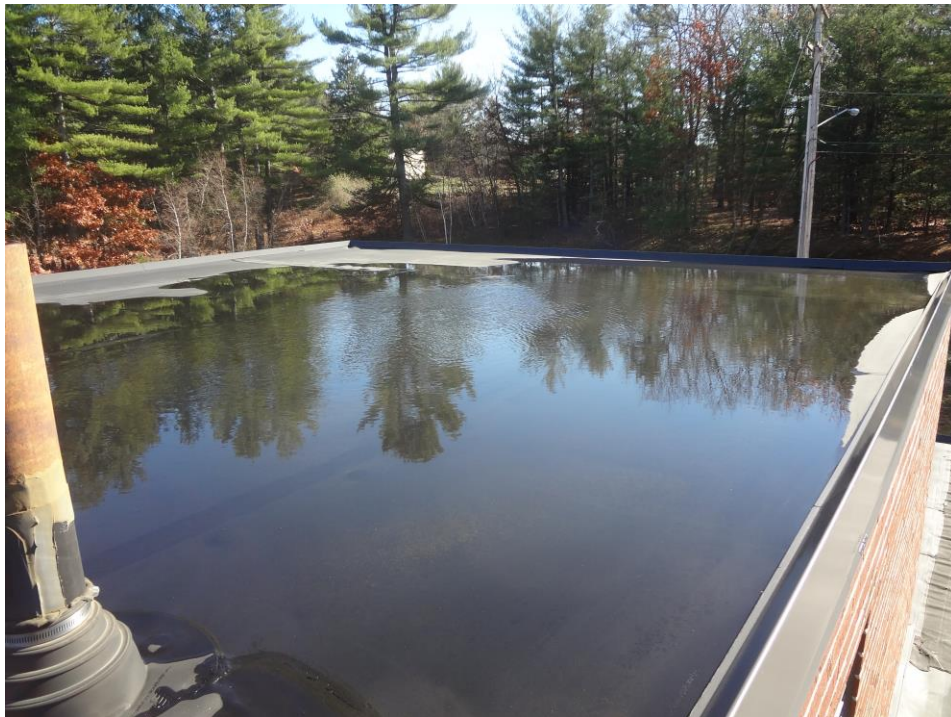
Ponding on Mechanical Area Roof

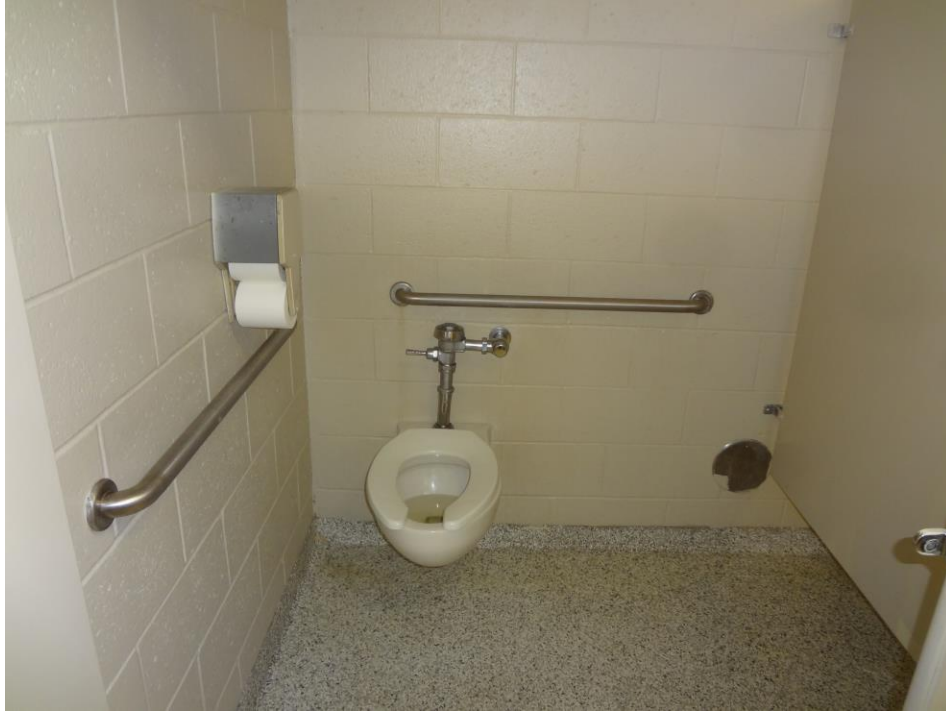
Door installed on wrong side of toilet stall

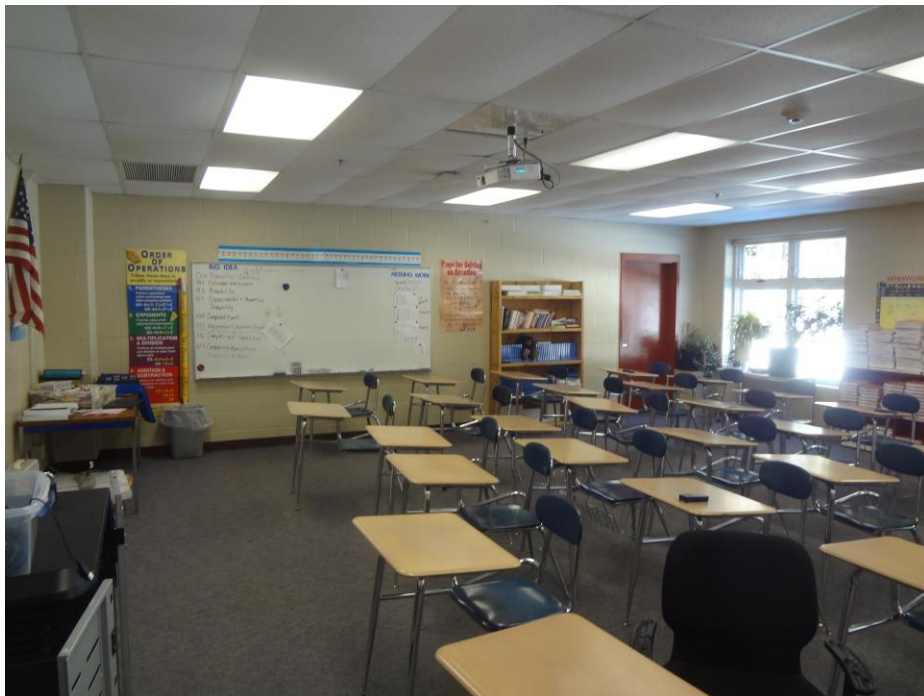
Example of sagging ceiling tiles through building

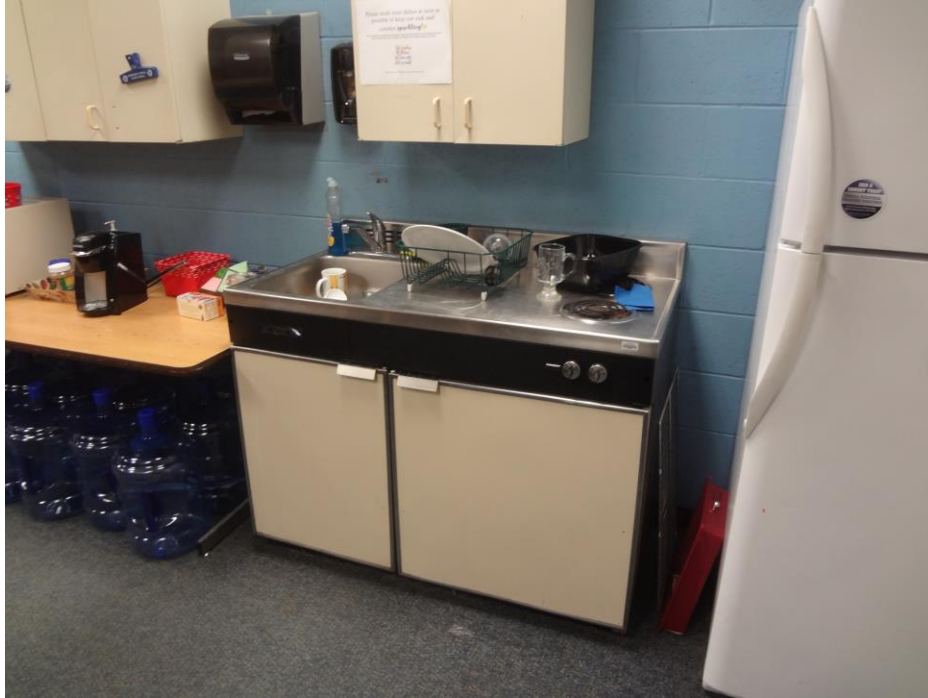
Non-functioning unit kitchen

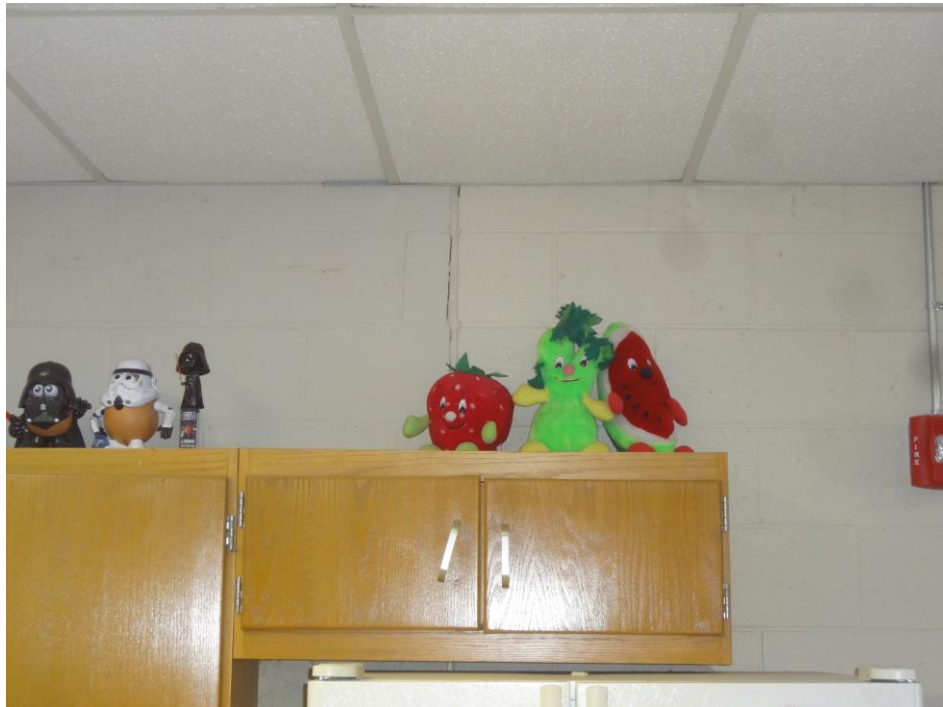
Control joint to be resealed

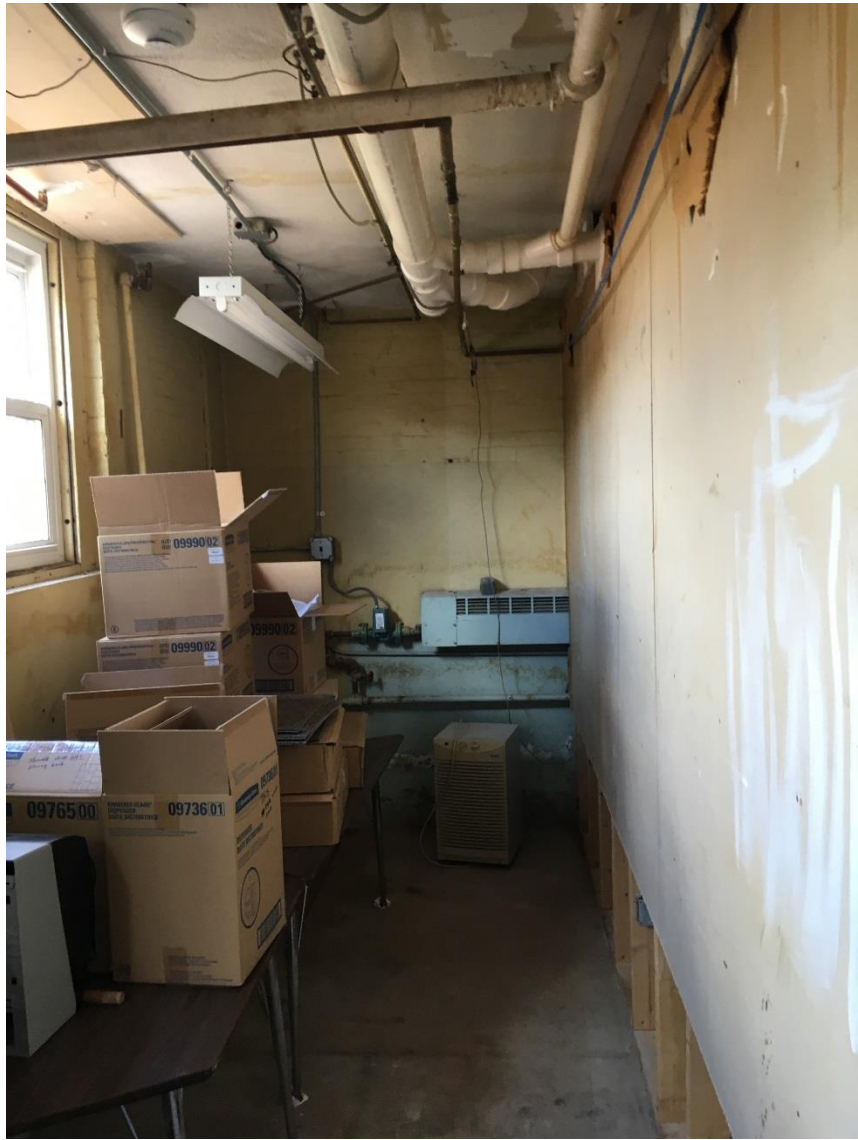
# Lower Level

The building does not have an operational ventilation system and the heating system appear to be beyond its service life. Staff has noted that the lower level has flooded in the past. There is evidence of water vapor intrusion in the lower level. The site has a high water table which would not allow for the installation of a foundation drain.

With the smaller classroom sizes and difference in floor levels the use of the building as teaching space is limited. The existing classrooms do not meet state standards for classroom size. The area floor levels do not have to be accessible if the service being provided in the building can be provided in another location in the building for students that can't ascend the stairs. Due to the past flooding and present use of the lower level we would not recommend occupancy on that level.

The only recommended use for the second floor would be as an office space for different teaching staff or as a tutoring space. However, we would not recommend this be undertaken without a full renovation of the floor level and the lower level portion leading to the stair. A means of reducing the vapor intrusion to the second floor would be recommended.
